Nagpada Police Hospital complex

Card No.: E-1			
	Ward (Part): E IV			
	CS No.: 1447			
	Plot Area: 4992.60 sq.m.			
	B U Area: Not available			
	Date: June, 2005			
	Record by: Ojas P, Gauri J			
	Review by: Neera Adarkar			
	Internal: As above			
External: As above				
Photo Ref.: T-III-E:Ward E\ Nagpada Police Hospital complex

1.0	Denomination			
1.1	Name of Premises	Nagpada Police Hospital complex		
1.2	Earlier Name	Not applicable		
1.3	Built in	Late 19 th century	Extension Date (if any)	Not applicable

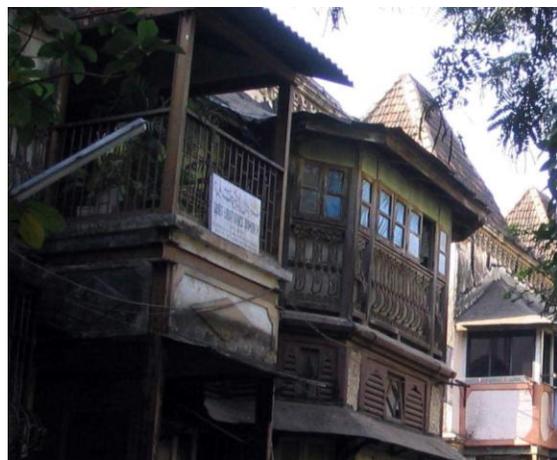
Carved wooden balconies replaced by parapet walls at some places

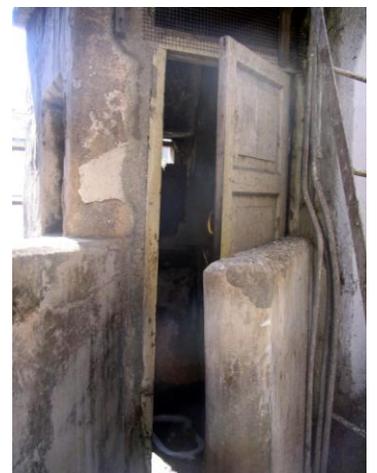
Toilets need heavy repairs

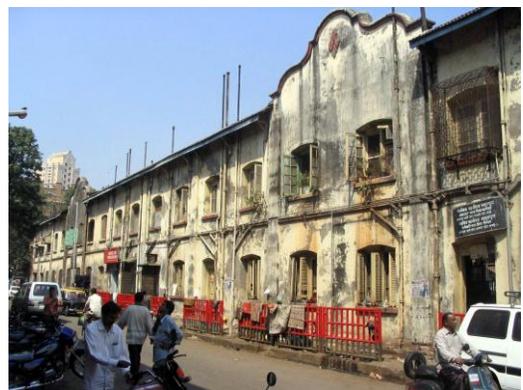
Leakage from the downtake pipes damage the plaster

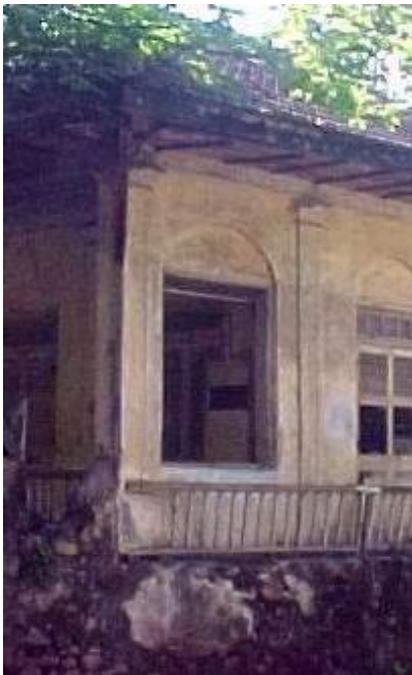
Settlement of plinth observed near the road
