LISTING & GRADING OF HERITAGE BUILDINGS & PRECINCTS IN MUMBAI  
 TASK II: Review of Sr. No. 317 to 632 of the Heritage Regulations

622		D.L. PERIERA'S VILLA - VILCDAMERZ	
 	Common Ref no:2005/GII/622		 
	Card No.306		
	Ward (Part) H- West		
	CS No. 434-B		
	Plot Area 117 sq m		
	B U Area NA		
	Date 30 <sup>th</sup> March 05		
	Record by Aishwarya Tipnis		
	Review by Abha Lambah		
Int AT Ext AT			
Photo Ref 622a-622ac

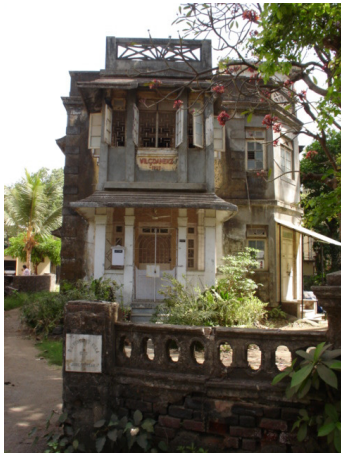
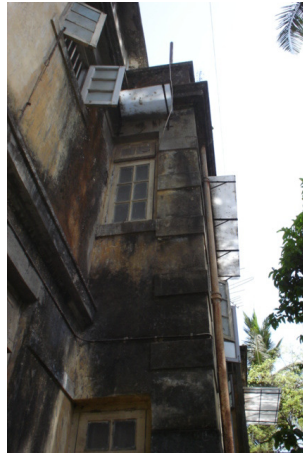
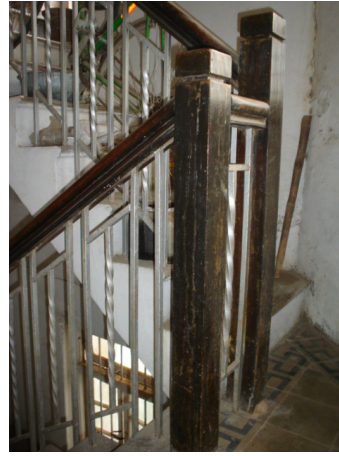
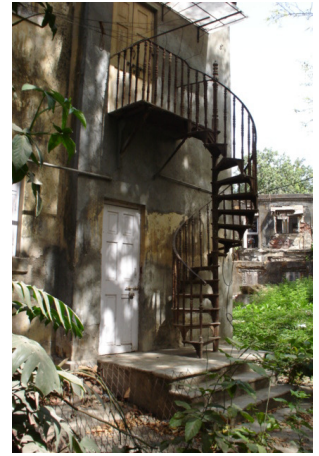
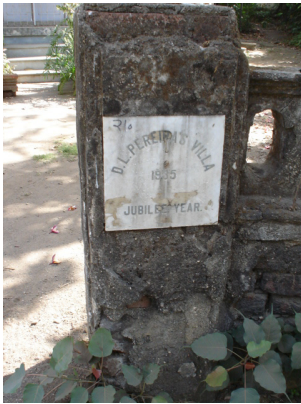
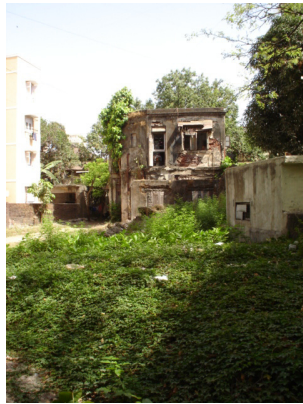
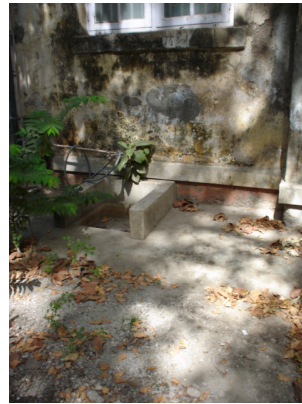
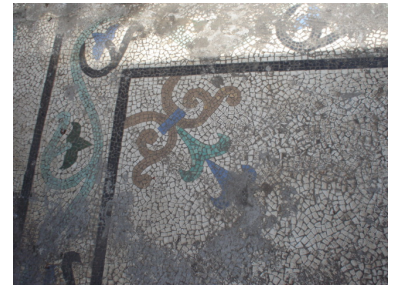
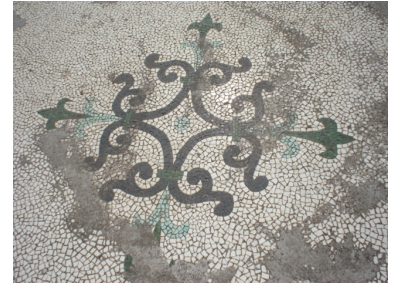
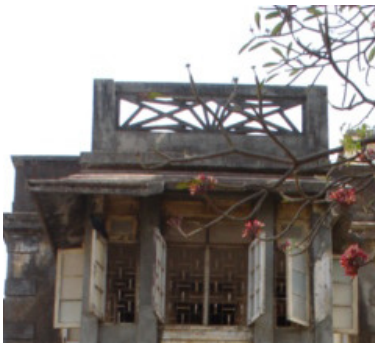
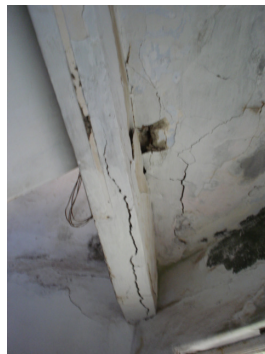
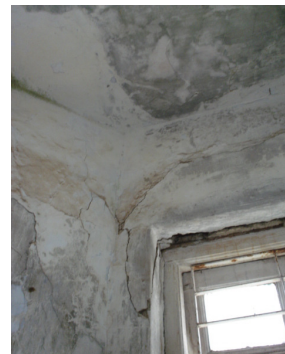
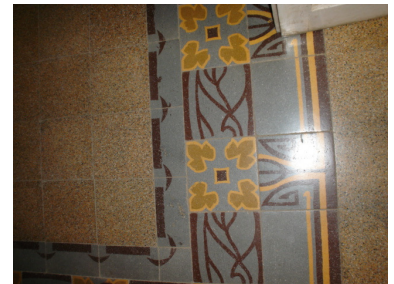
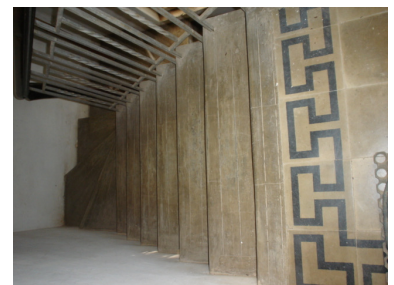
622 | D.L. PERIERA'S VILLA - VILCDAMERZ

9.2	Walls	As most tenanted properties, the building is in need of immediate repairs, water seepage from the roof is predominantly of concern. Water seepage has led to weakening of the masonry and paint flaking. Some recent repairs have been carried out in cement plaster on the facades.

9.4	Stairs	The building is in need of structural consolidation, large structural distress cracks are visible at the landing at the second floor level. The cast iron staircase however is in a good condition.

622	D.L. PERIERA'S VILLA - VILCDAMERZ	
		and warping. Fibre glass chajjas have been introduced some openings along the side façade.
9.6	Roofing	The building is in need of structural consolidation, large structural distress cracks are visible on the roof. Water seepage from the roof is a problem plaguing the building leading to further adding to the structural distress.

9.7	Articulation & Finishes	Most of the stucco plaster has been redone in cement plaster, china mosaic on the terrace is on a bad shape, the cement chajjas also show signs of deterioration with reinforcement bars exposed at some places.

9.10	Overall Condition	As the building is tenanted, with rents frozen at Rs 40, the owner does not get enough to maintain the building and the tenants do not maintain the building shirking their responsibility as a result the building is neglected and in immediate need of structural consolidation. Maintenance level Poor needs immediate structural consolidation.

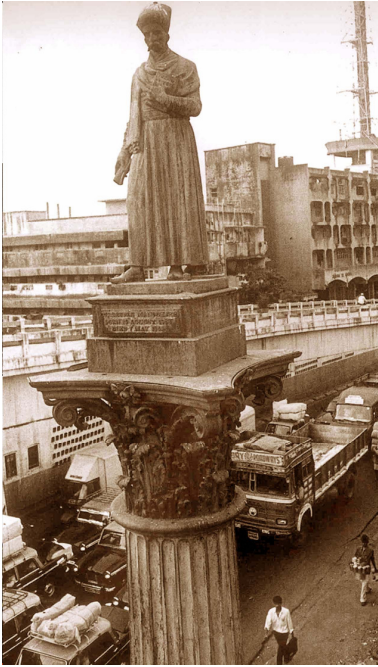
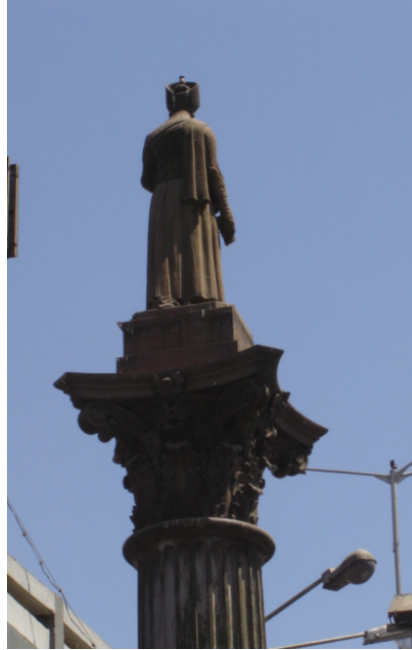
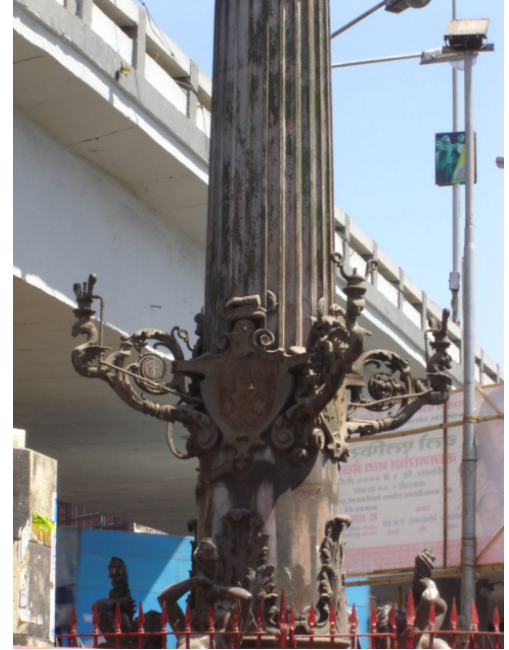
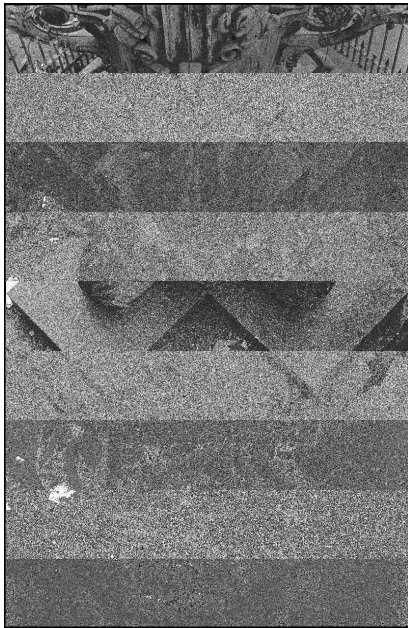
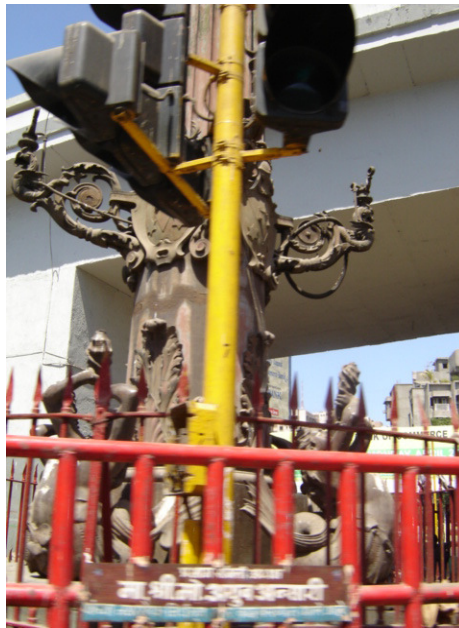
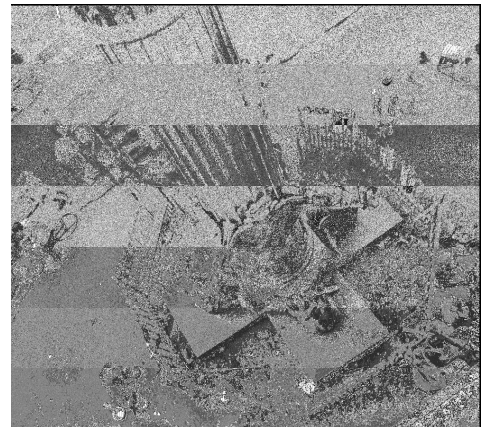
625 KHADA PARSİ STATUE

7.11	Curtilege/ Un-built space/ out buildings/ landscape	The urban landscape has been marred by the construction of the flyovers that completely dwarf the Khada Parsi Statue. Moreover, the design of the mild steel railing around the statue is most incongruous and to add to this, is the appalling condition of the immediate vicinity of the statue. There are hawkers and street dwellers who sell shoes in the immediate curtilege of the bronze statue, drying clothes on the railing and the space is badly neglected.

9.2	Walls	The statue shows signs of damage at the base and decorative elements such as the four cast iron and glass lamps that once surmounted its ornate brackets, are now missing. The bronze also shows signs of extensive corrosion and staining.

9.4	Stairs	Not Applicable
9.5	Openings	Not Applicable
9.6	Roofing	Not Applicable
9.7	Articulation & Finishes	The decorative elements such as the four cast iron and glass lamps that once surmounted its ornate brackets, are now missing. The statue shows signs of damage at the base and the details exhibit signs of extensive corrosion and staining.

9.10	Overall Condition	Poor Maintenance level: Non-existent A yellow and red painted iron fence that has been installed around the historic statue seems to be most inappropriate, given the scale and visual character of the statue. It is most often used by the local street dwellers to hang clothes and is testimony to the utter lassitude of the Municipal authorities. The immediate vicinity of the base of the statue, where a stone cistern once stood, is practically reduced to a garbage dump. The condition of the Khada Parsi statue highlights the contemptible indifference shown by civic agencies towards the upkeep and maintenance of the city's prime heritage.

10.2	Structure	The structure has not been transformed but the incongruous red painted iron fencing around the structure is most inappropriate.
10.3	Articulation & Finishes	The bronze shows signs of deterioration and corrosion. The original lamps are now missing.

625	KHADA PARSI STATUE	
11.0		<b>DP REMARKS/PERCEIVED THREATS</b>
12.0		<b>ADDITIONAL NOTES/ REFERENCES/ DOCUMENTS AVAILABLE/ RECOMMENDATIONS &amp; SUGGESTIONS FOR IMPLEMENTATION</b>
		<p>An important urban artefact like the Khada Parsi statue deserves a greater sensitivity in terms of its site planning and setting. This has been unfortunately neglected while designing the traffic routing and site context of the statue has been radically transformed. In the light of this, it may be well advised to shift the statue to a more appropriate site, perhaps an equally evocative urban node or such setting that would do justice to its heritage value. It is not, as a rule recommended to shift or relocate a historic artefact, but there have been cases, where it becomes necessary for the safety of the artefact, as well as its need for a sympathetic environment, to suggest such an action. The Khada Parsi statue is in dire need of restorative intervention to address the corrosion that has damaged its fixings and decorative elements. There may also be a case perhaps, for restoring its cistern and hydraulic works, in case a comprehensive restoration project is undertaken. The missing lamps should be re-constructed at a future date, since specific archival evidence in the form of old photographs depicting the design of the lamps is available.</p>

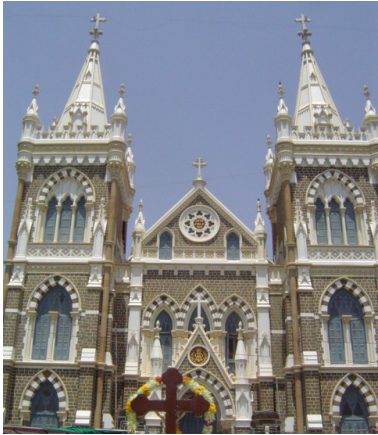
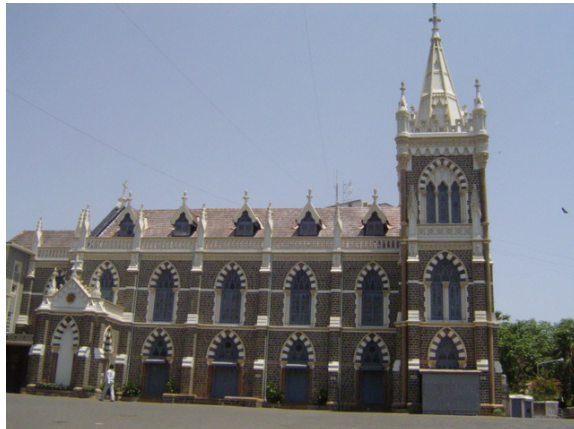
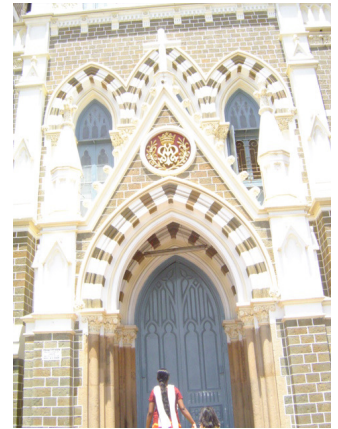
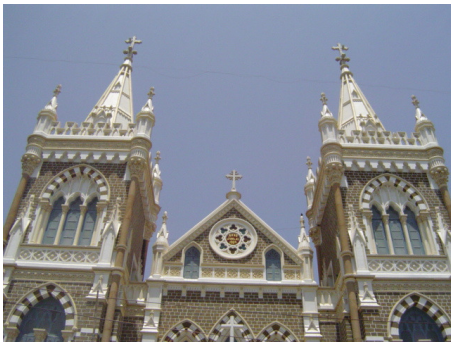
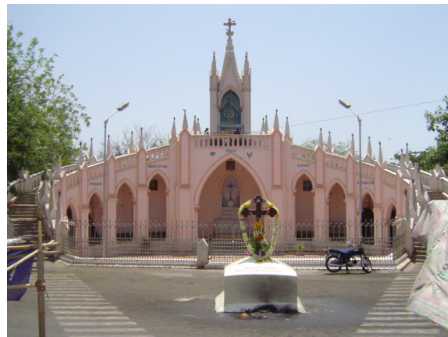
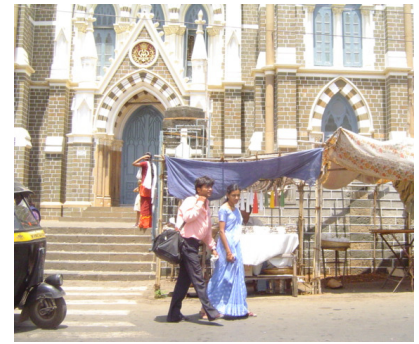
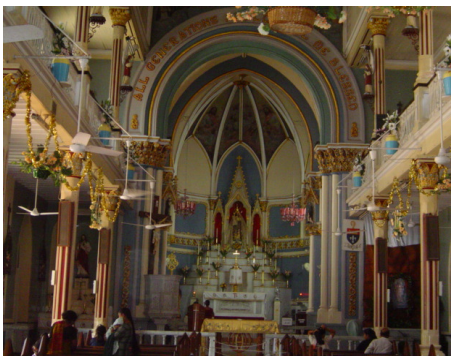
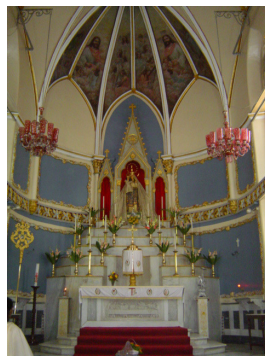
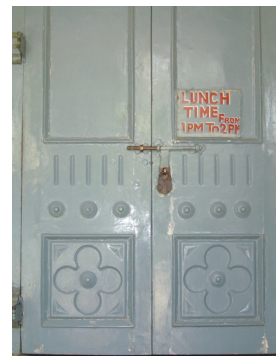
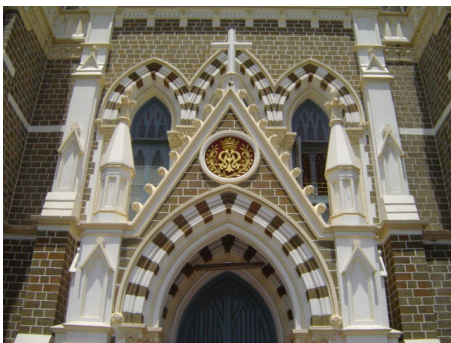
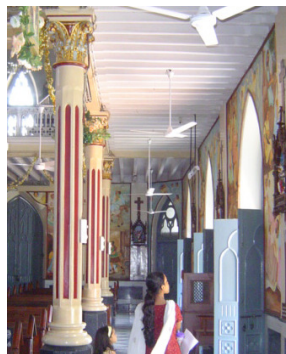
626 MOUNT MARY CHURCH

9.0		<b>CONDITION</b>
9.1	Plinth	Sound condition. No major defects except that flower beds are planted close to the plinth.
9.2	Walls	Considering the 20 <sup>th</sup> century construction of the church, it is not surprising that the building is quite well maintained and is in good stead. The pointing along the northern face of the structure however, is a hard ribbon pointing and looks rather ungainly. Another issue that is typical of structures with external plumbing lines, is the incidence of <i>peepal</i> plants, generally sited close to rain water down take pipes. Some amount of paint flaking is visible along painted columns

9.4	Stairs	No visible threat
9.5	Openings	No visible threats except minor paint flaking or such superficial damage
9.6	Roofing	In sound condition
9.7	Articulation & Finishes	in sound condition except the excessive use of oil paints that is aesthetically a bit gaudy

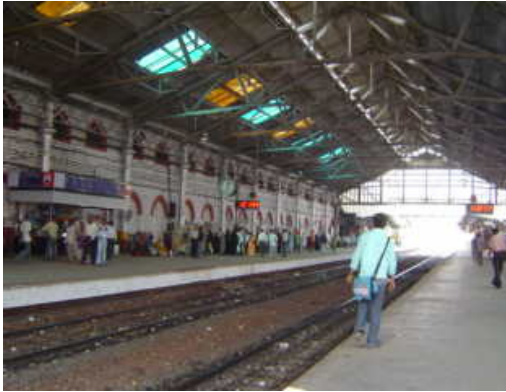
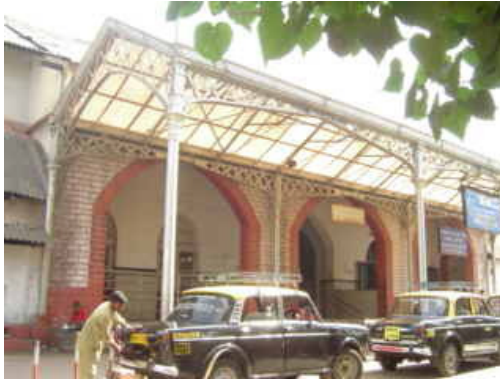
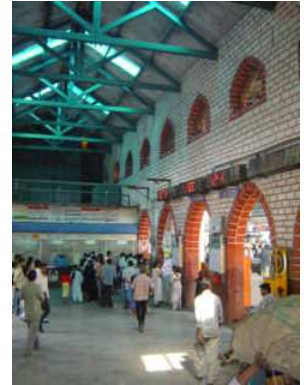
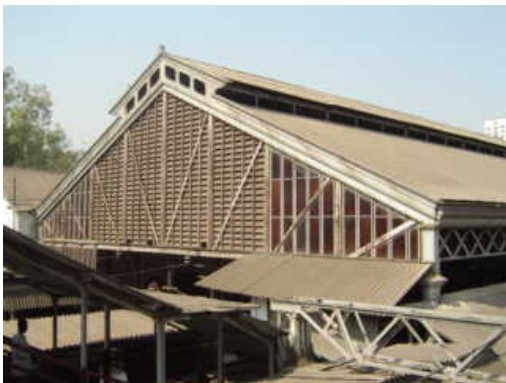
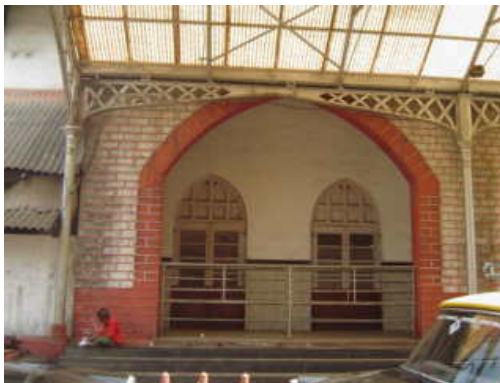
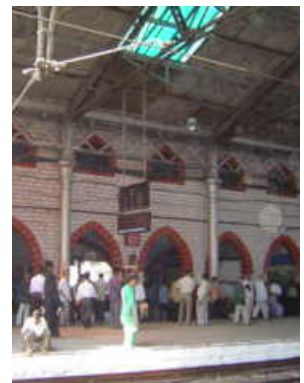
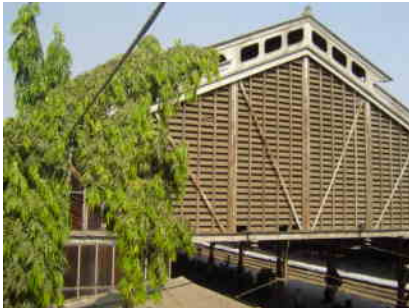
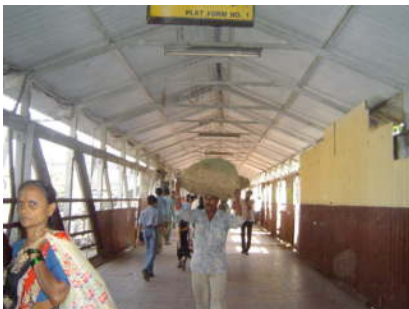
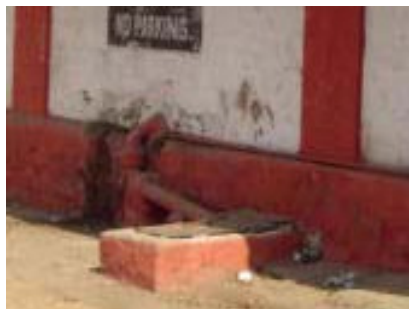
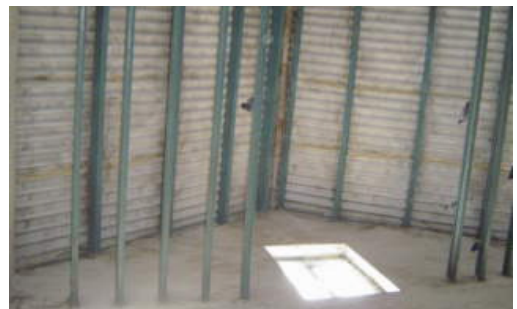
9.0		<b>CONDITION</b>
9.1	Plinth	The plinth shows algae growth in places where there is accumulation of water due to lack of proper slopes of the surrounding site and inappropriate location of service pipes, etc. Unsightly plumbing and pan stains destroy the visual ambience.

9.3	Floor	The Polished Kota stone has been replaced by ceramic tiles, which totally modifies the original character of the structure.
9.4	Stairs	The stairways along with the bridges have not been maintained well over the years and hence shows a lot accumulation of waste, pan stains, etc.

627	BYCULLA RAILWAY STATION
	<p>attention to its cleanliness and upkeep. Insensitive additions such as patterned acrylic panels along the roof should be carefully removed and the gable ends restored to their original timber louvered pattern. Efforts at integrating the floor finishes through the structure should be made, to create some kind of conformity in type of materials.</p> <p>Care should be taken in any future repairs, that the historic fabric is not lost and if inevitable should be replaced with a sensitive design and material, ideally replicating existing details and with reversible techniques.</p>
