Card No.: G/n-1

Ward (Part): G north-V

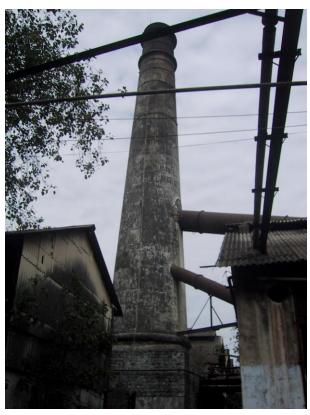
View of brick masonry chimney with boiler room
