LISTING & DOCUMENTATION OF HERITAGE SITES IN THANE DISTRICT

URBAN AREAS

MUMBAI METROPOLITAN REGION HERITAGE CONSERVATION SOCIETY

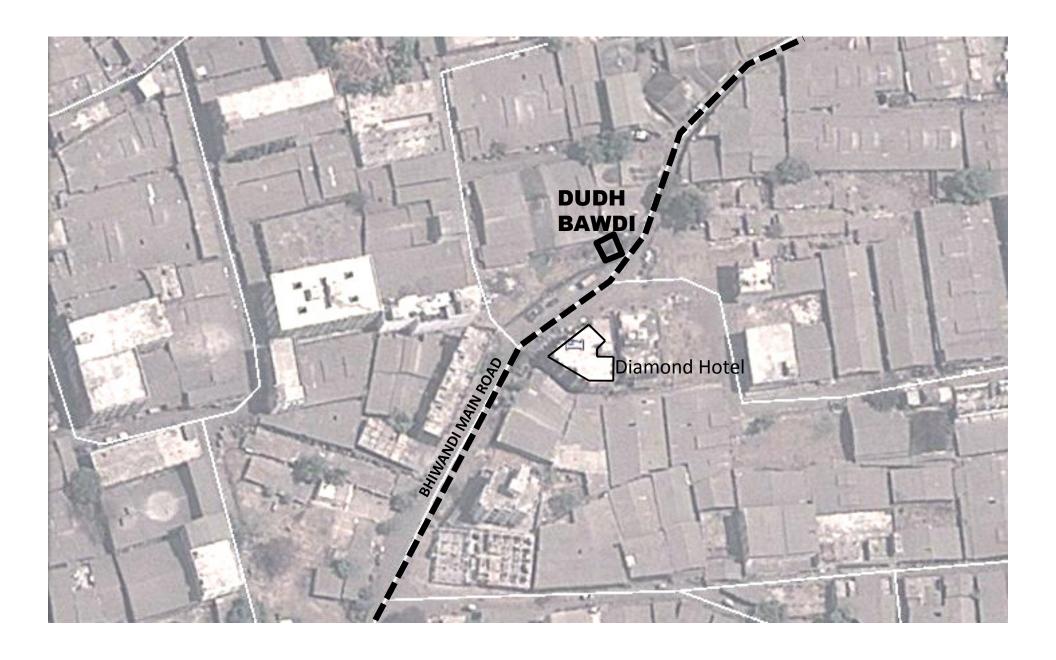
SITE NO:BWU2 NAME: DUDH BAWDI

3.04	Plinth	Not applicable	Not applicable	-
3.05	Walls	Stone masonry walls	Not maintained at all	Major Repair
3.06	Floors	Not applicable	Not applicable	-

3.07	Stairs	Stone steps	Not maintained	Major Repair
3.08	Openings	Not applicable	Not applicable	-
3.09	Roof	Not applicable	Not applicable	-
3.10	Articulation	Not applicable	Not applicable	-

3.22	Overall Maintenance Status	The Bawdi lies absolutely neglected and is currently used for dumping garbage.		
3.23	Overall Condition	Major Repair

Garbage dumping in and around the bawdi

4.03	Guidelines for Intervention: The bawdi should be cleared of weeds and other wild vegetation. The water inlets and channels feeding it should be cleaned so that the well is once more revived. 5 m all around the bawdi should be kept free of an construction. Structural repairs should be carried out, if required. But the work should not be undertaken in an indiscriminate manner. The repair/restoration work should be undertaken under the guidance of a local historian, a conservation architect and a structural engineer experienced in carrying out repairs of such historic structures. These interventions must be documented in written records. It is recommended that a board/plaque be installed near the bawdi, narrating its historical significance.

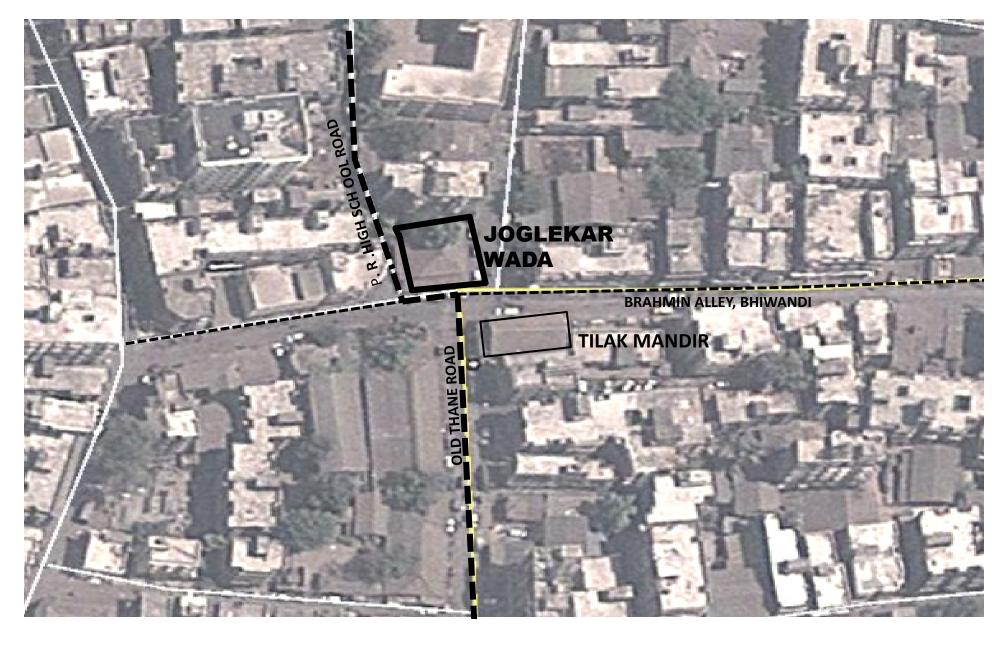
SITE NO: BWU3

3.01	Height	9m approx.		
3.02	No. of Floors	G+1		
		Description	Problem/Threat	Condition
3.03	Structural System	Load bearing structure with stone masonry on ground floor and brick masonry on first floor	Poor- cracks are seen	Major Repair

3.04	Plinth	0.6m high black basalt stone plinth	Poor (cracks and settlements observed)	Major Repair
3.05	Walls	450 - 600mm deep thick black basalt stone walls. Load bearing structure. Brick wall at first floor level.	Poor (dirty and rough finishing)	Major Repair

3.08	Openings	Flat lintels with full height window openings with wooden shutters at 1st floor level. Few windows have been sealed with roughly placed bricks for internal partitions. Rectangular window frames with glass shutter openings at ground floor level.	Poor (few openings have been sealed)	Major Repair
