STUDY, RESEARCH AND DOCUMENTATION OF MARINE DRIVE PRECINCT FOR MUMBAI METROPOLITAN REGION HERITAGE CONSERVATION SOCIETY STUDY CONDUCTED BY RIZVI COLLEGE OF ARCHITECTURE **CONSULTANCY CELL** MARCH 2001

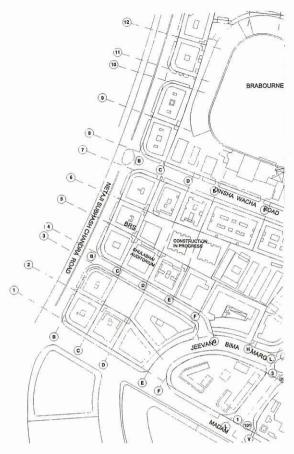
**Drg. 3. Enlarged detail for grid reference** Source RCACC 1999/2000

4.4 Refer Drg 3 & 4 for enlarged detail and grid reference system of Marine Drive precinct respectively.

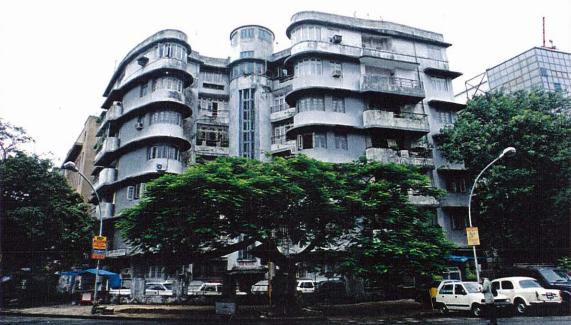
OPICINAL FACADE IN A SPATE OF GEVERE DECAY CRACKS EVIDENT, FICUS GROWTH AT BALCONY/PIPE JUNCTIONS

4.6.2 Construction and façade details, architectural quality, fire precautions, main and subsidiary access, parking requirements, parking provisions and potentialities of use were noted for each of the five hundred and forty eight buildings. Refer Sample Surveys No. 5 to 13 attached herewith.

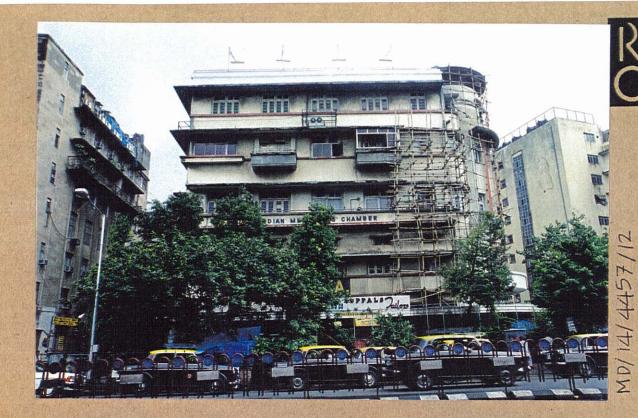
Plot 76 Address V. NARIMAN RD. MUMBAI-20 Floors 5

E ESCAPE / GERVANIS STAT	RCASE
	E ESCAPE STAIRCAGE NOT US	
a) D	HE TODILAPIDATED STRUCTUR	
	IMPED WITH GARBAGE ISTO	PACIE
Natural		
Lighting		
Existing 4001	- THROUGH BALCONY AG W	ELLAS IDIEDIDAU
	EXTERNAL PEDETRATION	
Potential	STAIRCASE PLOCE WITH G	ENTINUOUS VERTICAL
	volidado aperiag.	
Access		
Main Access	JAMGHED TATA ROAD.	
Subsidiary	TWO MAID, ODE OF WHICH IS	SUDT IN USE AS
Access

- Recess	IT IS ENCHROACHED BY	
Potential	FROM CHANKAR JAIKISHA	
Access		PRIVATE USE OF
*Access		RASHA RESTAURANT
Vehicles		
Vemeres	SAME AS ABOVE.	<b>建筑市村</b> 第二十二年
Parking	2.000000000000000000000000000000000000	
Requirement	20 (L.M.V - WHIT MOTOR VE	HICLE) 3 TWO-WHEBLEY
	15 PARICED IN COMPOUND	
Provision	(3 PARIETO II- CONFOCIETY	POAD :
	OPEN PARKING FOR MEDUT	
	GARACIES OUT OF COLICH & AN	
Contilana		
Curtilege	DESTAGRAM.	4 5000 C EASNA
Unbuilt Space	PESTACIPALTI.	
Unbuilt Space	PART OF GIDE OPEN SPACE	FINANCED BY
	PART OF GIDE OPEN SPACE PARNA RESTAURANT , COMP	FULLOSEID BY BUND DIACL
Unbuilt Space Outbuildings	PESTACIRALITY  PART OF GIDE OPEN SPACE  PARNA RESTACIRANT I COMP  PILAPIDATED WITH CORROR	FULLOSEID BY BUND DIACL
Unbuilt Space	PESTAGRANT:  PART OF GIDE OPEN SPACE  RAGINA RESTAGRANT: COMP  PHAPIDATED WITH CORROR  1)	FULLOSEID BY BUND DIACL

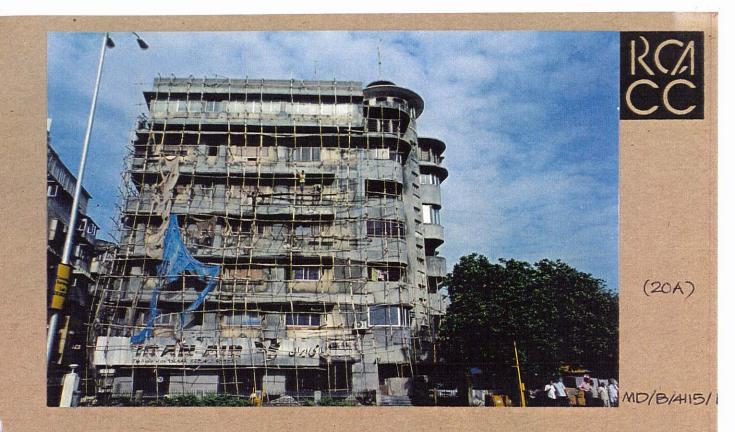
Plot 141 Address 141, 5 C BCSE ROAD, MUMBAI - 20 Floors 7

Fire Precaution	<b>在10年,1987年,1987年,1987年,1987年</b>
FIRE	ESCAPE STAIRCAGE IN CHOOK NOTFUTIONAL AS
	T OF NON ACCESSIBILITY
Natural Lighting	
	. THROUGH INTERNAL CHOOK & EXT WINDOWS
Existing GOOD	BUT MOSTLY ARTIFICIAL UGIHTING IS USED FOR
Potential	THE INDOOR.
	CHOWE COULD BE USED AS EXCELLENT WANT &
Access	VENTILATION SHAFT.
Main Access	FROM CORNER (AT JUNC" OF VEER HARIMAN RO
Subsidiary	& E-ROAD)
Access	TWO SUBSIDIARY ACCESS ROAD
	FROM 1) VEER HARIMAN ROAD
Potential	2) NETAJI BUBASHCHANDRA BOSE
Access	ROAD.
Vehicles	FROM THE TWO ADJOINING ROADS NAMED
	ABOVE
Parking	
Requirement	25/30 CAPS
School Service School Service	
Provision	7/10 CARS
	GARAGE THAT IS PROVIDED IS USED AS
Curtilege	STATIONARY SHOP.
Unbuilt Space	GARAGE USED AS STATIONARY SHOP &
	GO DOWN.
Outbuildings	
	THE COMPOUND WALL AT DLACES HAS BEEN
	BROKEN DOWN BY HOTEL OWNER FOR HIS

BUSINESS PURPOSE.

FACADE PECENTUR REPLASTERED FURDOVES VOST, TW. FRAME WINDOWS REPLACED BY AUUNINUM FRMEDONES

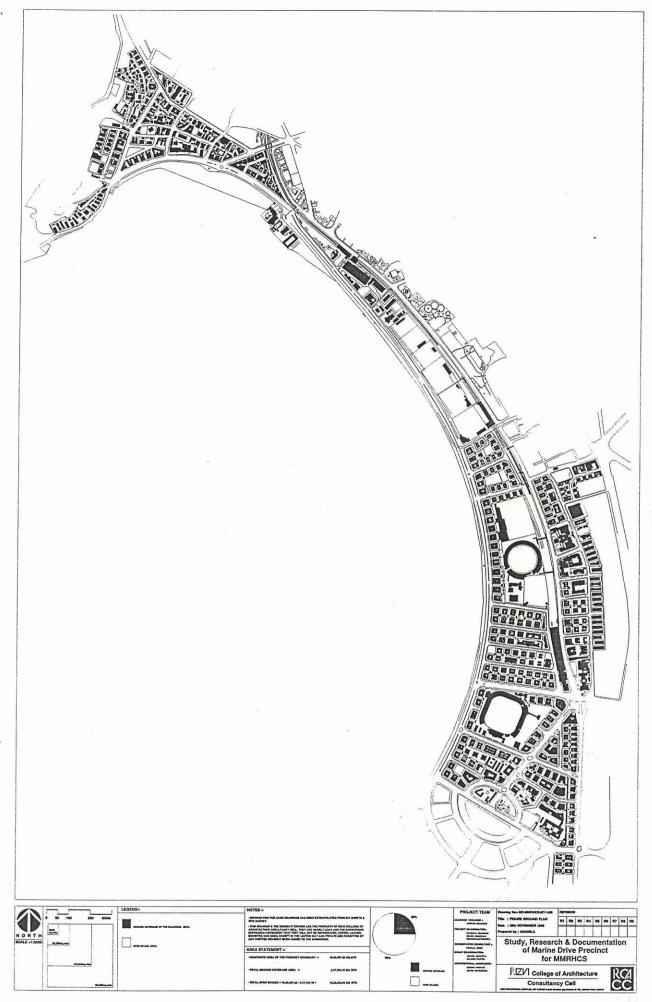
Drg. 18. Open Space and Built Form Pattern I Source RCACC 1999 / 2000

# 5.5 Open Space and Built Form Pattern

Contrast in built form is observed between organically planned and controlled planning mechanisms. The ratio of the ground coverage to the open space (inclusive of the streets) is nearly 1:3 showing lower plot coverage.

Total Built up Area 20,70,375.62 SQ.MTS
Open area 12,22,343.40 SQ.MTS
Plot/plinth coverage 04,17,194.19 SQ.MTS
Precinct area (total) 16,39,537.59 SQ.MTS
BUA/Precinct area = Global F.S.I. 1.2628

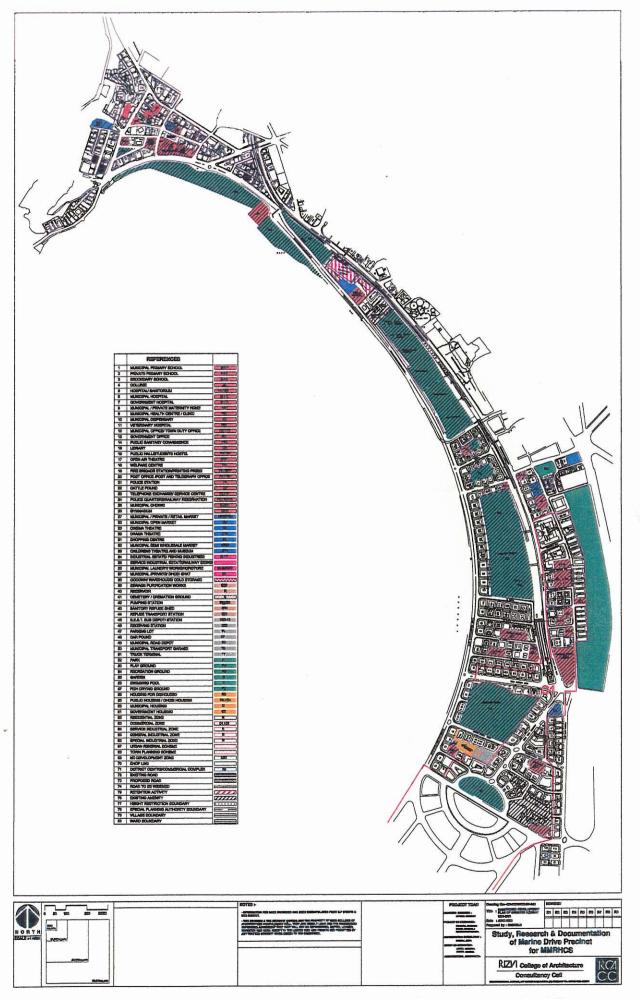
Drg. 20. Proposed Development Plan Land Use Source Greater Mumbai Development Plan 1981-2001 1999 / 2000

#### **5.6** Proposed Land Use Development Plan (refer Drg. 20)

The proposed development plan supports the figure ground survey with substantial span of land reserved as recreation ground for beach, stadia's, gymkhanas, maidans, playgrounds and recreation centres.

Although the area is predominantly residential the southern section adjoining Nariman point CBD and Churchgate station is delineated as a commercial zone. Large concentration of institutional user is observed in area adjoining Churchgate station. The north extremity of Babulnath Mandir and Chowpatty has a mix of commercial, institutional and residential user.

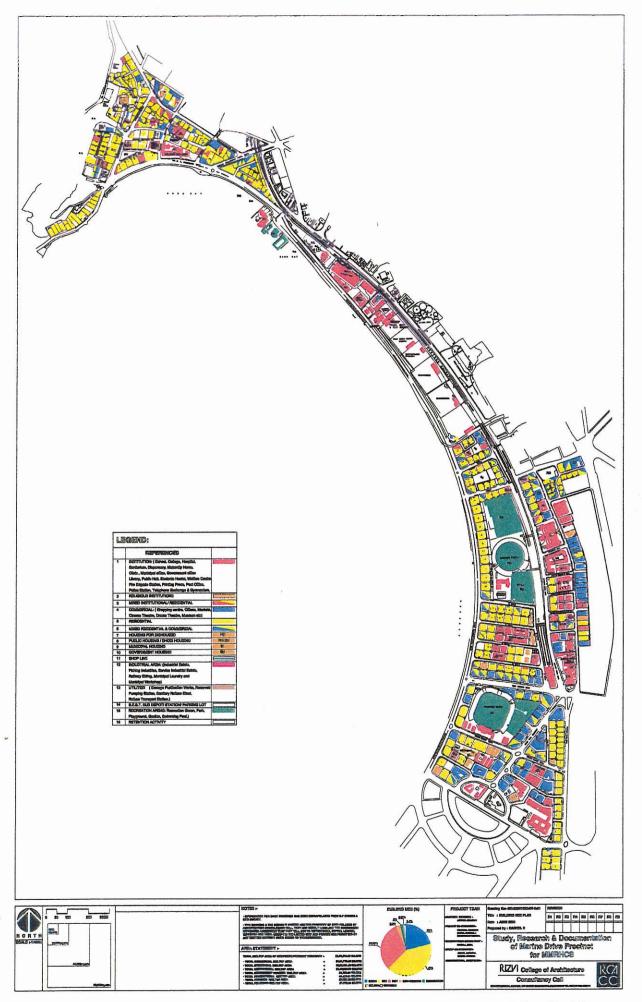
Drg. 21 Existing Building Use Plan Source RCACC 1999/2000

Building use distribution in area of study

Total Built up Area	20 70 375.62	
Residential user	9 26 513.81	(44.75%)
Commercial user	3 97 027.88	(19.18%)
Institutional user	5 71 051.00	(22.58%)
Recreational user	48 737.43	(2.79%)
Utilities	13744.39	(0.66%)
Religious	6655.22	(0.32%)
Public/Govt. Housing	48949.70	( 2.63%)
Others	57696.41	( 2.79%)

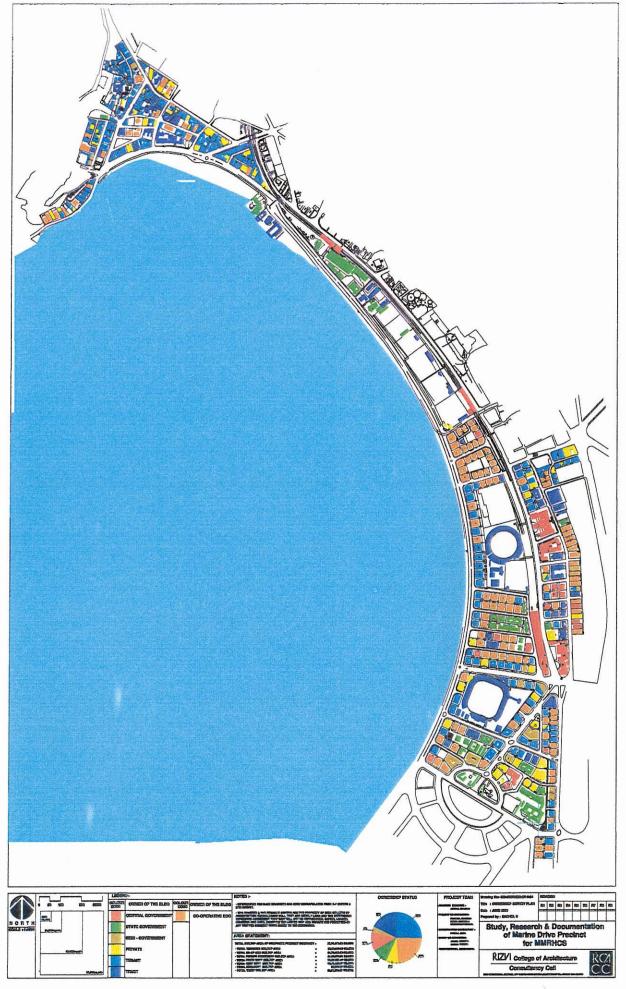
Drg.22 Ownership of Buildings Source RCACC 1999/2000

# **5.8** Building Ownership Survey (Refer Drg. 22)

Total Built up Area	20 70 375.62	
Co-op. Hsg. Society	474110.03	(22.90%)
Tenant	536257.00	(25.90%)
Ownership	148802.72	(22.58%)
Central Govt	197115.40	(9.52%)
Semi Govt	95464.10	( 4.61%)
State Govt	196897.87	(9.51%)
Trust	364032.09	(17.58%)
Others	57696.41	( 2.79%)

The locality encompassing Marine Drive precinct a predominant tenanted pattern followed by state and central government owned buildings. This content of tenanted properties prompts towards guidelines with requisite input conforming to The Maharashtra Housing and Area Development Act, 1976 and the Rent Control Act, 1942.

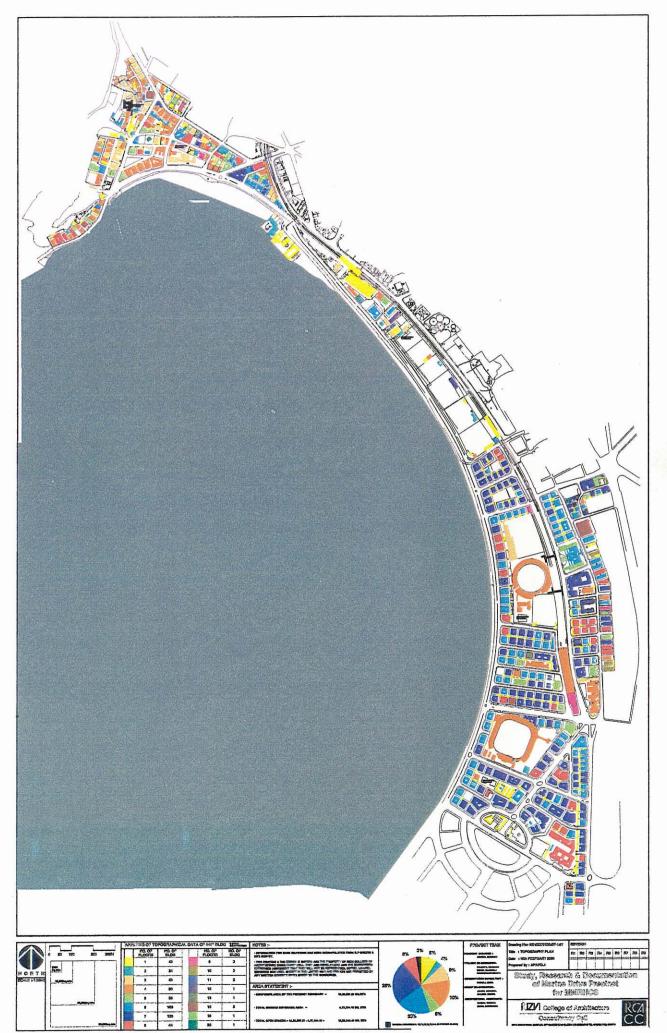
Drg. 23 show height of buildings in Marine Drive precinct making apparent the general topography of the area. The study area consists mostly of low to mid-rises from four to seven stories.

1 storey -	49 nos. i.e.	9.0%
2 storied -	24 nos. i.e.	4.0%
3 storied -	48 nos. i.e.	9.0%
4 storied -	88 nos. i.e.	16.0%
5 storied -	35 nos. i.e.	6.0%
6 storied -	109 nos. i.e.	20.0%
7 storied -	130 nos. i.e.	25.0%
8 storied -	44 nos. i.e.	8.0%
9 storied -	3 nos. i.e.	0.6%
10 storied -	3 nos. i.e.	0.6%
11 storied -	2 nos. i.e.	0.4%
12 storey -	1 no. i.e.	0.2%
13 storied -	1 no. i.e.	0.2%
16 storied -	3 nos. i.e.	0.6%
19 storied -	1 no. i.e.	0.2%
25 storied -	1 no. i.e.	0.2%

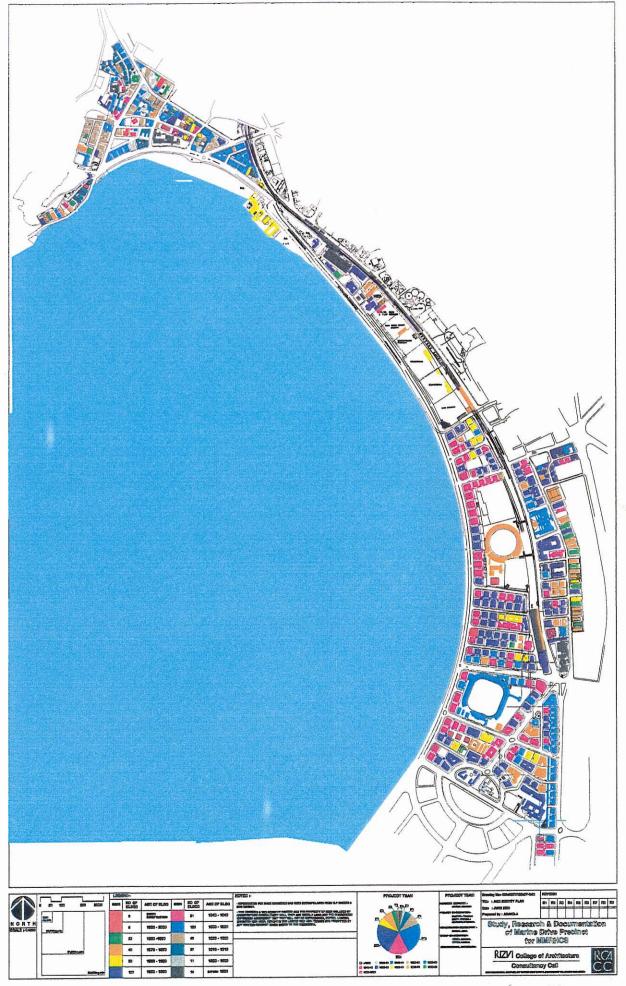
Drg 24 Age of Buildings Source RCACC 1999/2000

# **5.10** Age of Buildings (refer Drg.24)

Before 1900	( >100yrs)	16	( 3%)
1900 – 1909	(100 - 90yrs)	11	(2%)
1910 – 1919	( 90 – 80yrs)	27	(5%)
1920 – 1929	(80 - 70 yrs)	48	(9%)
1930 – 1939	( 70 – 60yrs)	128	(24%)
1940 – 1949	(60 - 50 yrs)	81	(15%)
1950 – 1959	(50 - 40yrs)	127	(23%)
1960 – 1969	(40 - 30yrs)	33	(6%)
1970 – 1979	(30 - 20yrs)	43	(8%)
1980 – 1989	(20 - 10yrs)	22	(4%)
1990 – 2000	( <10yrs)	6	(1%)

With a considerable pressure of transformation on the Marine Drive the structures have so far sustained their scale and expression.

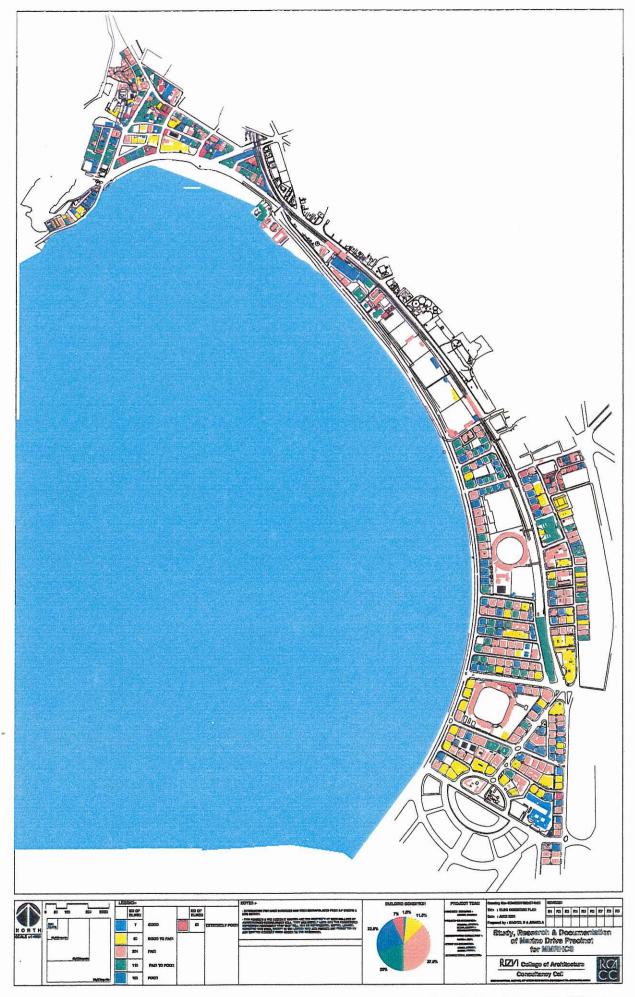
Drg 25 Condition of Buildings Source RCACC 1999/2000

## **5.11** Condition of Buildings (refer Drg.25)

In this survey buildings have been classified on their structural stability and requirement of remedial measures.

38 buildings (7%) are in extremely poor condition urgently requiring complete rehabilitation or reconstruction.

123 buildings (22.5%) are in poor condition requiring urgent major repairs.

110 buildings (20.0%) are in fair to poor condition requiring major to moderate repairs

204 buildings (37.5%) are in fair condition requiring moderate repairs

60 buildings (11.5%) are in good to fair condition requiring minor repairs

7 buildings (1.5%) are in good condition requiring minimum repairs and maintenance

The sea facing Marine drive buildings due to extreme climatic exposure are in need of some immediate measures of repairs. The inner rows of buildings have fared well with exceptions of certain sea facing buildings that adhere to regular maintenance

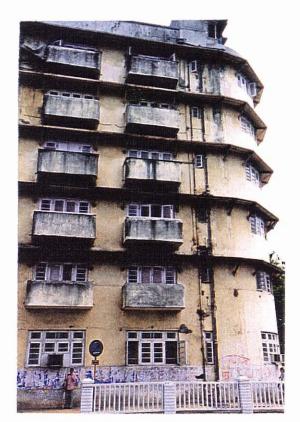
Chhajas Replaced, Moonlight Building Source www.geocities.com

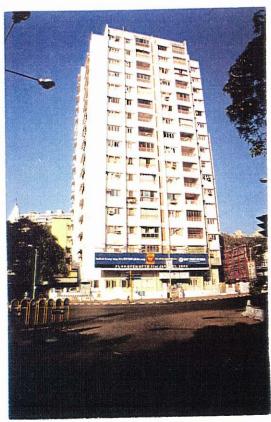
Disharmonious Scale, Aderbad Building Source RCACC 1999/2000

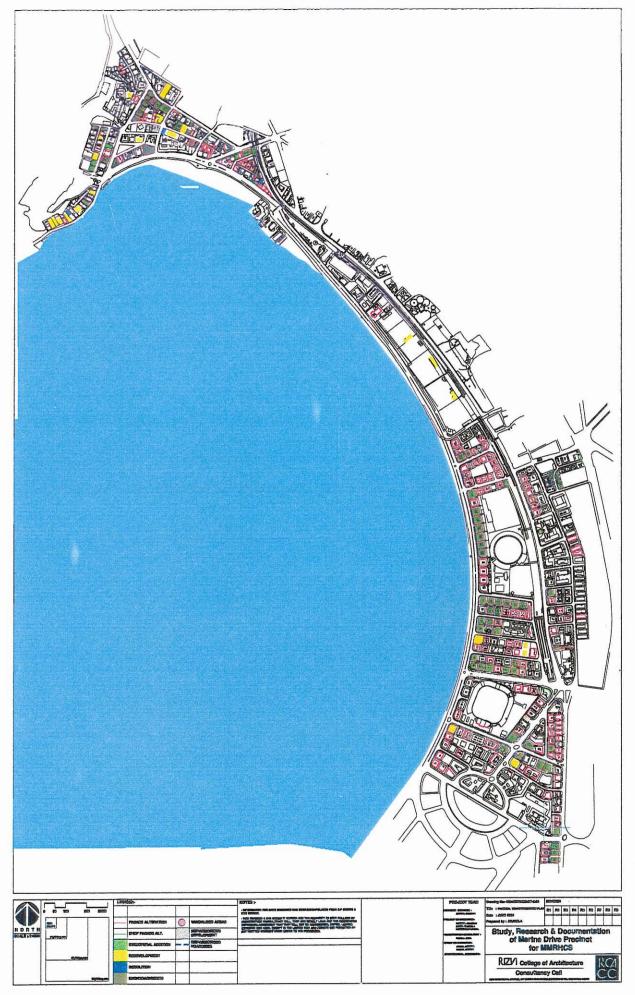
Drg 26 Physical Transformation of Buildings Source RCACC 1999/2000

#### **5.12** Physical Transformation Survey (refer Drg. 26)

Physical transformation in buildings is mostly due to insensitive reconstruction's and facade alterations done by repairing agencies, private and government run. Incongruous and disharmonious scale of hoarding and advertisement boards is further adding to this adversity.

Decay of reinforced concrete fabric, especially thin slabs of chhajja and parapet walls has led to their removal. These are inappropriately replaced by thin chhajja of cement sheet supported on MS brackets. The articulation on wall surfaces, edges, trims and borders are removed during re plastering leading to further decay due to surface expansion and cracking of large surfaces.

55 Buildings (10.2%) have been redeveloped with completely disharmonious scale and incongruous development.

In addition to this fair number of buildings are demolished and are under re construction all over the precinct.

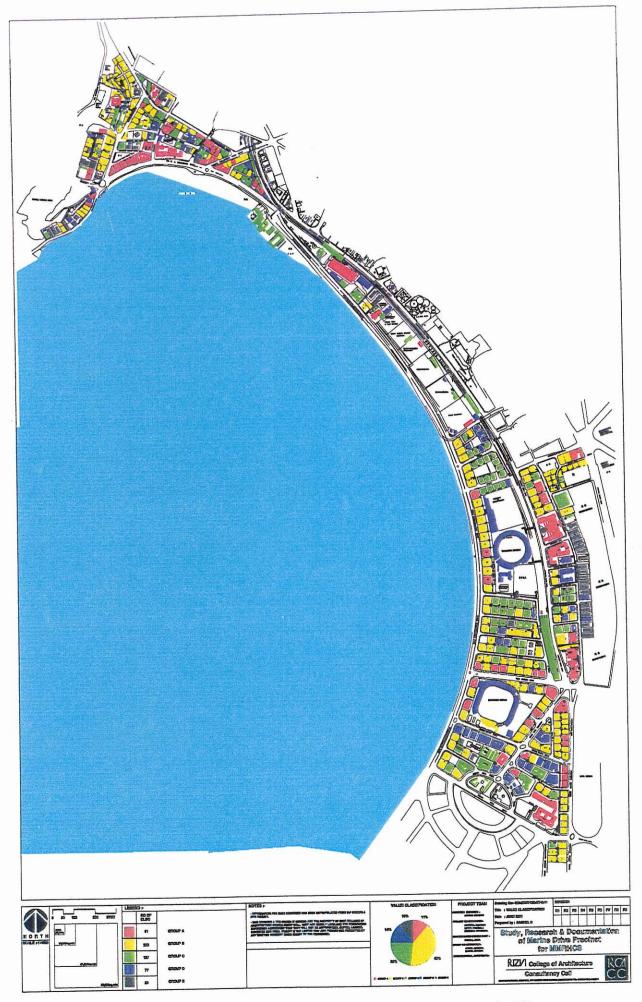
Drg 28 Value Classification of Buildings Source RCACC 1999/2000

# 5.14 Value Classification Survey (refer Drg. 28)

associated value in the long w	ving order
61 nos (11 %) Group A	(>Fun, Con, Sty,
200 000 000	Loc, Lan, UD, Sca)
222 nos (42 %) Group B	(>Fun, Con, Sty,
	Sca,)
127 nos (23 %) Group C	(>Fun, Con, Sca)
77 nos (14 %) Group D	(>Fun, Sca)
55 nos (10 %) Group E	(DSDD)

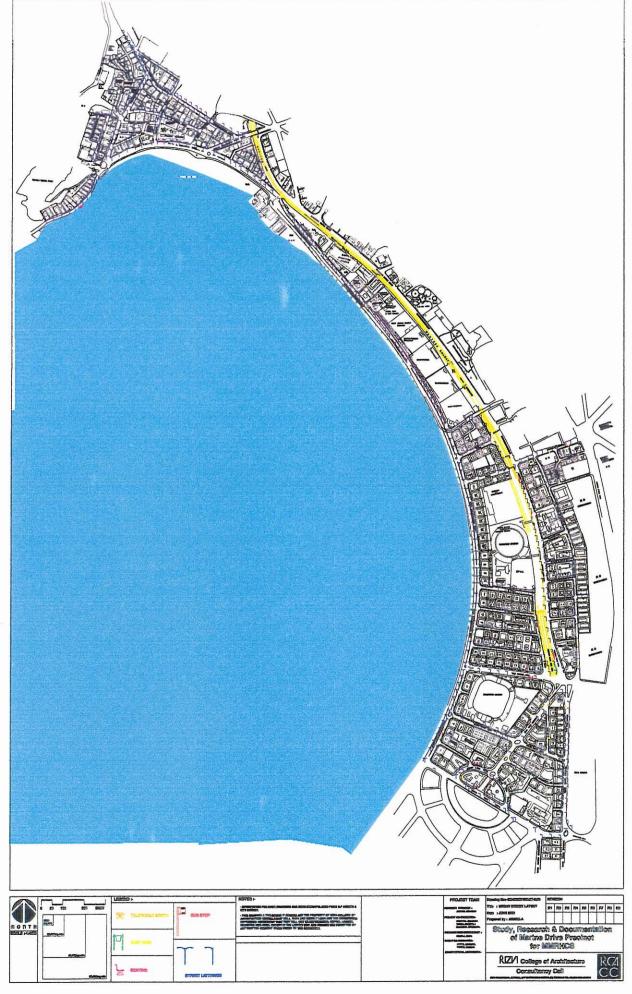
Drg 30 Urban Design Survey 1 Source RCACC 1999/2000

**5.16** Urban Design Survey 1 (refer Drg 30, 31,32, 33, 34, 35)

The urban design surveys were designed to understand the formal as well as the informal components of the urban fabric which affects the day to day functioning of the citizens.

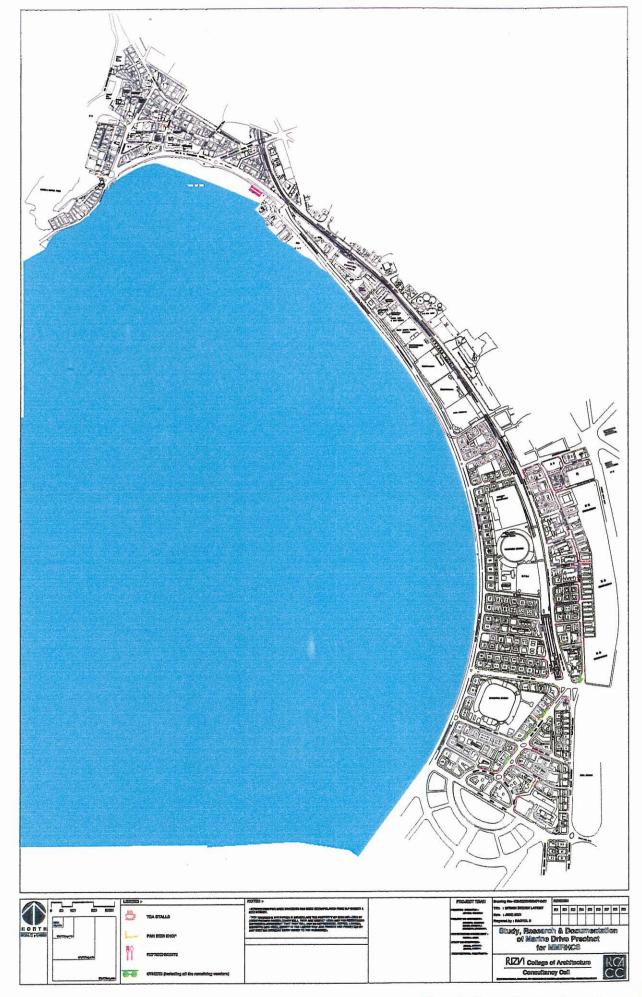
Drg 36 Urban Design Survey 2 Source RCACC 1999/2000

**5.16** Urban Design Survey 2 (Drg. 36, 37, 38, 39, 40)

The second urban design survey records the informal activity in the precinct.

Recording the informal activity reveal a series of patterns of movement of hawkers, their clientele as well as the need for optimum infrastructure for their activities. It also reflects the omnipresent need for informal sector in the CBD of a bustling metropolis.

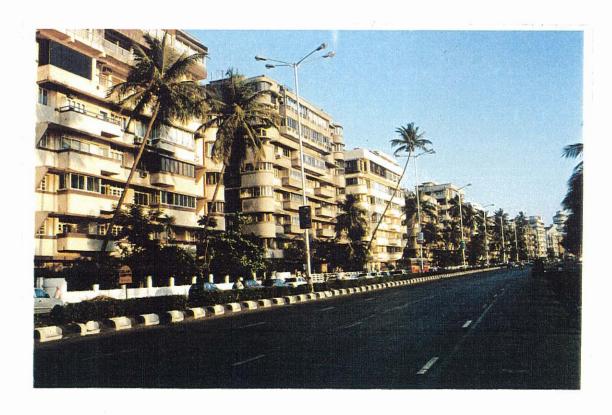
Group of Cessed Buildings on Marine Drive Source RCACC 2000 / 2001

More than 40% buildings (with 66% built up area component) in precinct and nearly most of the Drive and Oval Maidan facing which belong to the significant stock of Group A structures are cessed structures. Hence implications of Development Control Regulation 33(7), 33(8) and 33(9) would be extremely harmful for the conserving the essential character of the precinct.

With very high existing Floor Space consumption the "incentive FSI" would spell complete subjugation of the existing fabric.

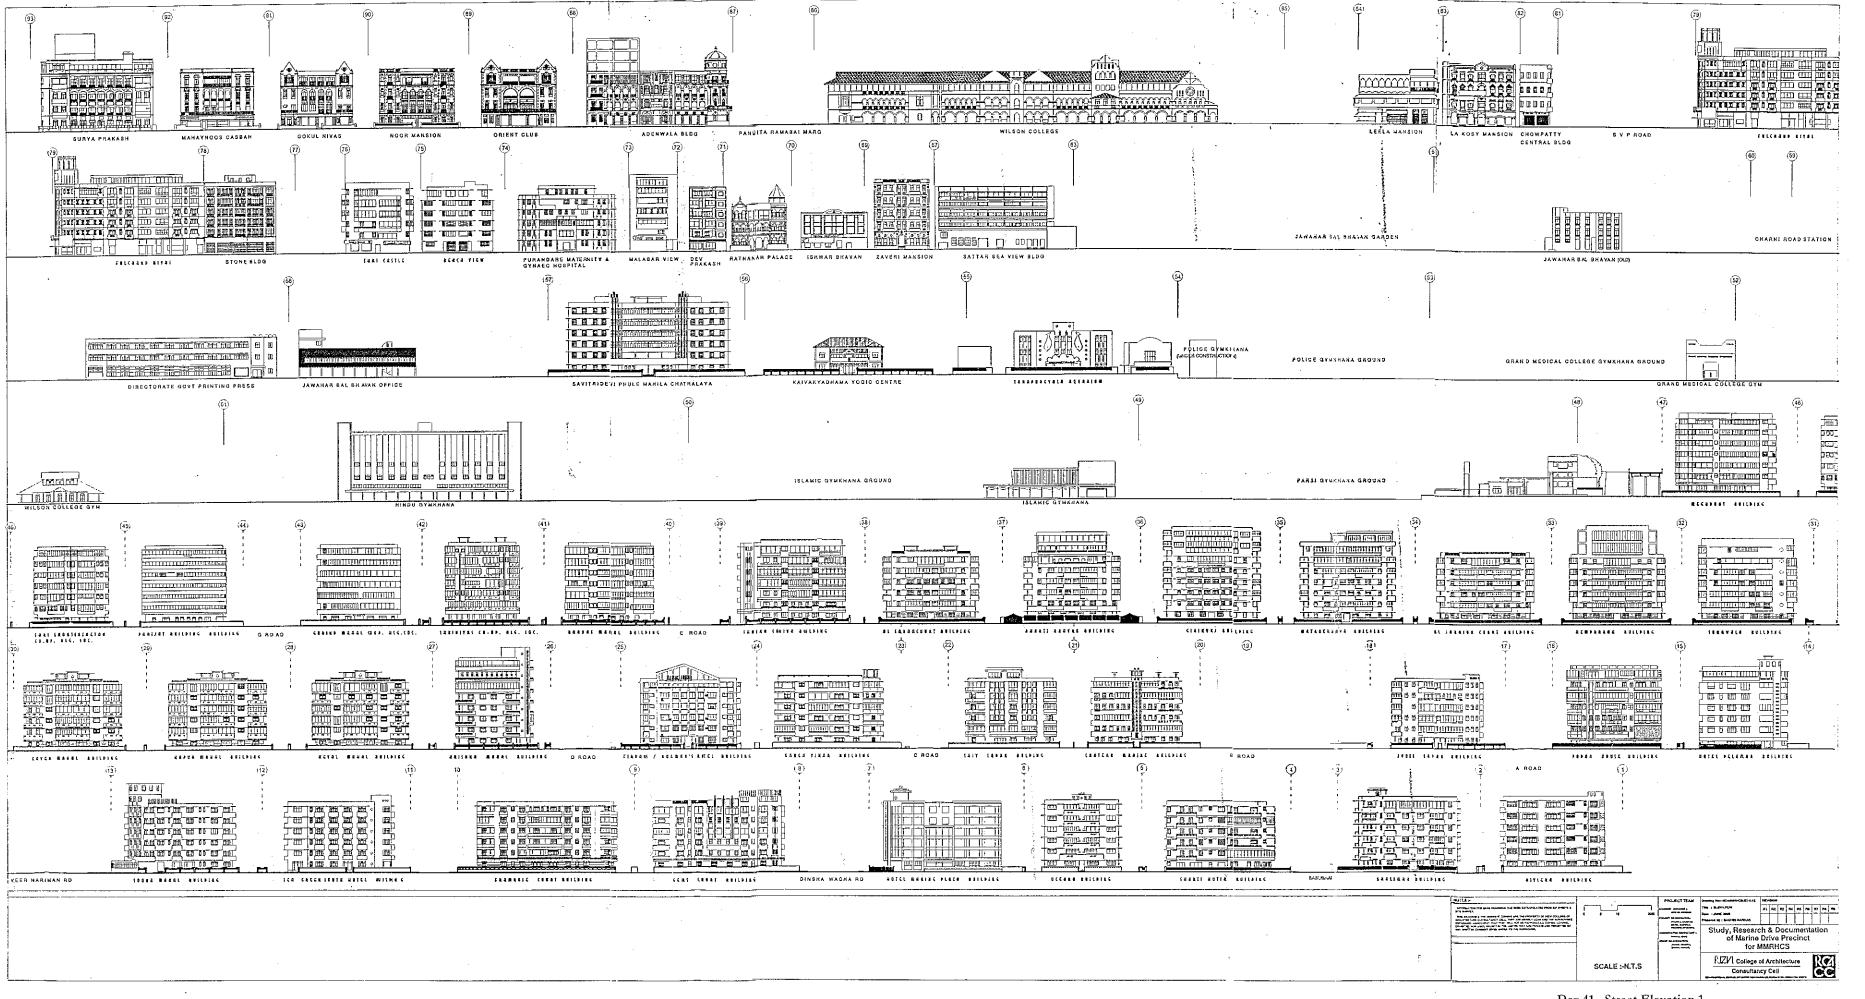
Drg 41 Street Elevation 1 N S C Bose Road (Marine Drive) Source RCACC 1999/2000

**6.1.**Street Elevations (refer Drg. 41, 42, 43)

On a brief glance the street facades present complete failure in the reciprocity of the advertisements, signage hoarding and building services to the existing built fabric.

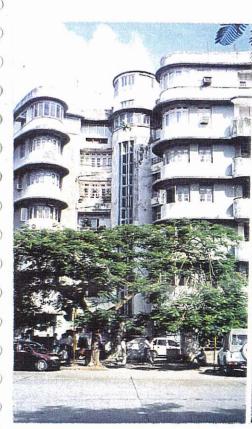
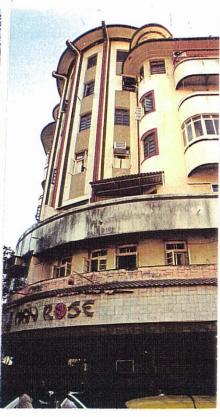
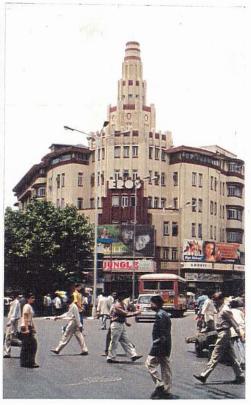
Drg 44 Street Sections 1 Source RCACC 1999/2000

Documentation of street sections facades will ascertain the proportions of open spaces to the building height and the setback controls needed for varying widths of streets. These sections would also ascertain the actual sight lines to be incorporated as guidelines for elevation controls.

This documentation also recorded the degree of transparency required in the form of balconies or outdoor rooms to ensure the wider perceived open space from the vehicular and pedestrian sections of the main, secondary and tertiary roads.

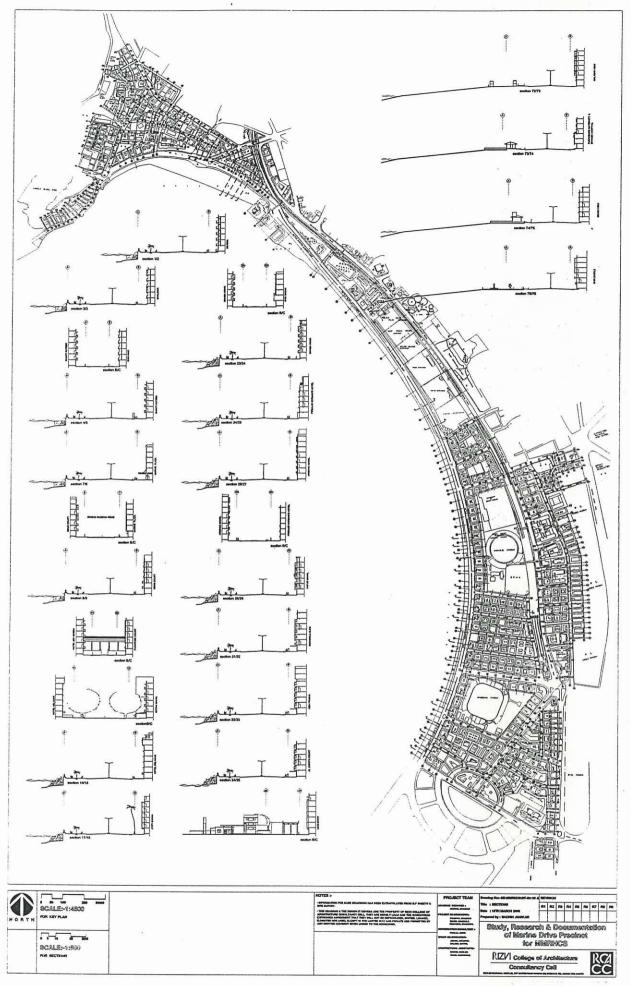
## **6.2** Street Sections (Refer Drg.44, 45)
