study of forts

within the Mumbai Metropolitan Region - Vol.3

MMR Heritage Conservation Society

Academy of Architecture, Mumbai

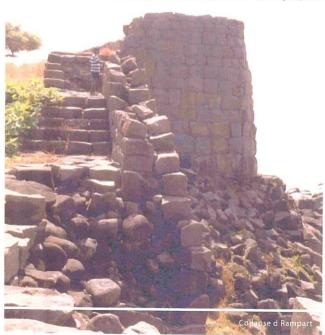
Although the lighthouse is generally well maintained with periodic maintenance measures such as annual painting and white washing in place,

the surrounding fort is not covered in this repair work, resulting in collapse of several of the bastions and rampart walls. The merlons and embrasures in addition to the parapets of most of the bastions are non-existent. The collapse of these fortifications has been attributed to structural failure of some out of plumb bastions as well as the relentless force of the sea waves, lashing on to the ramparts. A break in the fortifications has also made access to various levels difficult.

Moreover, although the fort walls are relatively free from vegetation, the areas inside are entirely covered with grass and weeds, not only making access difficult to the interior areas but also making it impossible to assess the entire nature of the fort development and disrepair. Extensive graffiti on the fortifications has led to defacing of the historic fabric.

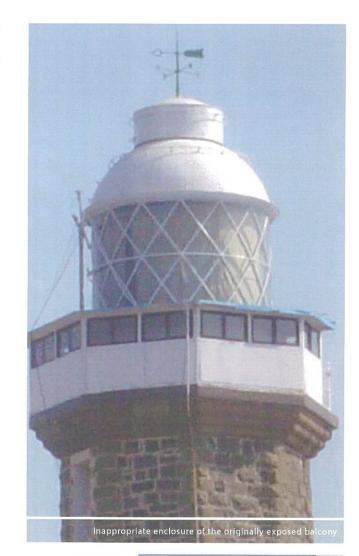
Over the years, the old lighthouse has also undergone several alterations in the form of boarding up of the rear openings of the portion jutting out of the main building. Ad-hoc weather shades using inappropriate materials have been added to several of the semi-circular openings. The continuous balcony running right round the tower has also been boarded up and the original rail can be observed on the inside (archival images in the West Coast Pilot show this circular balcony exposed). This has been by far the most incongruous alteration as it has disrupted the inherently open form of the tower balcony. However, the maintenance and upkeep of the structure is regular albeit not entirely respecting conservation sensitivity. Other interventions in the form of construction of a medley of kitchen quarters, outhouses and stores have also contributed to insensitive additions within the fort complex.

Records also indicate that as part of the upgradation process it is intended that the older flashing mechanism of the lighthouse would be eventually replaced with a conventional device. Such an action of improvement of devices for better functioning of the lighthouse, although crucial for its modernization would also mean destruction of a part of its historicity. Hence it is advised that upon removal of the original device it should be retained on site and not trashed as a redundant relic.

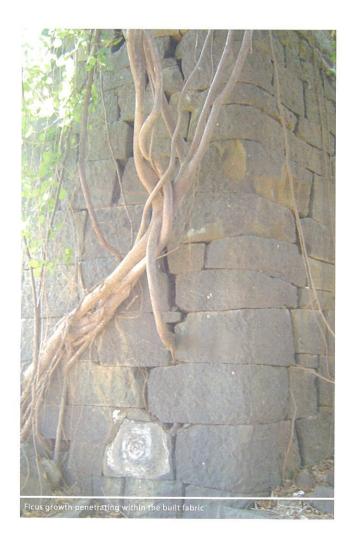
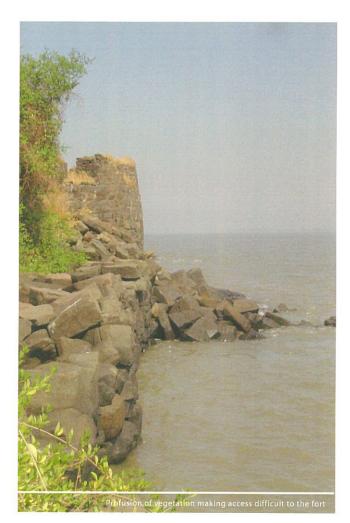
No maintenance measures have been initiated till date at Underi, which is primarily the reason for collapse of several ramparts, some as recent as a couple of years back. The ravaging sea waves have taken a huge toll on the fortifications, and broken sections can be observed all along the fort walls, making access difficult. Apart from the natural weathering action, causing minimal damage due to the excellent hard wearing stone, and the action of the sea waves, no other intervention in terms of additions or alterations within the complex are observed, marking this as a pristine site, practically untouched. However, ignorance about this historic site has also led to its disrepair as no maintenance measures have been ever initiated at this fort. This has resulted in gradual disintegration through the sea wave action of several of the fortifications, which might lead to eventual loss of such a lot of heritage material that there would be no coherence as to the original built fabric. Hence, it is urged that urgent stabilization measures be initiated as soon as possible.

Rampant vegetation in the form of tall grass and weeds grow within the entire fort complex, making it highly difficult to assess the existence of any more remnants within the site. Every year the Society Office undertakes a clearing expedition, where the entire grass is set on fire. Ficus growth and an extensive banyan tree have sprouted from the entrance bastion and are growing out into the entrance arch. This should be immediately uprooted, as eventually the vegetation growth will dislodge the masonry and cause loss of a valuable and irreplaceable part of the fort edifice. Vegetation at the precarious landing site also makes access dangerous to the fort. Cleaning and de-weeding of all the reservoirs needs to be urgently initiated, as the larger vegetation threatening to dislodge the stone masonry within the reservoirs can be immediately tackled.

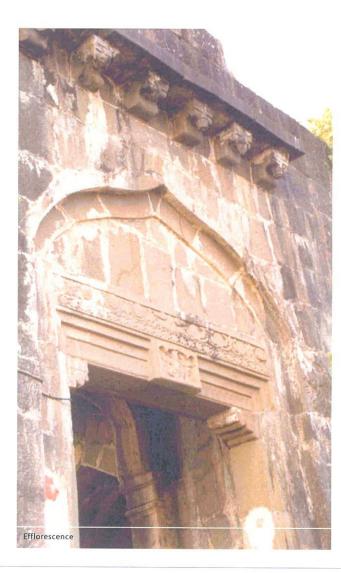
Routine maintenance measures and periodic repair work has been initiated at the Kulaba fort. This includes pointing of the masonry joints, stabilization of the ramparts, clearing of vegetation etc. However, an observation is made here about the nature of the conservation remedies. The pointing work undertaken is not in conformity with the original mode of construction, which was of the dry mortar type. In addition to this, the pointing has been carried out using cement mortar, an extremely incompatible material with stone. This has led to large-scale deposition on the stone surface and consequent efflorescence. The salt deposition has completely defaced the entrance doorways and should be urgently remedied.

The practice of burning of vegetation grown after the monsoons should be stopped and more conservation sensitive techniques adopted. However, excepting the profuse grass growth no other form of vegetation was observed on any of the structures.

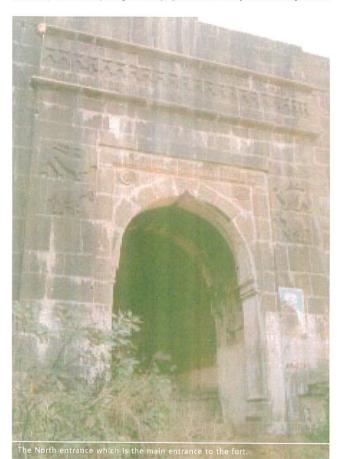
The average height of the fortifications is about 30′, which increases at the gateways particularly the north and the west where it reaches almost 40′, including the parapet, responsible for absence of a moat for additional protection. The thick rampart wall consists of a walkway approximately 8′ wide at the top accessed by a flight of steps provided at every entranceway. Access

from the north is through a huge arched entrance, flanked by strong bastions on either side, with the characteristic Islamic arch profile with a pipal leaf ogee at the crown. Simple but well-cut decorative features adorn this entranceway with the typical rearing lions and garlanding elephants motif with a tracery of floral elements along the face and running at the top of the entrance, with lotus medallions punctuating either side of the tympanum. At the central portion between the arch crown and the cornice, the Marathi inscription proclaiming capture of the Arnala fort, is placed. This too is well-cut and in good condition.

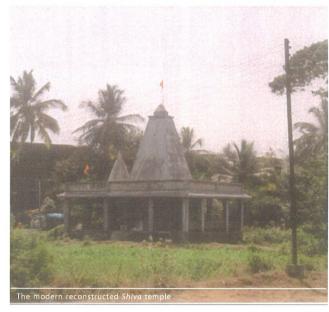
Other notable structures within the fort enclosure are the two temples and Muslim shrine. The temple dedicated to Trimbakeshwar with a Shiva ling is entirely new. Although the old Shiva ling has been retained, the nandi of the outer sanctum is a new idol installed in place of the original which can still be seen outside. The older nandi idol along with other original deities such as a Ganapati idol has been placed on the stone parapet of the octagonal well abutting the temple. This stone lined fresh water well is the largest well in the fort enclave with small decorative niches, access steps and space for drawing water.

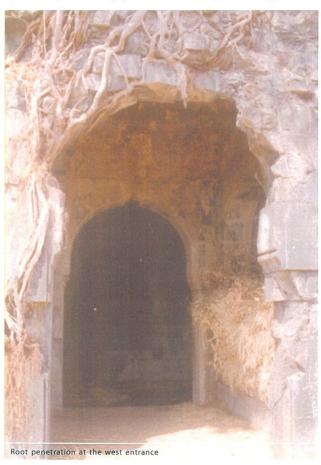
No repairs have been undertaken by any agency since the fort does not fall on either the State List or under Central notification. On account of its robust construction material the fort is rendered stable, but has been showing gradual signs of disrepair. This is largely on account of the deep rooted tree growth that

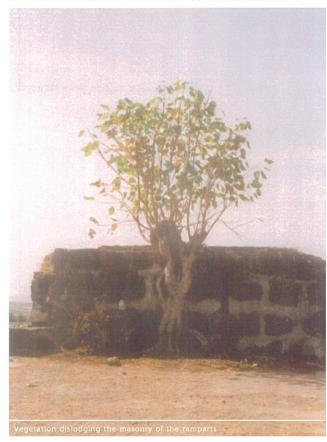
has sprouted within the masonry joints, particularly in case of the inner face of the west entrance that has almost completely disintegrated due to this extensive growth. Not only has the hard rock split because of the root penetration but the masonry has also dislodged threatening the structural stability of this entrance. Several sections of the forts display seepage stains and efflorescence due to salt action, particularly noticed on the inner corbelled domes where huge runnels of lime mortar are observed on the upper reaches of the walls.

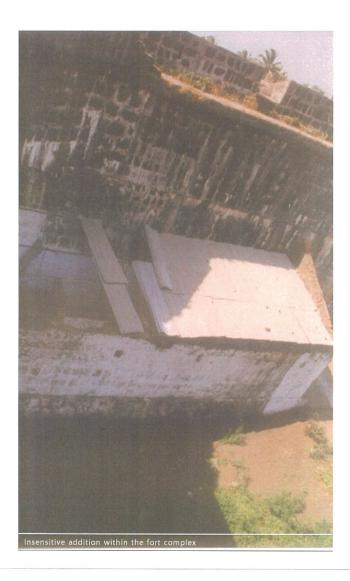
While these are signs of incremental deterioration due to weathering and disrepair, the other primary concern is vandalism where historic walls have been in some cases been covered with indelible graffiti. Where basic lime washing has been undertaken, it can be removed with gentle alkaline solvents but in cases of enamel paint, these would have to be removed using chemical consolidants, treated on a case by case basis. Although most of the significant structures are noticeable within the fort enclave, agricultural cultivation could have gone over some of the archaeological remnants. In addition to this, some sections of the fort interior are also profusely grown over with wild vegetation that needs to be carefully removed to bring to light probable historic remains as well as protect the fort from being overrun with this vegetation. The original Trambakeshwar temple too has been reconstructed entirely using modern materials, not only resulting in damaging the authenticity but also irretrievably destroying the original temple. A canteen and store has cropped up abutting the ramparts, disrupting the integrity of the site. Such acts should in the future be prevented, possible only by means of active heritage protection.

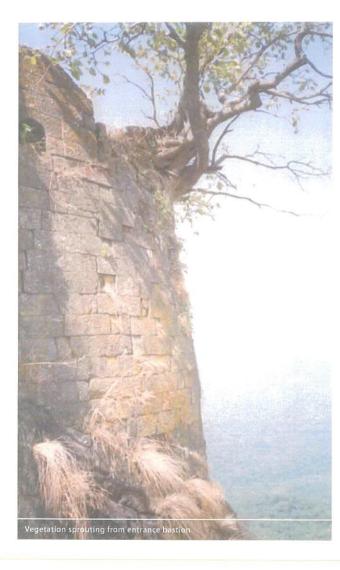
Currently the fort is in a fairly intact condition, with very few of the walls or bastions out of plumb or structurally threatened. This fair condition has much to do with its inherent hard wearing and robust mode of construction and material methodology as otherwise the absence of periodic maintenance would have led to the fort's complete disrepair. However, the bastion next to the main entrance of the lower fort has been rendered unstable due to the presence of a large tree growth sprouting right from the masonry joints. If the vegetation is not appropriately removed, it could cause collapse of the bastion at a later date. The extensive vegetation sprouting near most of the fortifications and structures, especially after the monsoons, should be immediately removed and a periodic maintenance plan put in place to eradicate such growth. Not only is such vegetational growth a threat to the structural integrity of the monument but also makes access difficult to certain sections of the fort. In addition to this, extensive vegetation has led to the covering up of elements or structures that perhaps lie unexposed below the abundance of vegetation.

Some amount of the original remnants are found fallen around the gateways and other structures. These should be properly catalogued and if possible reinstated in their original position. This could easily be undertaken in case of the first entrance where a dislodged beam piece has fallen right next to the gateway. Such an inventory needs to be urgently undertaken in order to prevent pilferage and loss of historic material.

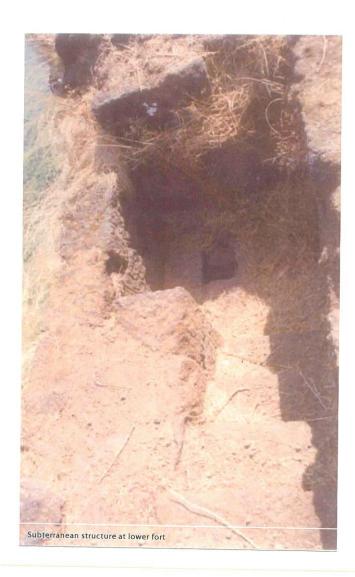
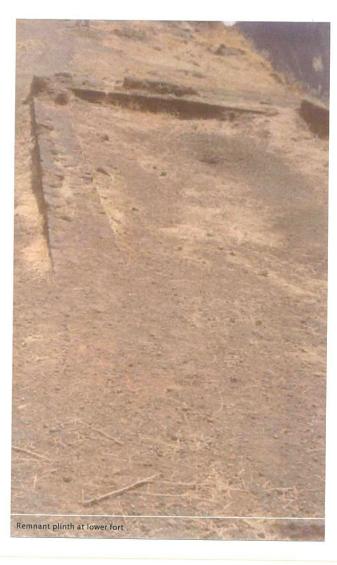
survives and two rock hewn reservoirs nothing has survived. A few other notable features are some sort of subterranean stone lined chambers with window cut outs opening out on to the eastern landscape. Two rock-cut water cisterns (a few sections of which display lime plaster) can also be seen at the lower fort. Fragments of fortifications, only a single course of masonry of which survives, are observed along the scarps, but can be considered almost non-existent. It is unfortunate that this once significant fort has not too much to offer in terms of the extant historic material as most of it was perhaps dismantled preindependence.

The upper fort is accessed through another series of steps, the approach to which is extremely dangerous and should be attempted only with an experienced trekker. These steps lead to rocky ledge that has collapsed and after going a short distance it leads to another series of steps onto the upper fort. The collapse of the ledge has made the access practically impossible, which has been bridged over currently by a rickety horizontal ladder. The upper fort comprises of an old building and five cisterns.

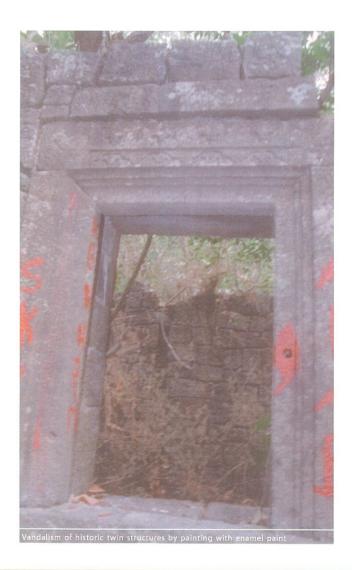
Lack of heritage protection coupled with difficult access has meant that hill forts such as Prabal have never been restored. This has led to massive visitor abuse in the form of graffiti, pilferage and uncontrolled construction. At Prabal oil paint has been smeared on the historic twin units while commemorative plaques installed at vantage points.

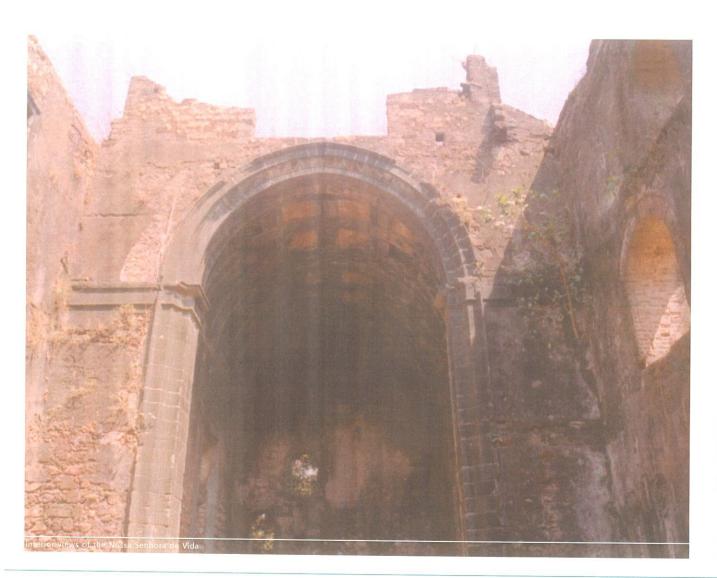
The floor of the church is currently unpaved, which could be just layers of debris, and the roof is non-existent. The altar on the east has a high arch with coffered ceiling, characteristic of Portuguese churches of Bassein. Oblong lancet windows provided light inside the church and seem to have earlier had glazing. Some of the larger windows, segmental in profile, are lined with brick and the composition of windows on the walls is not uniform and differ in placement and type. This could perhaps be that this church was constructed over a period of time. A sugar refinery was located in the nave of the church which was closed down in 1874. While digging the foundations for this refinery the bones of a man and horse were found buried together in a grave. Such cases of joint burials of master and animal were frequent till as late as 1781 at Treves in Germany.

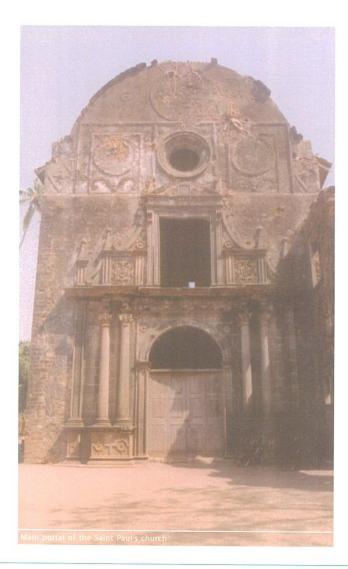
The terracotta tiled roof above is comparatively new, introduced during repairs in 1905-06 (the older roof was steeper), it gives an indication of how the layout and form of the church structures. The date over the door (1636) is probably that of repairs as the foundation of the Church and Monastery were laid in 1548 by Fr. Malchior Gonsalves, a lose friend of St. Xavier, by whom the Jesuits had, in the year before established Bassein. Fryer (1675) speaks of a goodly church, a spacious refectory and a college of polite structure, with fine square cloisters and side cells above stairs as well as below, in the portico was a copy of

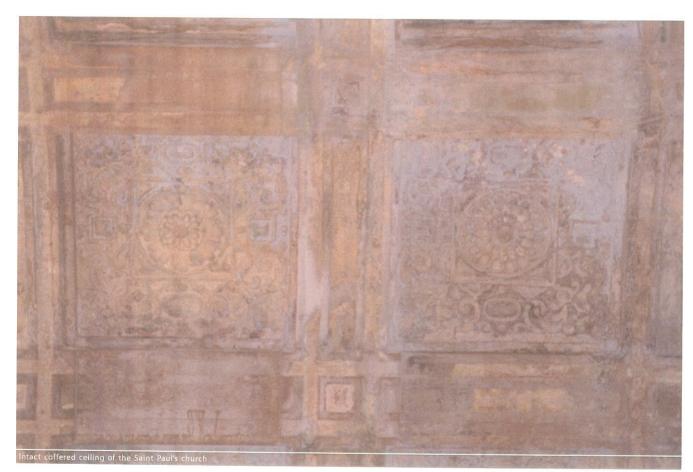
Michelangelo's picture of the Resurrection.¹ The space on the inside is well paved with the altar on the west with a high arch and vaulted coffered ceiling. This is the one of the few instances where the fine quality of the floral lime stucco work on the ceiling is visible as elsewhere it has deteriorated. Traces of old paint too have survived.

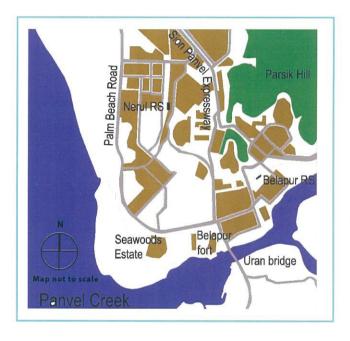
The fort falls in the Urbanisable Zone and is hence the area around is being rapidly developed. Not only has a Club sprouted next to the fort but a residential colony too has sprouted in close proximity that has already broken the fort wall boundary.

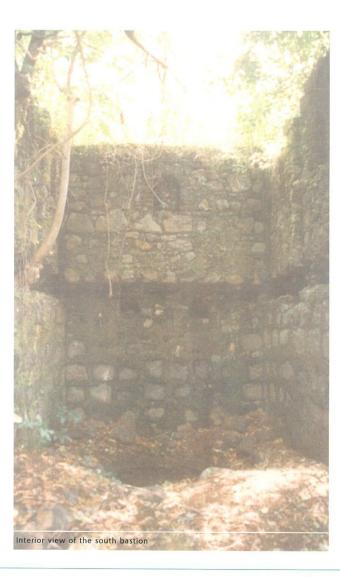
complex and club consists of a square enclosure approximately 20' height faced with random rubble masonry. It is provided with rectangular openings with slanting jambs and narrow slits at the upper levels. The general appearance of this gateway indicated that it could have been a significant structure when the fort was being utilized. The south bastion is a U-shaped structure located in the interiors of the dense vegetation and can be accessed by climbing over a broken wall of loose stones from a housing complex, whose compound wall has run through the original fortified wall. This structure was the complementing bastion along with another, as mentioned in the historical description, which manned the mouth of Panvel Creek. While the other bastion was dismantled in the 1990s, apparently during a film shoot, this bastion is also severely threatened both by development pressure as well as by vegetation. The roof mentioned in 1818 too has collapsed. This U-shaped structure, serving as a lookout point over the Belapur Harbour (known as Belawal by the Portuguese in 1570 as a European Konkan Port) consists of two levels, the floor of which has also collapsed. Faced with random rubble masonry, the bastion is approximately 15' high with small arched openings, arch niches on the inside and a half round stone cornice indicating the floor level on the external face. An opening on the ground was the subterranean store mentioned in the historical description, but the proper access to it does not exist unless hidden underneath the rubble within the enclosure.

At the base of the high point where the south bastion is located is a temple dedicated to Govardhani Devi renovated in 1953 and managed by a trust.

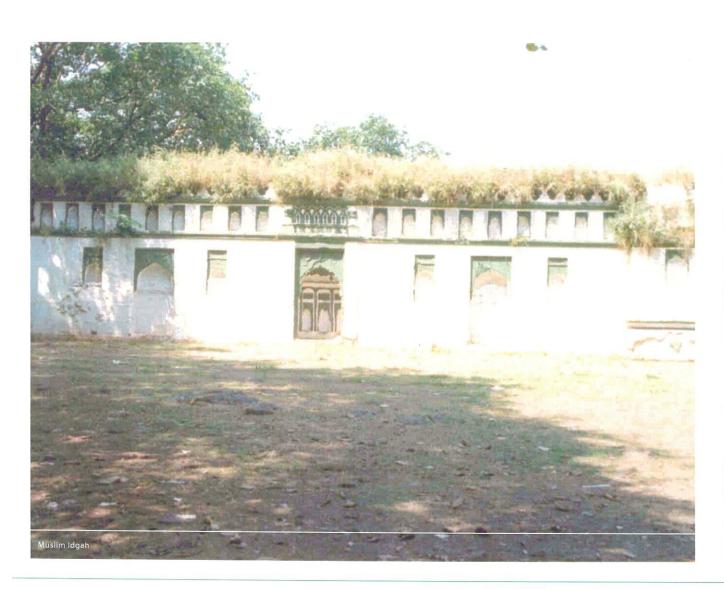
Access to the fort is through a modern gateway, built to resemble a fort entrance, but largely fails on account of the modern materials used and the garish finishes. A series of wide steps and ramp lead to the Durgadevi temple located on the highest point. Built on a high plinth, the shrine is covered with a dome. Beyond the fort are the remains of a Muslim Idagah, comprising of a narrow structure with several arched recesses. Entries to the temple and Idagah are through separate steps and at a lower level of the fort a police chowky has been built.

The original construction methodology has been replaced by random rubble masonry embankments. At several instances the bastions have been plastered and a pointing pattern has been painted over to resemble pointed masonry construction. The Public Works Department is in charge of the repairs at the fort.

The original construction methodology has been completely replaced with random rubble masonry. Due to collapse of the entrance bastion, measures were undertaken to stabilize it and this was plastered on the external face with cement mortar like several other fortifications. Most of the original materials and finishes have been entirely altered not in conformity with the authentic mode.
