MATHERAN:
A COMPREHENSIVE HERITAGE LISTING
PROPOSAL

FINAL REPORT
VOLUME III & IV

PROJECT CONSULTANT
K. UNWALLA ARCHITECTS

FOR
**M.M.R. HERITAGE CONSERVATION
SOCIETY**

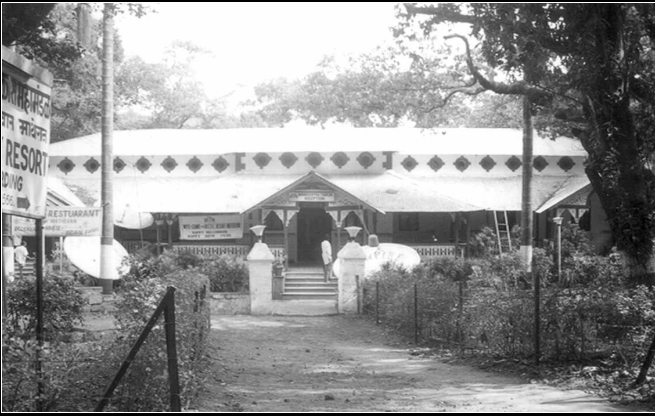
LOCATION		PIN	MH/RA/410102/A-01/(0)/2000	M.T.D.C. LODGING AND BOARDING

6.5	REFERENCES	Municipal Records / Map (1903-04) / DP 1987 / Books on Matheran / Field Surveys			
7.0 ARCHITECTURAL SYSTEMS IN THE STRUCTURE					
7.1	FOUND. & PLINTH	Stepped laterite foundation. Plinth in coursed laterite - exposed and pointed.

7.2	WALLS	Loadbearing, polygonal laterite, partly plastered & partly painted externally with rusticated basalt quoins & jambs.			
7.3	FLOOR	Encaustic tiles in the interior & marble laid in a diagonal pattern in the verandah.

8.3	FINISHES	Original floor tiles replaced by marble & ceramic tiles. Walls plastered & painted. Roofing sheets recently replaced.			
9.0 PRESENT STATUS

9.1	STRUC. STABILITY	Fair			
9.2	MAINTENANCE	Fair			
10.0 REMARKS					
10.1	CONSERVATION & DEVELOPMENT	The structure with the ancillary block form an important landmark at the entry of the hill station, hence must be preserved as they are. Incongruous extensions of a temporary nature in front of the ancillary block should be removed. No scope for additions.

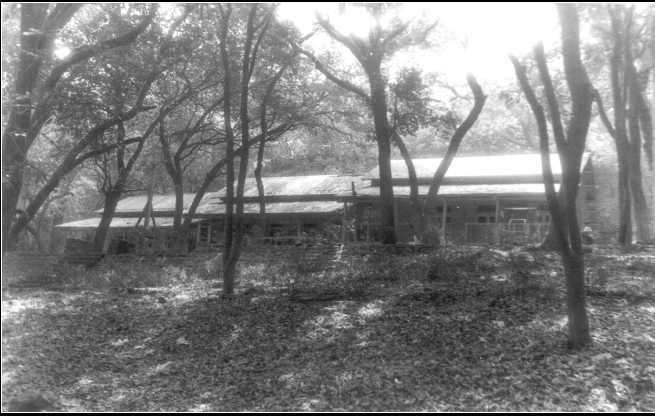
LOCATION	PIN	MH/RA/410102/A-02/(0)/2000	MTDC HOLIDAY HOME

6.5	REFERENCES	Municipal Records / Map (1903-04) / DP 1987 / Books on Matheran / Field Surveys		
7.0	ARCHITECTURAL SYSTEMS IN THE STRUCTURE			
7.1	FOUND. & PLINTH	Stepped laterite foundation. Plinth in coursed laterite - painted.

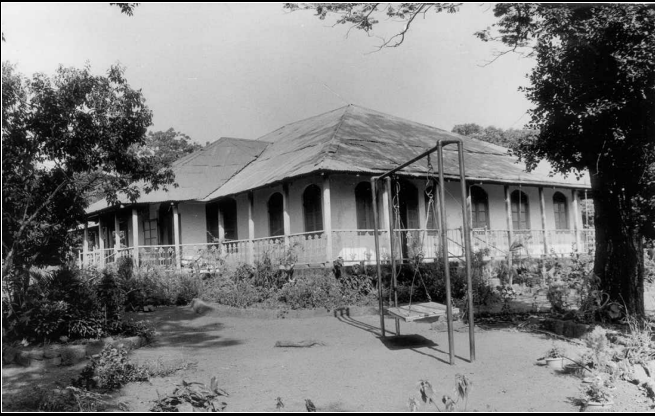
LOCATION	PIN	MH/RA/410102/B-01/(0)/2000	THE CHALET

6.5	REFERENCES	Municipal Records / Map (1903-04) / DP 1987 / Books on Matheran / Field Surveys		
7.0	ARCHITECTURAL SYSTEMS IN THE STRUCTURE			
7.1	FOUND. & PLINTH	Stepped laterite foundation. Plinth in coursed laterite - exposed and pointed.

9.0	PRESENT STATUS			
9.1	STRUC. STABILITY	Good		
9.2	MAINTENANCE	Excellent		
10.0	REMARKS			
10.1	CONSERVATION & DEVELOPMENT	Adaptive reuse of the main bungalow may be allowed retaining the original structure. Detached add-ons on the site may be permitted, provided they are sufficiently away from the main building and respecting the existing forest cover and topography.

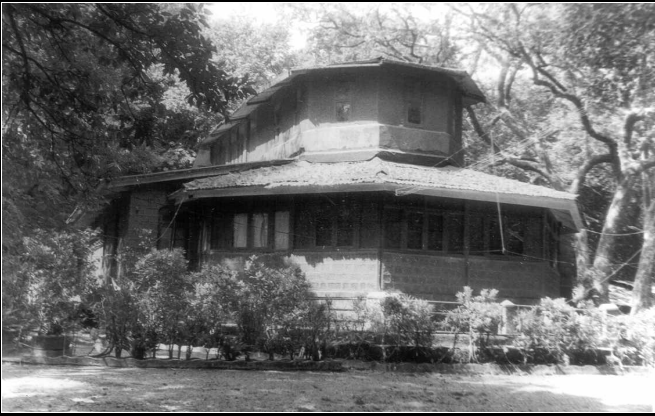
LOCATION		PIN	MH/RA/410102/B-02/(0)/2000	AMAN LODGE

6.5	REFERENCES	Municipal Records / Map (1903-04) / DP 1987 / Books on Matheran / Field Surveys			
7.0 ARCHITECTURAL SYSTEMS IN THE STRUCTURE					
7.1	FOUND. & PLINTH	Stepped laterite foundation. Plinth in coursed laterite - exposed and pointed.

8.0 TRANSFORMATION					
8.1	FORM	Verandah enclosed and C.I. railings replaced by parapet wall and casement windows.			
8.2	STRUCTURE	None			
8.3	FINISHES	Plastering and painting of walls.

9.0 PRESENT STATUS					
9.1	STRUC. STABILITY	Fair			
9.2	MAINTENANCE	Fair			
10.0 REMARKS					
10.1	CONSERVATION & DEVELOPMENT	<p>The bungalow has an important association with Dasturi naka and Sir Adamjee Peerbhoy (it being his former residence) hence must be preserved and maintained. Adaptive re-use of the bungalow and detached add-ons on the site may be allowed.</p>

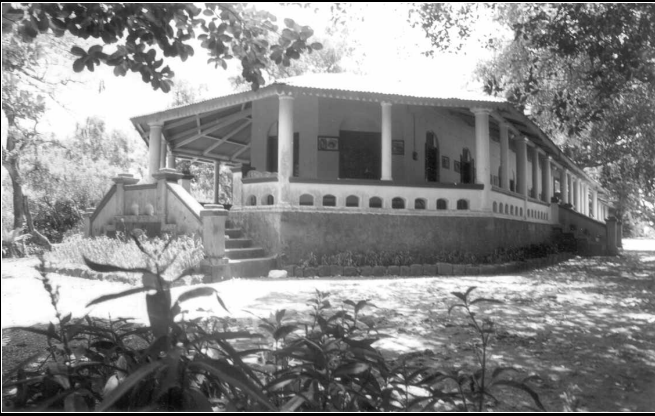
LOCATION	PIN	MH/RA/410102/B-03/(0)/2000	GARBUT HALL

6.5	REFERENCES	Municipal Records / Map (1903-04) / DP 1987 / Books on Matheran / Field Surveys		
7.0	ARCHITECTURAL SYSTEMS IN THE STRUCTURE			
7.1	FOUND. & PLINTH	Stepped laterite foundation. Plinth in random polygonal laterite, exposed and pointed with projecting plinth course.

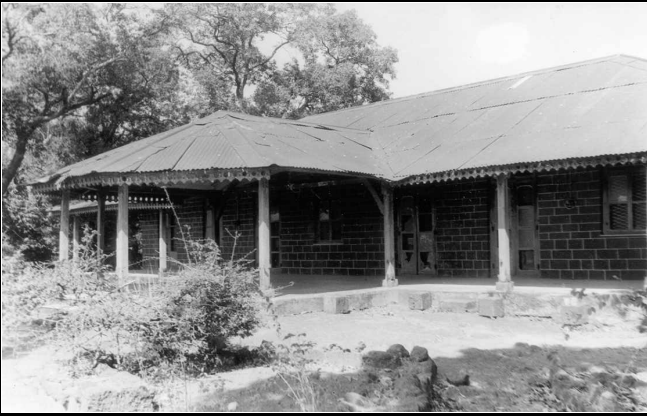
LOCATION	PIN	MH/RA/410102/C-01/(0)/2000	RAJASTAN

6.5	REFERENCES	Municipal Records / Map (1903-04) / DP 1987 / Books on Matheran / Field Surveys		
7.0	ARCHITECTURAL SYSTEMS IN THE STRUCTURE			
7.1	FOUND. & PLINTH	Stepped laterite foundation. Plinth in coursed laterite - exposed.

9.0	PRESENT STATUS			
9.1	STRUC. STABILITY	Average		
9.2	MAINTENANCE	Irregular		
10.0	REMARKS			
10.1	CONSERVATION & DEVELOPMENT	The structure is an important landmark located at a strategic site having potential for extra built space. The structure needs proper maintainence. Its residential use may continue. Add-ons as attached or detached extensions may be allowed on the north-east and south-east sides.

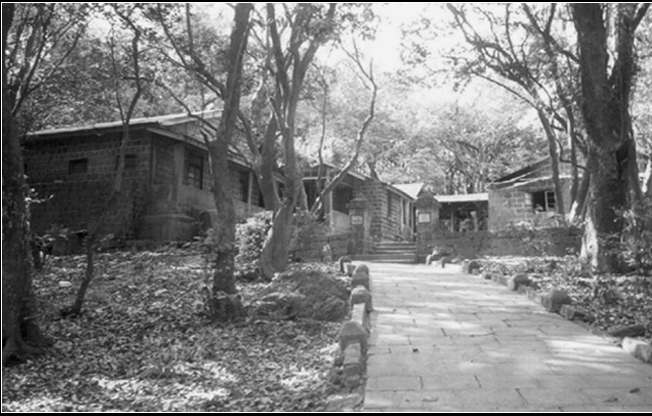
LOCATION	PIN	MH/RA/410102/C-02/(0)/1998	KASTURI VILLA

6.5	REFERENCES	Municipal Records / Map (1903-04) / DP 1987 / Books on Matheran / Field Surveys		
7.0	ARCHITECTURAL SYSTEMS IN THE STRUCTURE			
7.1	FOUND. & PLINTH	Stepped laterite foundation. Plinth in coursed laterite - exposed.

8.0	TRANSFORMATION			
8.1	FORM	Complete verandah on the western side reconstructed and modified.		
8.2	STRUCTURE	Timber posts and timber railings of verandah replaced by brick piers and masonry upto sill height.

9.1	STRUC. STABILITY	Fair		
9.2	MAINTENANCE	Fair		
10.0	REMARKS			
10.1	CONSERVATION & DEVELOPMENT	One of the three significant structure associated with 'The Tryst' on M.G. road near Sakharam Tukaram point. If maintained well the structure has a potential to continue its original use.

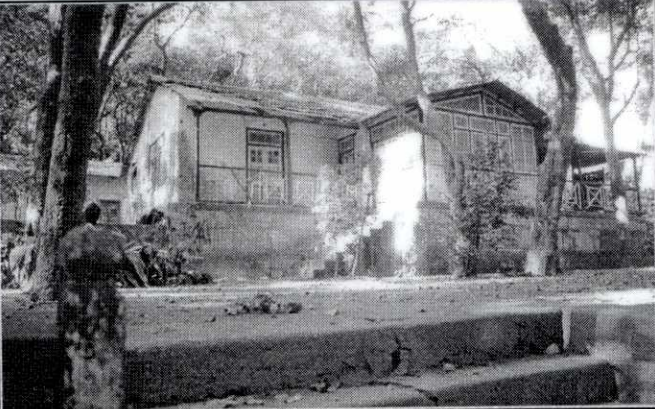
LOCATION		PIN	MH/RA/410102/C-03/(0)/2000		HEMANTINI KUNJ

6.4	REFERENCES		Municipal Records / Map (1903-04) / DP 1987 / Books on Matheran / Field Surveys			
ARCHITECTURAL SYSTEMS IN THE STRUCTURE						
7.0	FOUND. & PLINTH		Stepped laterite foundation. Plinth in coursed laterite - plastered and painted.

9.0	STRUC. STABILITY		Fair			
9.1	MAINTENANCE		Roof covering needs repair and maintenance.			
REMARKS						
10.0	CONSERVATION & DEVELOPMENT		Hemantini Kunj, with its adjoining properties Kasturi Villa and Emerald Banks, located at 'The Tryst' and associated with Sakharan Tukaram point holds importance in its a group value. The small plot has very little scope for extensions. Adaptive re-use may be permitted.

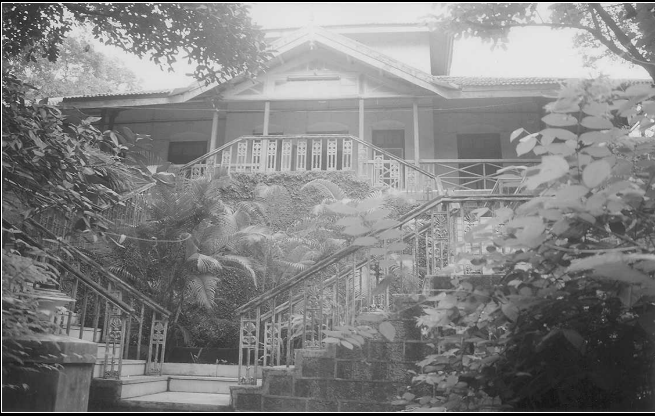
LOCATION		PIN	MH/RA/410102/C-04/(0)/2000	EMERALD BANKS

CARD	C-04/(0)
				GRADE	II-B
				ZONE	HART POINT
				ZONE REF.	C 04
				CO-ORD.	L,12
				PLOT #	203
				SURVEY #	10

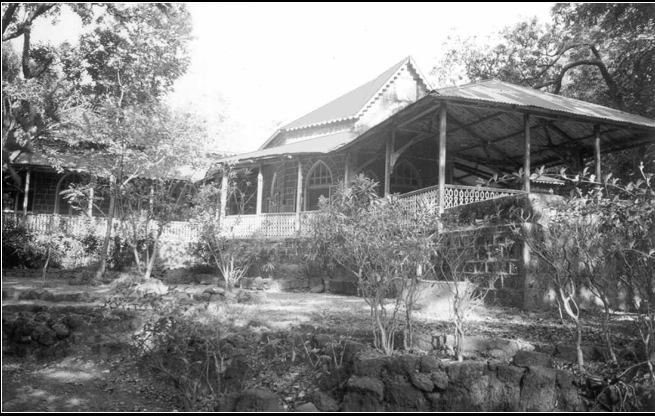
LOCATION	PIN	MH/RA/410102/C-05/(0)/2000	CRAIGIE BURN

CARD	C-05/(0)
			GRADE	II-A
			ZONE	HART POINT
			ZONE REF.	C 05
			CO-ORD.	J,10
			PLOT #	49
			SURVEY #	19

1.0	NAME OF THE PROPERTY			
1.1	NAME	CRAIGIE BURN		
1.2	HISTORIC NAME	SITE OF ROPER'S BUNGALOW		
1.3	BUILT IN	1854 - 1900		
2.0	AREA (SQ. MTS.)			
2.1	PLOT AREA	21431.70

6.5	REFERENCES	Municipal Records / Map (1903-04) / DP 1987 / Books on Matheran / Field Surveys		
7.0	ARCHITECTURAL SYSTEMS IN THE STRUCTURE			
7.1	FOUND. & PLINTH	Stepped laterite foundation. Plinth in coursed laterite - exposed and pointed.

8.0	TRANSFORMATION			
8.1	FORM	None		
8.2	STRUCTURE	None		
8.3	FINISHES	IPS and Shahabad stone have replaced the original flooring. G.I. sheets have replaced mangalore tile roofing.

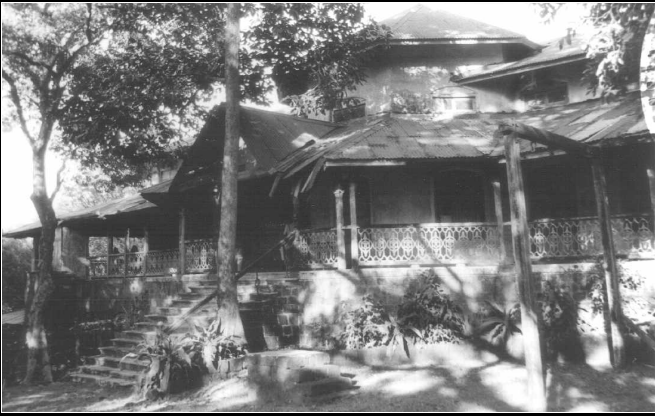
LOCATION		PIN	MH/RA/410102/D-01/(0)/2000	BELL VUE

6.5	REFERENCES	Municipal Records / Map (1903-04) / DP 1987 / Books on Matheran / Field Surveys			
7.0		ARCHITECTURAL SYSTEMS IN THE STRUCTURE			
7.1	FOUND. & PLINTH	Stepped laterite foundation. Plinth in coursed exposed laterite - tapered & stepped on its external face.

9.2	MAINTENANCE	Nil			
10.0		REMARKS			
10.1	CONSERVATION & DEVELOPMENT	One of the few early houses with a tower - a landmark - earlier visible from the train. Owing to its unique scale and planform Bell Vue needs to be restored to its original grandeur and may be put to adaptive re-use for an appropriate purpose.

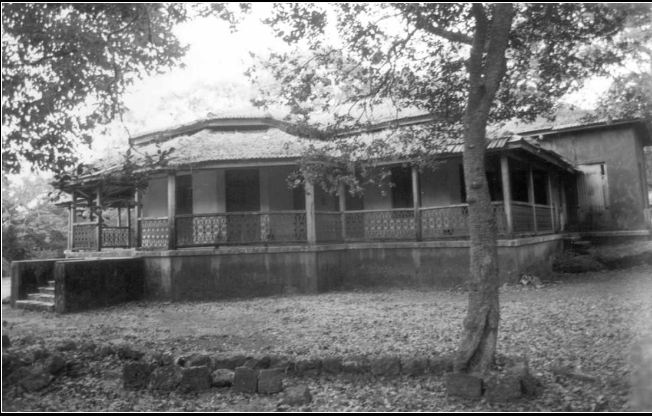
LOCATION		PIN	MH/RA/410102/D-O2/(0)/2000	REDLANDS

6.5	REFERENCES	Municipal Records / Map (1903-04) / DP 1987 / Books on Matheran / Field Surveys			
7.0		ARCHITECTURAL SYSTEMS IN THE STRUCTURE			
7.1	FOUND. & PLINTH	Stepped laterite foundation. Plinth in coursed laterite - plastered and painted with projecting plinth course.

9.2	MAINTENANCE	Average			
10.0		REMARKS			
10.1	CONSERVATION & DEVELOPMENT	Holds potential for regular use as a residence or holiday home if maintained regularly. Landscaping needs to be restored. Detached additions only towards the east of the bungalow may be permitted.

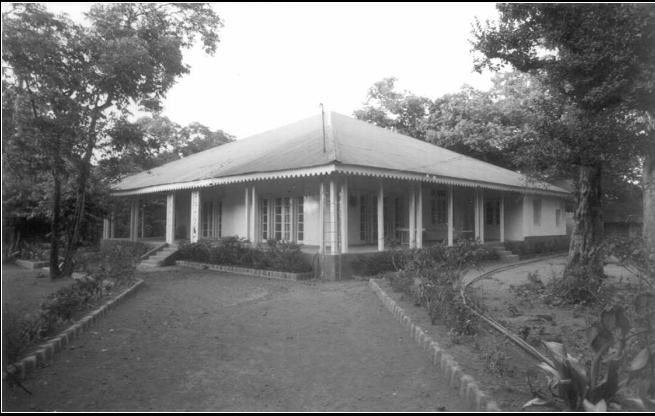
LOCATION	PIN	MH/RA/410102/D-03/(0)/2000	RUTLANDS

6.5	REFERENCES	Municipal Records / Map (1903-04) / DP 1987 / Books on Matheran / Field Surveys		
7.0	ARCHITECTURAL SYSTEMS IN THE STRUCTURE			
7.1	FOUND. & PLINTH	Stepped laterite foundation. Plinth in coursed laterite - painted and pointed in Terracotta colour.

8.0	TRANSFORMATION			
8.1	FORM	Toilet blocks added at the rear.		
8.2	STRUCTURE	None		
8.3	FINISHES	Flooring in verandah replaced.		
9.0	PRESENT STATUS			
9.1	STRUC. STABILITY	Good

9.2	MAINTENANCE	Excellent		
10.0	REMARKS			
10.1	CONSERVATION & DEVELOPMENT	A good example where an existing residential structure is being used as a company guest house, which ensure good maintenance and thereby a longer life to the building. Detached add-ons at the rear may be allowed.

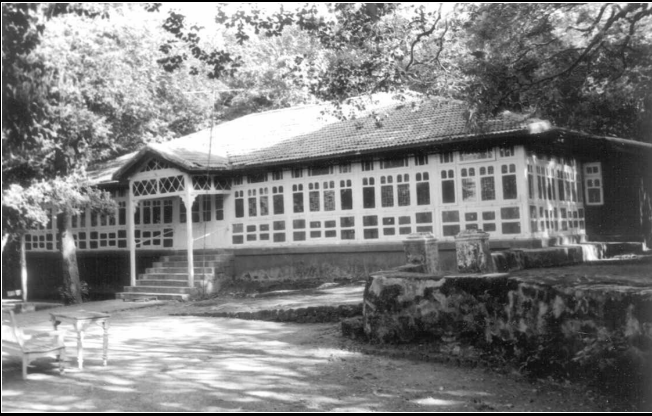
LOCATION		PIN	MH/RA/410102/D-04/(0)/2000	MARITIME HOUSE

6.5	REFERENCES	Municipal Records / Map (1903-04) / DP 1987 / Books on Matheran / Field Surveys			
7.0 ARCHITECTURAL SYSTEMS IN THE STRUCTURE					
7.1	FOUND. & PLINTH	Stepped laterite foundation. Plinth in coursed laterite - plastered and painted with projecting plinth course.

9.2	MAINTENANCE	Fair			
10.0 REMARKS					
10.1	CONSERVATION & DEVELOPMENT	Since it is currently being used as a holiday home for and institution additional buildings (detached from the main building) on the plot may be allowed.

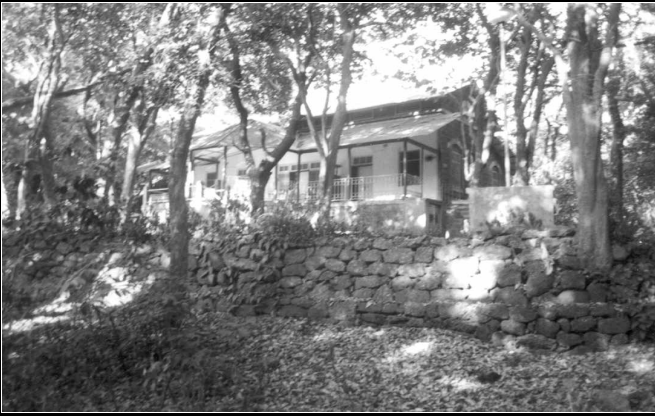
LOCATION		PIN	MH/RA/410102/D-05/(0)/2000	R. B. C. D. AROGYA BHAVAN BLDG. NO. 1

6.5	REFERENCES	Municipal Records / Map (1903-04) / DP 1987 / Books on Matheran / Field Surveys			
7.0 ARCHITECTURAL SYSTEMS IN THE STRUCTURE					
7.1	FOUND. & PLINTH	Stepped laterite foundation. Plinth in coursed laterite - exposed and pointed.

8.0 TRANSFORMATION					
8.1	FORM	None			
8.2	STRUCTURE	Timber members in verandah replaced by steel members.			
8.3	FINISHES	Installation of new M. S. grill in the verandah. Plastering and painting of the front façade wall.

9.0 PRESENT STATUS					
9.1	STRUC. STABILITY	Fair			
9.2	MAINTENANCE	Good			
10.0 REMARKS					
10.1	CONSERVATION & DEVELOPMENT	Adaptive re-use conducive to the form and structure may be permitted. The original structure must be retained and maintained as this group of three identical structures owned originally by Sir Adamjee Peerbhoy displays a particular built form typology developed in the beginning of the 20th century. No scope for extensions.

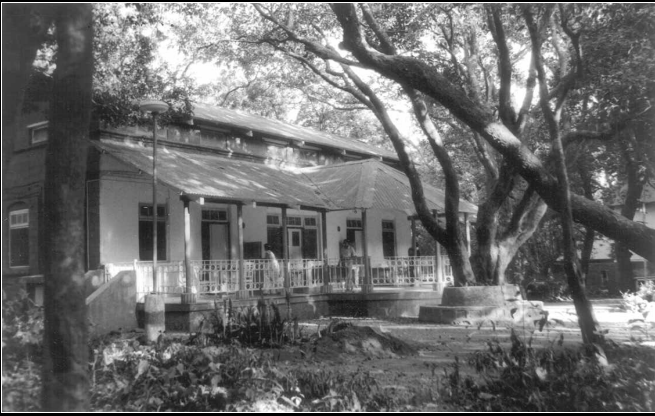
LOCATION	PIN	MH/RA/410102/D-06/(0)/2000	R. B. C. D. AROGYA BHAVAN BLDG. NO. 2

6.5	REFERENCES	Municipal Records / Map (1903-04) / DP 1987 / Books on Matheran / Field Surveys		
7.0	ARCHITECTURAL SYSTEMS IN THE STRUCTURE			
7.1	FOUND. & PLINTH	Stepped laterite foundation. Plinth in coursed laterite - exposed and pointed.

8.1	FORM	None		
8.2	STRUCTURE	Timber members in verandah replaced by steel members.		
8.3	FINISHES	Installation of new M. S. grill in the verandah. Plastering and painting of the front façade wall.

9.0	PRESENT STATUS			
9.1	STRUC. STABILITY	Fair		
9.2	MAINTENANCE	Good		
10.0	REMARKS			
10.1	CONSERVATION & DEVELOPMENT	Adaptive re-use conducive to the form and structure may be permitted. The original structure must be retained and maintained as this group of three identical structures owned originally by Sir Adamjee Peerbhoy displays a particular built form typology developed in the beginning of the 20th century. No scope for extensions.

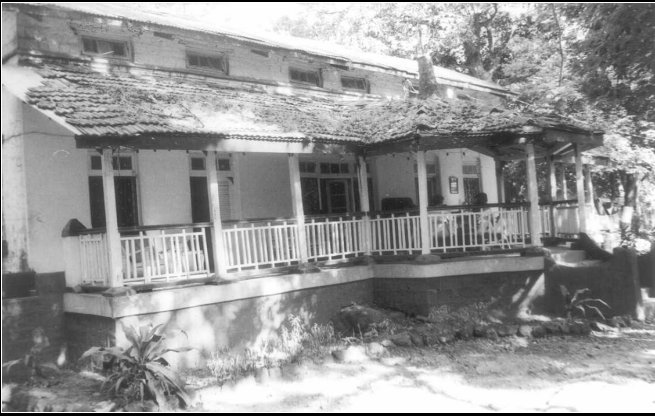
LOCATION		PIN	MH/RA/410102/D-07/(0)/2000	KHATIJA LODGE

6.5	REFERENCES	Municipal Records / Map (1903-04) / DP 1987 / Books on Matheran / Field Surveys			
7.0 ARCHITECTURAL SYSTEMS IN THE STRUCTURE					
7.1	FOUND. & PLINTH	Stepped laterite foundation. Plinth in coursed laterite - plastered with projected plinth course.

7.2	WALLS	Loadbearing in coursed laterite, plastered and painted externally and internally.			
7.3	FLOOR	Galicha tiles in the verandah (modern replacement) and encaustic tiles in the interior.

8.0 TRANSFORMATION					
8.1	FORM	None			
8.2	STRUCTURE	None			
8.3	FINISHES	Plastering and painting of walls and original tiles in verandah replaced by Galicha tiles.

9.0 PRESENT STATUS					
9.1	STRUC. STABILITY	Good			
9.2	MAINTENANCE	Good			
10.0 REMARKS					
10.1	CONSERVATION & DEVELOPMENT	Being one of the three identical structures in the area it holds significance as group value. It has retained its historic integrity. Adaptive re-use conducive to the form and structure may be permitted. The plot has no scope for extensions - attached or detached.

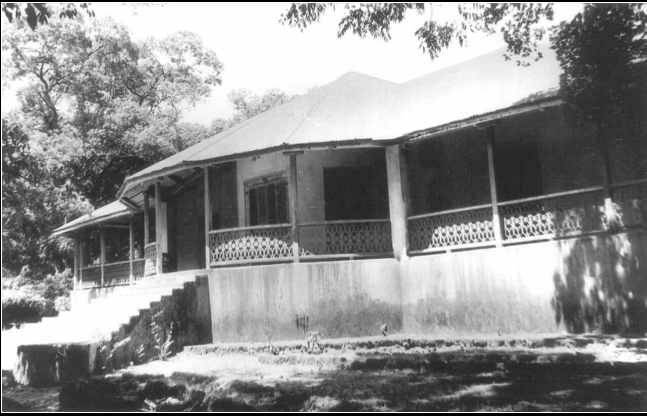
LOCATION	PIN	MH/RA/410102/D-08/(0)/2000	ELPHINSTONE LODGE

6.5	REFERENCES	Municipal Records / Map (1903-04) / DP 1987 / Books on Matheran / Field Surveys		
7.0	ARCHITECTURAL SYSTEMS IN THE STRUCTURE			
7.1	FOUND. & PLINTH	Stepped laterite foundation. Plinth in coursed laterite - plastered and painted.

7.2	WALLS	Loadbearing in coursed laterite, plastered and painted externally and internally.		
7.3	FLOOR	Shahabad tiles (replacement) in verandah and encaustic tiles in interior.

8.3	FINISHES	Plastering added, manglore tiles replaced by G.I. sheets.		
9.0	PRESENT STATUS			
9.1	STRUC. STABILITY	Fair		
9.2	MAINTENANCE	Not regular		
10.0	REMARKS

10.1	CONSERVATION & DEVELOPMENT	Proposed future developments on the site should essentially preserve and maintain this structure of great historic value and the dense forest cover of the sprawling site. Adaptive reuse and detached add-ons may be permitted.

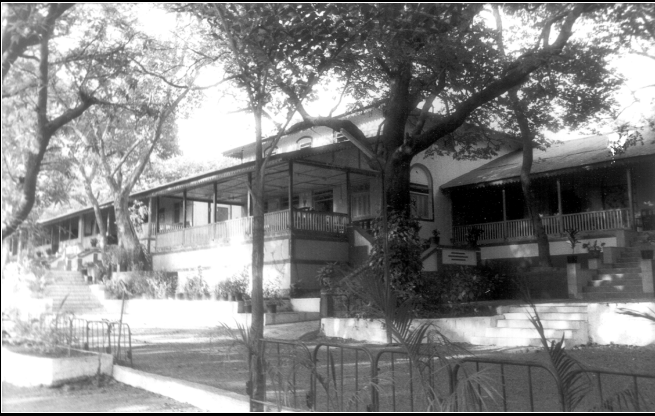
LOCATION	PIN	MH/RA/410102/D-09/(0)/2000	CECIL HOTEL

6.5	REFERENCES	Municipal Records / Map (1903-04) / DP 1987 / Books on Matheran / Field Surveys		
7.0	ARCHITECTURAL SYSTEMS IN THE STRUCTURE			
7.1	FOUND. & PLINTH	Stepped laterite foundation. Plinth in coursed laterite - some exposed and pointed and some painted.

9.1	STRUC. STABILITY	Good		
9.2	MAINTENANCE	Excellent		
10.0	REMARKS			
10.1	CONSERVATION & DEVELOPMENT	A sprawling, but, informal and organic layout with buildings and their settings retaining their historic integrity. The buildings hold significance in group value. Detached additions may be allowed on the site provided they do not disturb the historic setting of the existing structures, respect the natural topography and vegetation on the site and relate sensitively to them in terms of form, scale and treatment.

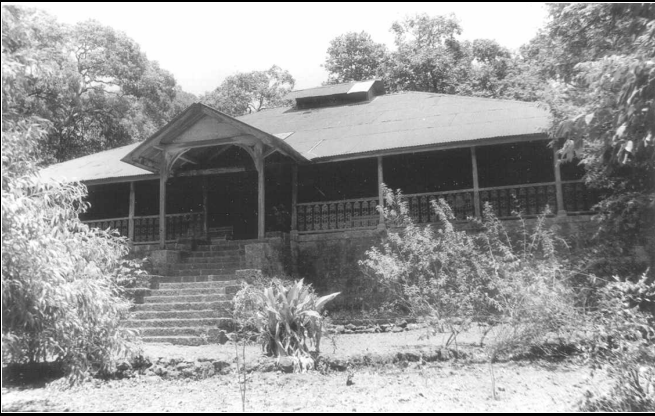
LOCATION		PIN	MH/RA/410102/D-10/(0)/2000	SPENCER VILLA

6.5	REFERENCES	Municipal Records / Map (1903-04) / DP 1987 / Books on Matheran / Field Surveys			
7.0		ARCHITECTURAL SYSTEMS IN THE STRUCTURE			
7.1	FOUND. & PLINTH	Stepped laterite foundation. Plinth in coursed laterite - exposed with projecting plinth course.

9.0		PRESENT STATUS			
9.1	STRUC. STABILITY	Fair			
9.2	MAINTENANCE	Fair			
10.0		REMARKS			
10.1	CONSERVATION & DEVELOPMENT	A typical bungalow format on a large plot - appropriate for residential use or other adaptive re-use such as for a company guest house.

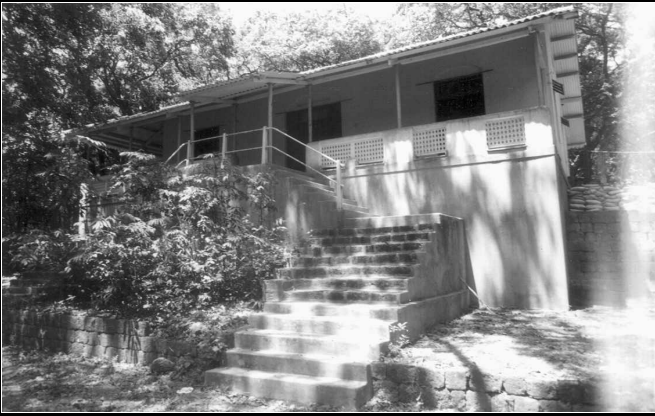
LOCATION	PIN	MH/RA/410102/D-11/(0)/2000	TOPIWALA BUNGALOW

9.2	MAINTENANCE	Regular		
10.0	REMARKS			
10.1	CONSERVATION & DEVELOPMENT	Generally a well maintained structure located on a small plot. Residential use may continue. Very little scope for extensions and additions.

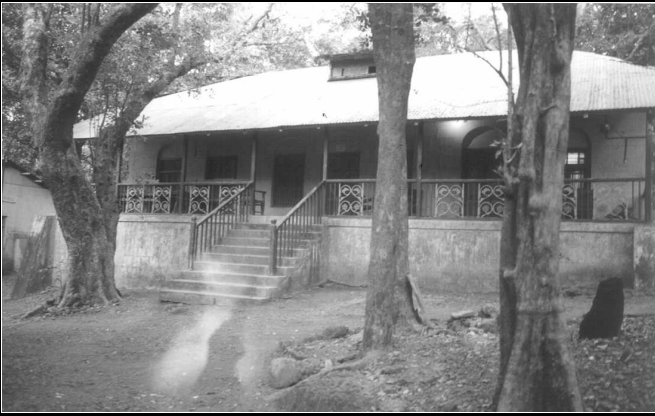
LOCATION		PIN	MH/RA/410102/D-12/(0)/2000	KHOJA SANATORIUM

10.0 REMARKS					
10.1	CONSERVATION & DEVELOPMENT	The large site with its privileged location holds great potential for being used as a hotel or sanatorium in the future if maintained properly. The structures as well as the landscape need to be looked after and developed. Extensions to new blocks or additions to suit the original form design may be allowed.

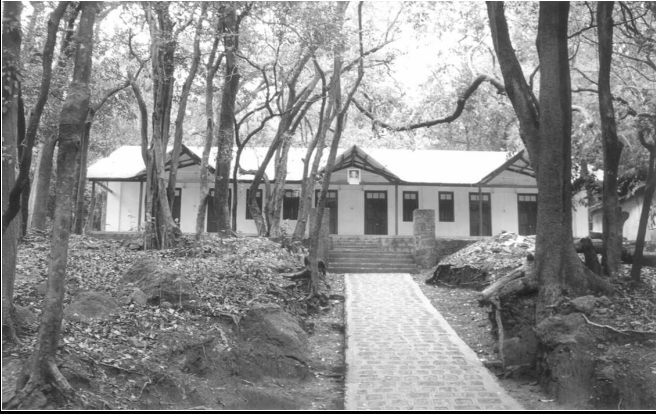
LOCATION	PIN	MH/RA/410102/E-01/(0)/2000	RANCHHODDAS AROGYA BHAVAN

9.1	STRUC. STABILITY	Good		
9.2	MAINTENANCE	Fair		
10.0	REMARKS			
10.1	CONSERVATION & DEVELOPMENT	The well maintained structure has a landmark value owing to its commanding position in relation to M. G. road. Ideal for its use as a sanatorium or a guest house. Attached extensions / additions should not be permitted. Detached additions in the rear open space may be permitted only if they relate sensitively to the original buildings.

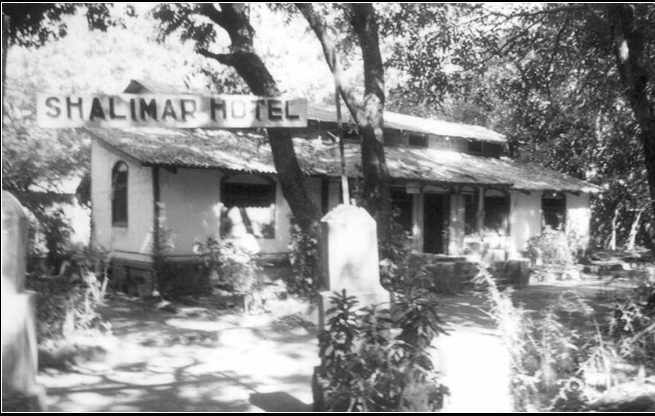
LOCATION		PIN	MH/RA/410102/E-02/(0)/2000	SHALIMAR HOTEL

9.2	MAINTENANCE	Fair			
10.0 REMARKS					
10.1	CONSERVATION & DEVELOPMENT	Moderately maintained structure with good façade value. Use as a hotel may continue. Detached additions sensitive to the original structure in terms of its form, scale and materials may be allowed in the rear open space or on the sides.

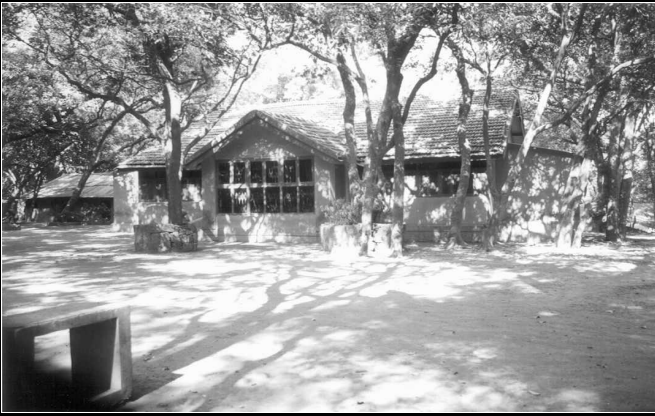
LOCATION		PIN	MH/RA/410102/E-03/(0)/2000	DAYANAND KUTI

1.0 NAME OF THE PROPERTY					
1.1	NAME	DAYANAND KUTI			
1.2	HISTORIC NAME	DAYANAND KUTI			
1.3	BUILT IN	1901			
2.0 AREA (SQ. MTS.)					
2.1	PLOT AREA	4935.70

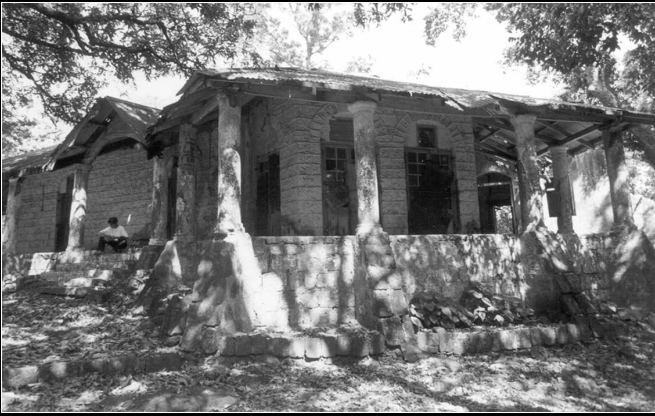
LOCATION	PIN	MH/RA/410102/E-05/(0)/2000	FERNWOOD

CARD	E-05/(0)
			GRADE	III
			ZONE	GALTI DARA
			ZONE REF.	E 05
			CO-ORD.	1,14
			PLOT #	83
			SURVEY #	32

6.5	REFERENCES	Municipal Records / Map (1903-04) / DP 1987 / Books on Matheran / Field Surveys		
7.0	ARCHITECTURAL SYSTEMS IN THE STRUCTURE			
7.1	FOUND. & PLINTH	Stepped laterite foundation. Plinth in coursed laterite - exposed and pointed. Plinth buttressed below columns.

7.7	DECO. ELEMENTS & INTERIORS	Decorative fascia board now damaged.		
8.0	TRANSFORMATION			
8.1	FORM	None		
8.2	STRUCTURE	Plinth strengthened by laterite buttresses just below the columns in the verandah.

8.3	FINISHES	None		
9.0	PRESENT STATUS			
9.1	STRUC. STABILITY	Structure unsound. Unequal settlement of plinth. Structural vertical cracks.		
9.2	MAINTENANCE	The structure is presently not in use and therefore neglected and not maintained.

10.0	REMARKS			
10.1	CONSERVATION & DEVELOPMENT	Though the structure has as a sound architectural character and historic value, its present structural condition may not permit adaptive re-use without major renovation. Attached or detached add-ons may be permitted retaining the original building.

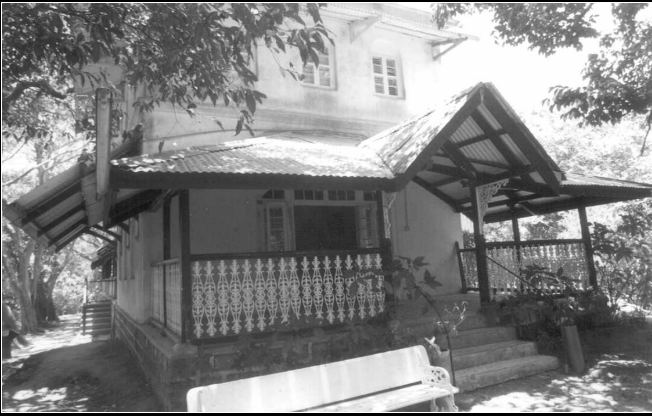
LOCATION		PIN	MH/RA/410102/E-06/(0)/2000	SETT VILLA

CARD		E-06/(0)
			GRADE		II-A
			ZONE		GALTI DARA
			ZONE REF.		E 06
			CO-ORD.		1,15
			PLOT #		47
			SURVEY #		30

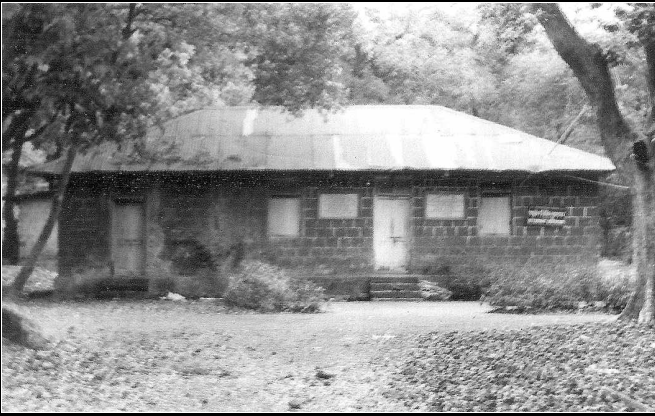
LOCATION		PIN	MH/RA/410102/E-07/(0)/2000	VETERINARY HOSPITAL

CARD	E-07/(0)
				GRADE	III
				ZONE	GALTI DARA
				ZONE REF.	E 07
				CO-ORD.	J,14
				PLOT #	235
				SURVEY #	42

6.5	REFERENCES	Municipal Records / Map (1903-04) / DP 1987 / Books on Matheran / Field Surveys			
7.0		ARCHITECTURAL SYSTEMS IN THE STRUCTURE			
7.1	FOUND. & PLINTH	Stepped laterite foundation. Plinth in coursed laterite - exposed and pointed.

9.2	MAINTENANCE	Fair			
10.0		REMARKS			
10.1	CONSERVATION & DEVELOPMENT	A neglected structure and an under-utilised site, may be put to more meaningful public use. The historic 'Paymaster Well' in the plot needs to be restored and rejuvenated.

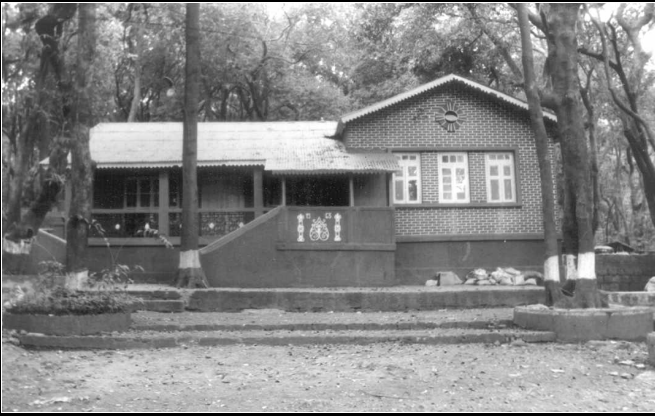
LOCATION		PIN	MH/RA/410102/E-08/(0)/2000	CUTCH COTTAGE

CARD		E-08/(0)
			GRADE		II-B
			ZONE		GALTI DARA
			ZONE REF.		E 08
			CO-ORD.		J,14
			PLOT #		211
			SURVEY #		43

6.5	REFERENCES	Municipal Records / Map (1903-04) / DP 1987 / Books on Matheran / Field Surveys			
7.0 ARCHITECTURAL SYSTEMS IN THE STRUCTURE					
7.1	FOUND. & PLINTH	Stepped laterite foundation. Plinth in coursed laterite - plastered and painted with projected plinth course.

9.2	MAINTENANCE	Excellent.			
10.0 REMARKS					
10.1	CONSERVATION & DEVELOPMENT	<p>A pretty little structure holding significance in group value. The small plot has no scope for additions and extensions. The informal kiosk in the premises may hamper the façade value of the main structure if allowed to expand and sprawl.</p>

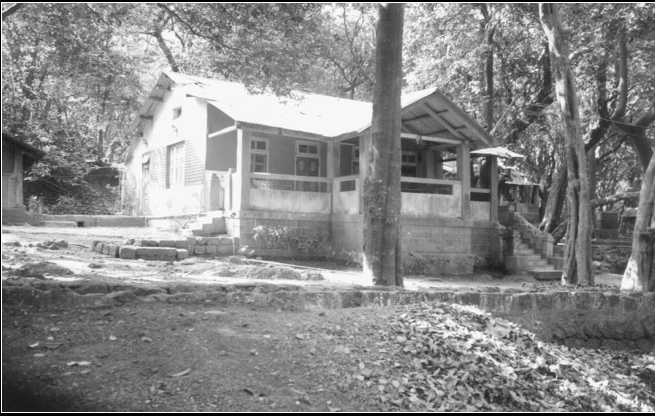
LOCATION		PIN	MH/RA/410102/E-09/(0)/2000	TAYYAB COTTAGE

CARD	E-09/(0)	
			GRADE	III	
			ZONE	GALTI DARA	
			ZONE REF.	E 09	
			CO-ORD.	J,14	
			PLOT #	212	
			SURVEY #	44

6.5	REFERENCES	Municipal Records / Map (1903-04) / DP 1987 / Books on Matheran / Field Surveys			
7.0 ARCHITECTURAL SYSTEMS IN THE STRUCTURE					
7.1	FOUND. & PLINTH	Stepped laterite foundation. Plinth in coursed laterite - exposed and pointed.

9.0 PRESENT STATUS					
9.1	STRUC. STABILITY	Fair			
9.2	MAINTENANCE	Fair			
10.0 REMARKS					
10.1	CONSERVATION & DEVELOPMENT	In spite of modern interventions, the structure has maintained its form and scale, hence holds significance in group value. No scope for additions and extensions.

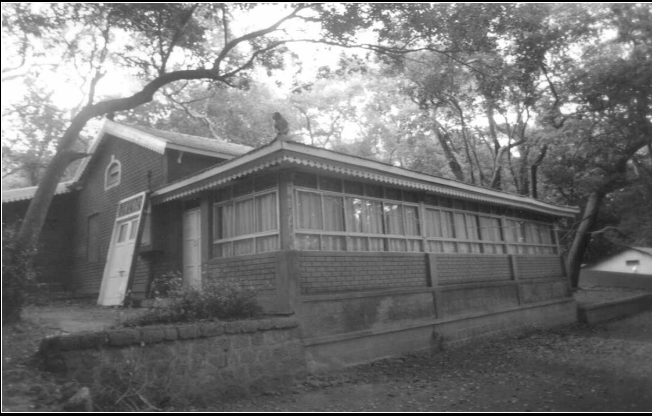
LOCATION		PIN	MH/RA/410102/E-10/(0)/2000	NETER VILLA

CARD	E-10/(0)	
			GRADE	III	
			ZONE	GALTI DARA	
			ZONE REF.	E 10	
			CO-ORD.	J,14	
			PLOT #	213	
			SURVEY #	45

6.5	REFERENCES	Municipal Records / Map (1903-04) / DP 1987 / Books on Matheran / Field Surveys			
7.0 ARCHITECTURAL SYSTEMS IN THE STRUCTURE					
7.1	FOUND. & PLINTH	Stepped laterite foundation. Plinth in coursed laterite - plastered and painted.

9.1	STRUC. STABILITY	Good			
9.2	MAINTENANCE	Good			
10.0 REMARKS					
10.1	CONSERVATION & DEVELOPMENT	Although the structure has not retained any of the original materials and finishes its scale and colour is complimentary to the general townscape character, hence contributes satisfactorily to the precinct. No scope for additions / extensions in the foreground.

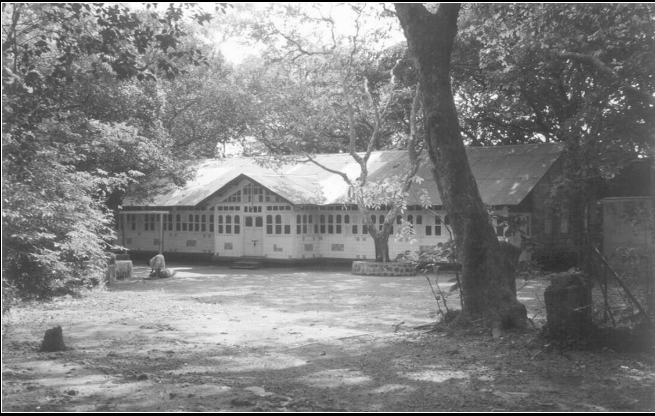
LOCATION		PIN	MH/RA/410102/E-15/(0)/2000	SUKAN VILLA

CARD	E-15/(0)
				GRADE	II-B
				ZONE	GALTI DARA
				ZONE REF.	E 15
				CO-ORD.	J,16
				PLOT #	163
				SURVEY #	54

6.5	REFERENCES	Municipal Records / Map (1903-04) / DP 1987 / Books on Matheran / Field Surveys			
7.0 ARCHITECTURAL SYSTEMS IN THE STRUCTURE					
7.1	FOUND. & PLINTH	Stepped laterite foundation. Plinth in coursed laterite - exposed with projecting plinth course.

9.1	STRUC. STABILITY	Fair			
9.2	MAINTENANCE	Fair			
10.0 REMARKS					
10.1	CONSERVATION & DEVELOPMENT	<p>Forms a significant part of the Galti Dara conservation area as it has a value in its form and scale and a unique façade which is characteristic of only this set of buildings in this area. Adaptive re-use may be permitted but there is no scope for further additions and extensions.</p>

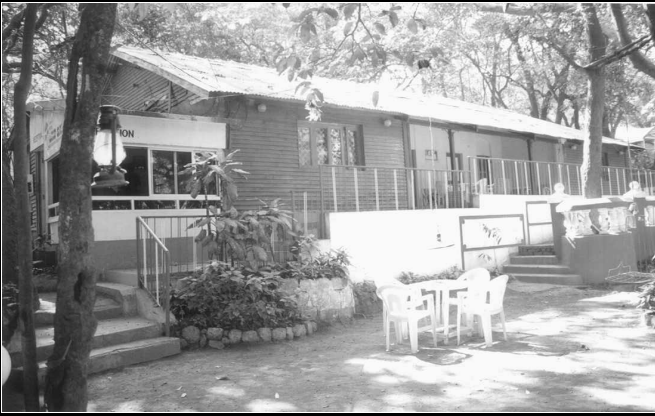
LOCATION	PIN	MH/RA/410102/E-11/(0)/2000	WOODSIDE HOTEL

CARD	E-11/(0)
			GRADE	III
			ZONE	GALTI DARA
			ZONE REF.	E 11
			CO-ORD.	J,14
			PLOT #	214
			SURVEY #	46

6.5	REFERENCES	Municipal Records / Map (1903-04) / DP 1987 / Books on Matheran / Field Surveys		
7.0	ARCHITECTURAL SYSTEMS IN THE STRUCTURE			
7.1	FOUND. & PLINTH	Stepped laterite foundation. Plinth in coursed laterite - plastered and painted.

9.2	MAINTENANCE	Good		
10.0	REMARKS			
10.1	CONSERVATION & DEVELOPMENT	In spite of being subjected to interventions such as extensions and change of finishes, the structure has maintained its scale and form, therefore, it holds significant group value. No scope for further additions and extensions.

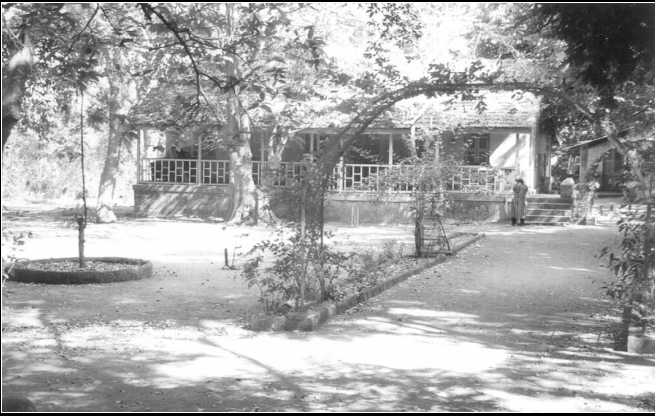
LOCATION		PIN	MH/RA/410102/E-12/(0)/2000	KACHWALA COTTAGE

CARD	E-12/(0)
				GRADE	II-B
				ZONE	GALTI DARA
				ZONE REF.	E 12
				CO-ORD.	J,15
				PLOT #	186
				SURVEY #	51

6.5	REFERENCES	Municipal Records / Map (1903-04) / DP 1987 / Books on Matheran / Field Surveys			
7.0 ARCHITECTURAL SYSTEMS IN THE STRUCTURE					
7.1	FOUND. & PLINTH	Stepped laterite foundation. Plinth in coursed laterite - exposed with projected plinth course.

10.0 REMARKS					
10.1	CONSERVATION & DEVELOPMENT	It holds landmark value owing to its setting and orientation. The large open foreground with formal landscaping contributes to the townscape character. The site permits no scope for additions and extensions.

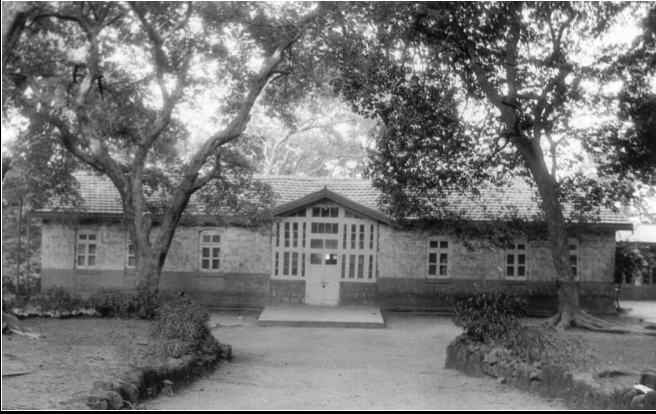
LOCATION	PIN	MH/RA/410102/E-13/(0)/2000	NOOR COTTAGE

CARD	E-13/(0)
			GRADE	II-B
			ZONE	GALTI DARA
			ZONE REF.	E 13
			CO-ORD.	J,15
			PLOT #	185
			SURVEY #	52

6.5	REFERENCES	Municipal Records / Map (1903-04) / DP 1987 / Books on Matheran / Field Surveys		
7.0	ARCHITECTURAL SYSTEMS IN THE STRUCTURE			
7.1	FOUND. & PLINTH	Stepped laterite foundation. Plinth in coursed laterite - painted

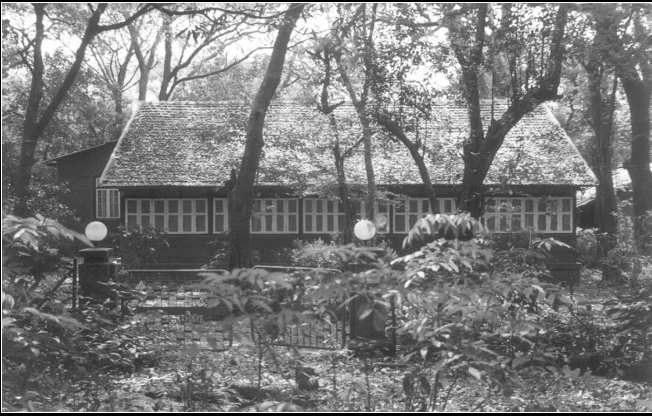
LOCATION		PIN	MH/RA/410102/E-16/(0)/2000	VELKAR VILLA

CARD	E-16/(0)	
			GRADE	II-B	
			ZONE	GALTI DARA	
			ZONE REF.	E 16	
			CO-ORD.	I,16	
			PLOT #	162	
			SURVEY #	55

6.5	REFERENCES	Municipal Records / Map (1903-04) / DP 1987 / Books on Matheran / Field Surveys			
7.0 ARCHITECTURAL SYSTEMS IN THE STRUCTURE					
7.1	FOUND. & PLINTH	Stepped laterite foundation. Plinth in coursed laterite - exposed with projected plinth course.

9.1	STRUC. STABILITY	Good			
9.2	MAINTENANCE	Good			
10.0 REMARKS					
10.1	CONSERVATION & DEVELOPMENT	<p>Excellent setting with well maintained building and landscape. Forms a significant part of the Galti Dara conservation area as it has a value in its form and scale and a unique façade which is characteristic of only this set of buildings in this area. Adaptive re-use may be permitted but there is no scope for further additions and extensions.</p>

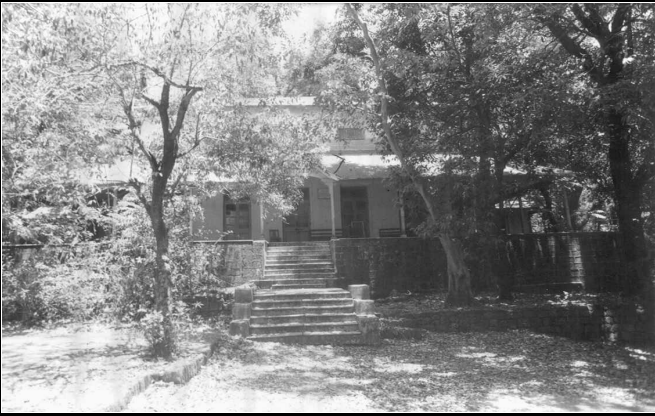
LOCATION		PIN	MH/RA/410102/E-17/(0)/2000	NEHRU BHAVAN

CARD	E-17/(0)	
			GRADE	II-B	
			ZONE	GALTI DARA	
			ZONE REF.	E 17	
			CO-ORD.	I,15	
			PLOT #	158	
			SURVEY #	49

6.5	REFERENCES	Municipal Records / Map (1903-04) / DP 1987 / Books on Matheran / Field Surveys			
7.0		ARCHITECTURAL SYSTEMS IN THE STRUCTURE			
7.1	FOUND. & PLINTH	Stepped laterite foundation. Plinth in coursed laterite - exposed and pointed.

10.0		REMARKS			
10.1	CONSERVATION & DEVELOPMENT	<p>The structure with its site designed for recreational use holds immense cultural value and also contributes to the townscape character. Any additions to the site must be guided by strict design control, so that they do not adversely affect the ambience of the setting and the architectural character of the structure .</p>

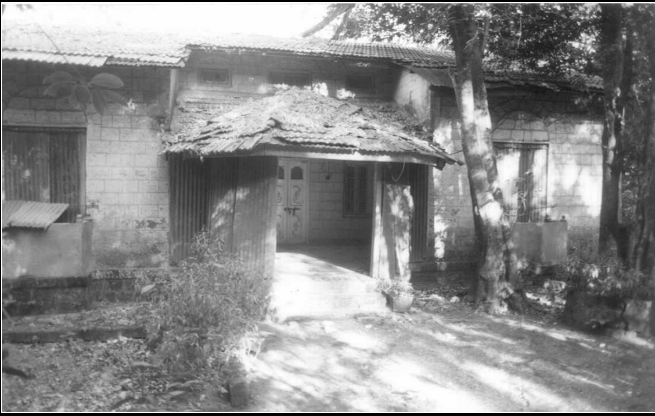
LOCATION		PIN	MH/RA/410102/E-18/(0)/2000	HONEY COMB

CARD	E-18/(0)
				GRADE	III
				ZONE	GALTI DARA
				ZONE REF.	E 18
				CO-ORD.	I,15
				PLOT #	198
				SURVEY #	56

6.5	REFERENCES	Municipal Records / Map (1903-04) / DP 1987 / Books on Matheran / Field Surveys			
7.0 ARCHITECTURAL SYSTEMS IN THE STRUCTURE					
7.1	FOUND. & PLINTH	Stepped laterite foundation. Plinth in coursed laterite - exposed and painted.

9.1	STRUC. STABILITY	Structurally unsound			
9.2	MAINTENANCE	Needs urgent repair and maintenance.			
10.0 REMARKS					
10.1	CONSERVATION & DEVELOPMENT	A completely neglected and ill-maintained structure at an important nodal location. The structure and its premises need urgent maintainence. Adaptive re-use may be permitted but there is no scope for additions and extensions.

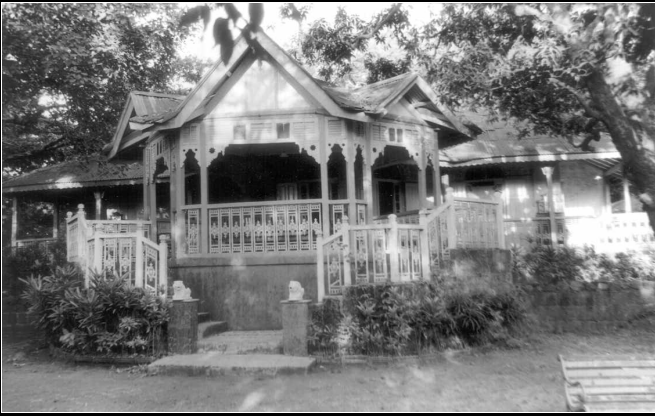
LOCATION		PIN	MH/RA/410102/F-01/(0)/2000	WOODLANDS

CARD		F-01/(0)
			GRADE		II-A
			ZONE		PORCUPINE POINT
			ZONE REF.		F 01
			CO-ORD.		C,13
			PLOT #		34
			SURVEY #		79

6.5	REFERENCES	Municipal Records / Map (1903-04) / DP 1987 / Books on Matheran / Field Surveys			
7.0 ARCHITECTURAL SYSTEMS IN THE STRUCTURE					
7.1	FOUND. & PLINTH	Stepped laterite foundation. Plinth in coursed laterite - exposed and partly plastered with projecting plinth course.

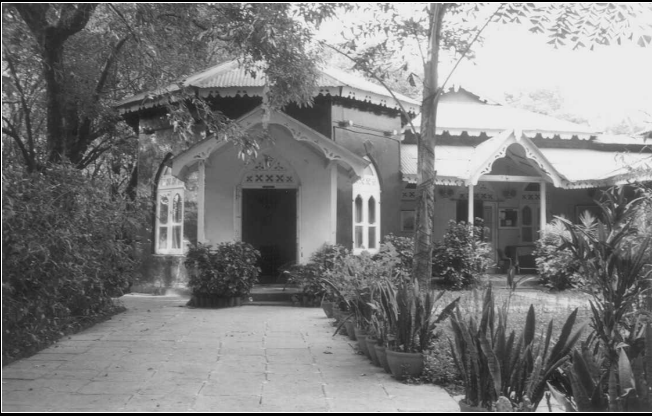
LOCATION	PIN	MH/RA/410102/F-03/(0)/2000	MALDUNGA HOUSE

CARD	F-03/(0)
			GRADE	II-A
			ZONE	PORCUPINE POINT
			ZONE REF.	F 03
			CO-ORD.	C,14-15
			PLOT #	44
			SURVEY #	81

6.5	REFERENCES	Municipal Records / Map (1903-04) / DP 1987 / Books on Matheran / Field Surveys		
7.0	ARCHITECTURAL SYSTEMS IN THE STRUCTURE			
7.1	FOUND. & PLINTH	Stepped laterite foundation. Plinth in coursed laterite - pointed and painted.

9.2	MAINTENANCE	Good		
10.0	REMARKS			
10.1	CONSERVATION & DEVELOPMENT	A well maintained structure in an excellent setting. Present use as corporate holiday home may continue for conducive maintenance. Interventions that would affect the historic integrity of the structure should not be permitted. Detached additions may be permitted only to the north of the existing bungalow provided they relate sensitively to the main bungalow in form, scale and treatment.

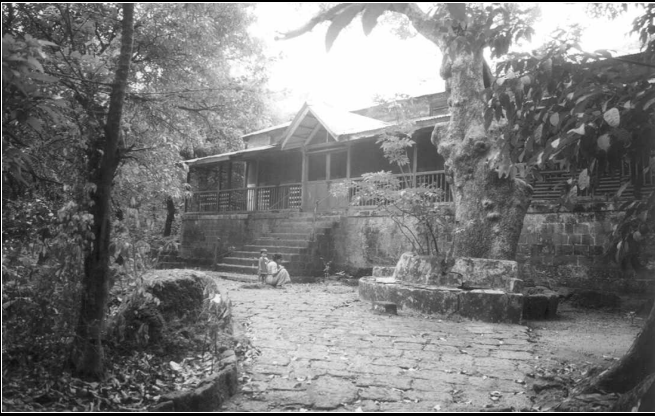
LOCATION		PIN	MH/RA/410102/F-04/(0)/2000	WEST VIEW

CARD	F-04/(0)
				GRADE	II-B
				ZONE	PORCUPINE POINT
				ZONE REF.	F 04
				CO-ORD.	B,15
				PLOT #	50
				SURVEY #	83

6.5	REFERENCES	Municipal Records / Map (1903-04) / DP 1987 / Books on Matheran / Field Surveys			
7.0 ARCHITECTURAL SYSTEMS IN THE STRUCTURE					
7.1	FOUND. & PLINTH	Stepped laterite foundation. Plinth in coursed laterite - exposed and pointed.

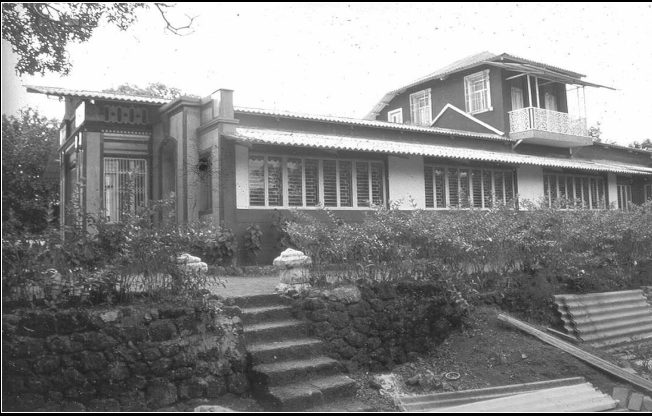
LOCATION		PIN	MH/RA/410102/F-06/(0)/2000	MOUNT ERIC

CARD		F-06/(0)
			GRADE		III
			ZONE		PORCUPINE POINT
			ZONE REF.		F 06
			CO-ORD.		D,16
			PLOT #		53
			SURVEY #		77

6.5	REFERENCES	Municipal Records / Map (1903-04) / DP 1987 / Books on Matheran / Field Surveys			
7.0 ARCHITECTURAL SYSTEMS IN THE STRUCTURE					
7.1	FOUND. & PLINTH	Stepped laterite foundation. Plinth in coursed laterite - plastered and painted.

9.0 PRESENT STATUS					
9.1	STRUC. STABILITY	Good			
9.2	MAINTENANCE	Good			
10.0 REMARKS					
10.1	CONSERVATION & DEVELOPMENT	Major interventions to the structure have led to the loss of its historic integrity. The structure qualifies for listing only due to its historic association and landmark value which contributes to the skyline of Matheran. Any additions or extensions to the structure or on the site should have due regard of the historic landscape and the skyline of the structure.

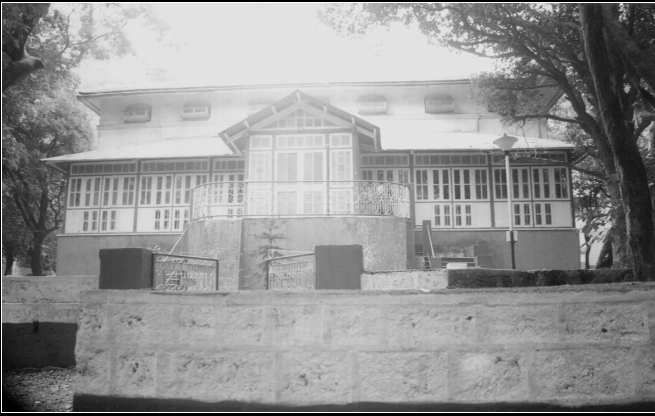
LOCATION		PIN	MH/RA/410102/F-07/(0)/2000	DULCI DOMUM

CARD		F-07/(0)	
		GRADE		II-B	
		ZONE		PORCUPINE POINT	
		ZONE REF.		F 07	
		CO-ORD.		D-E,16	
		PLOT #		216	
		SURVEY #		76

6.5	REFERENCES	Municipal Records / Map (1903-04) / DP 1987 / Books on Matheran / Field Surveys			
7.0 ARCHITECTURAL SYSTEMS IN THE STRUCTURE					
7.1	FOUND. & PLINTH	Stepped laterite foundation. Plinth in coursed laterite - plastered and painted.

10.1	CONSERVATION & DEVELOPMENT	<p>Holds importance in group value being one of the two identical structures in that location. Modern interventions to the structure have adversely affected the historic integrity of the structure. A recently built multi storeyed tower in place of the original watch tower (which had collapsed), is now an unsightly feature that has a detrimental visual impact on the character of the building and its environs. No further interventions to the building and site should be permitted.</p>

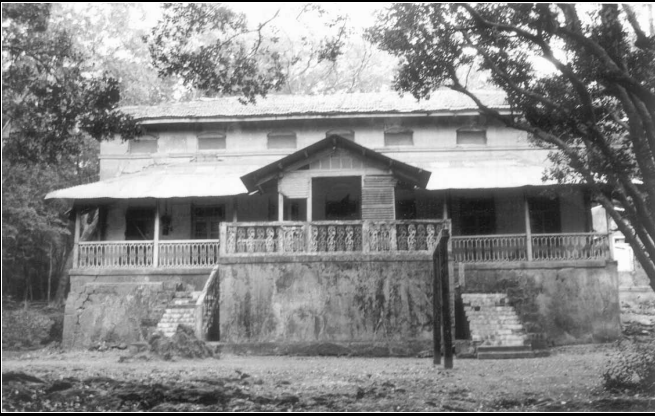
LOCATION		PIN	MH/RA/410102/F-08/(0)/2000	JAIN MANDIR

CARD		F-08/(0)
			GRADE		III
			ZONE		PORCUPINE POINT
			ZONE REF.		F 08
			CO-ORD.		E,16
			PLOT #		210
			SURVEY #		75

6.5	REFERENCES	Municipal Records / Map (1903-04) / DP 1987 / Books on Matheran / Field Surveys			
7.0 ARCHITECTURAL SYSTEMS IN THE STRUCTURE					
7.1	FOUND. & PLINTH	Stepped laterite foundation. Plinth in coursed laterite - plastered and painted.

7.2	WALLS	Loadbearing in coursed laterite, plastered and painted.			
7.3	FLOOR	Minton tiles replaced by glazed tiles.			
7.4	ROOF	TW purlin rafter roof structure with manglore tiles roofing over the rooms and G.I. sheets roofing over the verandah.

8.2	STRUCTURE	Internal modifications.			
8.3	FINISHES	Plastering and painting of walls.			
9.0 PRESENT STATUS					
9.1	STRUC. STABILITY	Poor - some major structural defects.

9.2	MAINTENANCE	Poor			
10.0 REMARKS					
10.1	CONSERVATION & DEVELOPMENT	Holds importance in group value being one of the two identical structures in that location. The structure and its surroundings need regular maintenance. No scope for attached or detached extensions or additions.

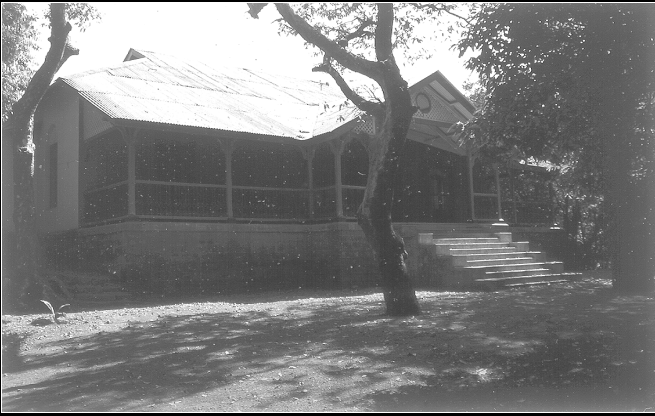
LOCATION		PIN	MH/RA/410102/F-09/(0)/2000	THE LILY

CARD	F-09/(0)	
			GRADE	II-B	
			ZONE	PORCUPINE POINT	
			ZONE REF.	F 09	
			CO-ORD.	E,17	
			PLOT #	27	
			SURVEY #	97

6.5	REFERENCES	Municipal Records / Map (1903-04) / DP 1987 / Books on Matheran / Field Surveys			
7.0 ARCHITECTURAL SYSTEMS IN THE STRUCTURE					
7.1	FOUND. & PLINTH	Stepped laterite foundation. Plinth in coursed laterite - exposed and pointed with projecting course and buttresses.

9.0 PRESENT STATUS					
9.1	STRUC. STABILITY	Fair - vertical cracks in masonry sealed with sealant.			
9.2	MAINTENANCE	Fair			
10.0 REMARKS					
10.1	CONSERVATION & DEVELOPMENT	A well maintained structure and setting depicting the typical character of Matheran. Residential use may continue. Attached and detached extensions may permitted towards the east or south of the structure provided they are sensitive to the from scale and treatment of the original structure.

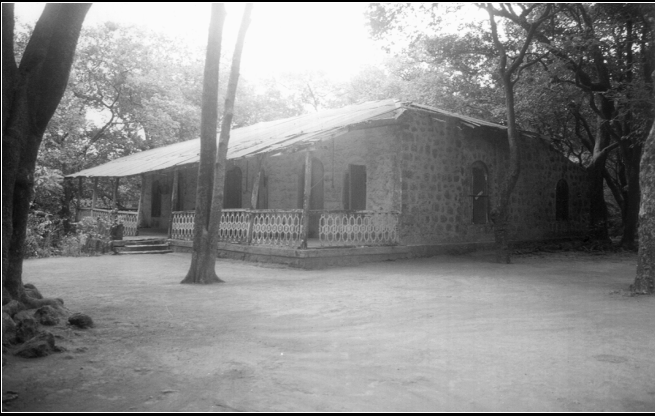
LOCATION		PIN	MH/RA/410102/F-10/(0)/2000	NAIMISHARANYA

CARD	F-10/(0)
				GRADE	III
				ZONE	PORCUPINE POINT
				ZONE REF.	F 10
				CO-ORD.	E,17
				PLOT #	17
				SURVEY #	98

6.5	REFERENCES	Municipal Records / Map (1903-04) / DP 1987 / Books on Matheran / Field Surveys			
7.0 ARCHITECTURAL SYSTEMS IN THE STRUCTURE					
7.1	FOUND. & PLINTH	Stepped laterite foundation. Plinth in coursed laterite - exposed.

9.1	STRUC. STABILITY	Poor			
9.2	MAINTENANCE	Poor			
10.0 REMARKS					
10.1	CONSERVATION & DEVELOPMENT	The main structure in the property is in a dilapidated condition, yet the property qualifies for listing because of its historic association, landscape and important nodal location. Adaptive re-use of the structure should be encouraged to ensure maintenance of the structures and the site. The main structure should be authentically restored and put to conducive use. Additions on site should respect the forest cover and the form and scale of the existing buildings.

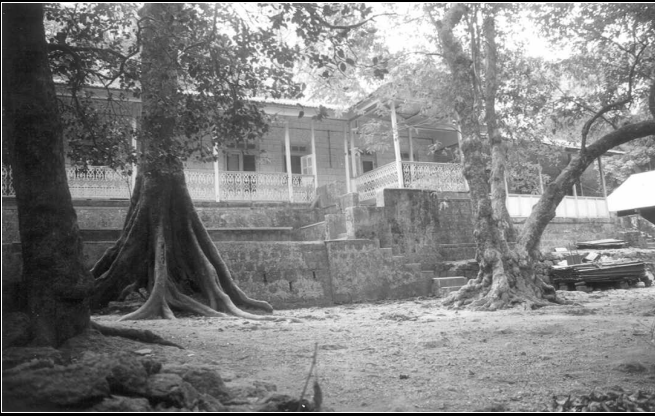
LOCATION		PIN	MH/RA/410102/F-11/(0)/2000	KRISHNA BHAVAN

CARD	F-11/(0)
				GRADE	III
				ZONE	PORCUPINE POINT
				ZONE REF.	F 11
				CO-ORD.	E,17
				PLOT #	23A
				SURVEY #	95

1.0 NAME OF THE PROPERTY					
1.1	NAME	KRISHNA BHAVAN			
1.2	HISTORIC NAME	PART OF JIVAJI HALL			
1.3	BUILT IN	1854 - 1900			
2.0 AREA (SQ. MTS.)					
2.1	PLOT AREA	6702.60
