MATHERAN:
A COMPREHENSIVE HERITAGE LISTING
PROPOSAL

FINAL REPORT
VOLUME III & IV

PROJECT CONSULTANT
K. UNWALLA ARCHITECTS

FOR
**M.M.R. HERITAGE CONSERVATION
SOCIETY**

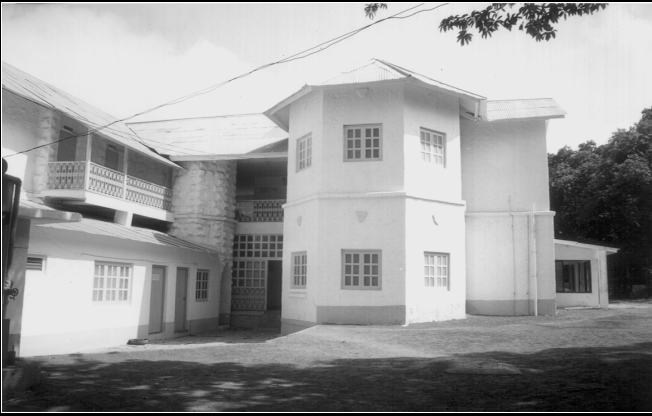
LOCATION		PIN	MH/RA/410102/F-12/(0)/2000	BOMBAY VIEW

CARD		F-12/(0)
			GRADE		II-B
			ZONE		PORCUPINE POINT
			ZONE REF.		F 12
			CO-ORD.		E,18
			PLOT #		52
			SURVEY #		94

6.5	REFERENCES	Municipal Records / Map (1903-04) / DP 1987 / Books on Matheran / Field Surveys			
7.0 ARCHITECTURAL SYSTEMS IN THE STRUCTURE					
7.1	FOUND. & PLINTH	Stepped laterite foundation. Plinth in coursed laterite - plastered and painted.

7.2	WALLS	Loadbearing, coursed laterite, plastered & painted. Quoins & jambs in projecting trap stone with rusticated finish.			
7.3	FLOOR	Shahabad tiles flooring.

8.1	FORM	Addition of massive concrete buttresses on corners 6'0" in height.			
8.2	STRUCTURE	Internal partitions added to create extra bedrooms. Timber floor replaced by steel joist floor.

8.3	FINISHES	Plastering and painting of walls and original tiles replaced by Shahabad tiles.			
9.0 PRESENT STATUS					
9.1	STRUC. STABILITY	Good			
9.2	MAINTENANCE	Good

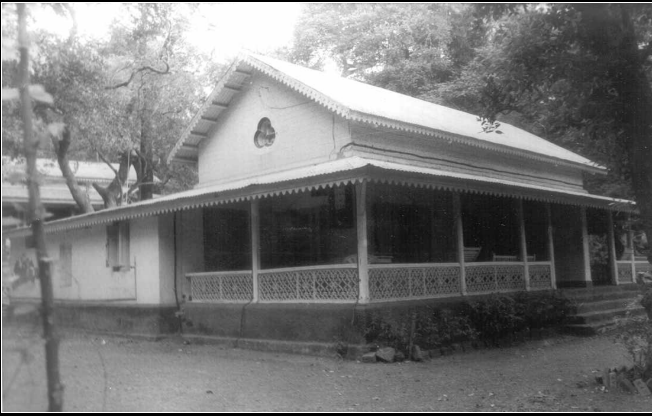
LOCATION	PIN	MH/RA/410102/G-01/(0)/2000	SETH MANSUKHLAL AROGYA BHAVAN

CARD	G-01/(0)
			GRADE	II-B
			ZONE	ARTIST POINT
			ZONE REF.	G 01
			CO-ORD.	F,16
			PLOT #	106
			SURVEY #	70

6.5	REFERENCES	Municipal Records / Map (1903-04) / DP 1987 / Books on Matheran / Field Surveys		
7.0	ARCHITECTURAL SYSTEMS IN THE STRUCTURE			
7.1	FOUND. & PLINTH	Stepped laterite foundation. Plinth in coursed laterite - painted.

7.2	WALLS	Loadbearing in coursed laterite, plastered and painted externally and internally.		
7.3	FLOOR	Original flooring replaced with Spartek flooring.

8.0	TRANSFORMATION			
8.1	FORM	None		
8.2	STRUCTURE	None		
8.3	FINISHES	Plastering and painting of walls and original flooring replaced by Spartek flooring.

9.0	PRESENT STATUS			
9.1	STRUC. STABILITY	Good		
9.2	MAINTENANCE	Good		
10.0	REMARKS			
10.1	CONSERVATION & DEVELOPMENT	A good example where a large amount of modern interventions on a historic site have retained the original character of the property and its environs, in spite of the use of modern materials. Any new detached additions should have regard to the existing forest cover and should not in any way obstruct the existing view of the old structure from the approach road. The present use is conducive for future maintenance of the property and should continue.

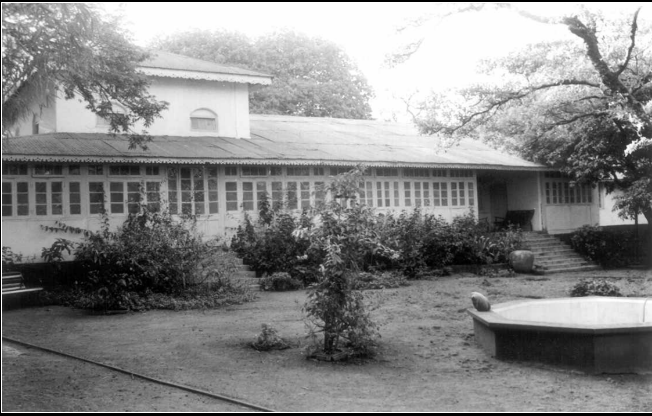
LOCATION		PIN	MH/RA/410102/G-02/(0)/2000		CAMBRIDGE LODGE

CARD		G-02/(0)	
			GRADE		II-B	
			ZONE		ARTIST POINT	
			ZONE REF.		G 02	
			CO-ORD.		F,16-17	
			PLOT #		37	
			SURVEY #		68

6.5	REFERENCES	Municipal Records / Map (1903-04) / DP 1987 / Books on Matheran / Field Surveys				
7.0		ARCHITECTURAL SYSTEMS IN THE STRUCTURE				
7.1	FOUND. & PLINTH	Stepped laterite foundation. Plinth in coursed laterite - plastered and painted.

9.2	MAINTENANCE	Good				
10.0		REMARKS				
10.1	CONSERVATION & DEVELOPMENT	Well maintained structures and landscaping, ideal for residential use or adaptive re-use as a guest house. Attached additions may damage the harmonious relationship between the structure and landscape. Detached additions may be permitted provided they respect the landscape and the natural forest cover and relate sensitively to the existing structures in form, scale and treatment.

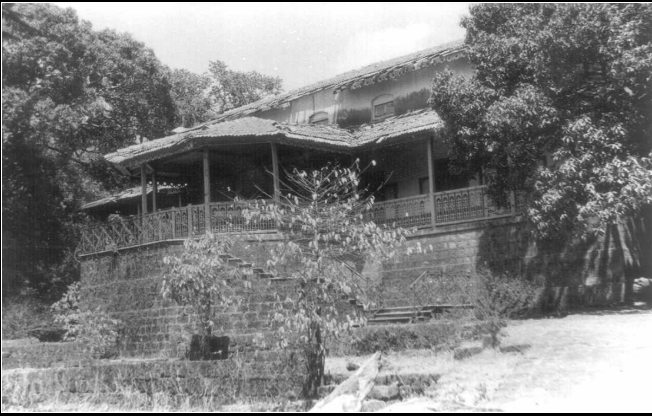
LOCATION		PIN	MH/RA/410102/G-04/(0)/2000	STEARNS COTTAGE

CARD	G-04/(0)	
			GRADE	II-B	
			ZONE	ARTIST POINT	
			ZONE REF.	G 04	
			CO-ORD.	H,16	
			PLOT #	21	
				SURVEY #	64

6.5	REFERENCES	Municipal Records / Map (1903-04) / DP 1987 / Books on Matheran / Field Surveys			
7.0 ARCHITECTURAL SYSTEMS IN THE STRUCTURE					
7.1	FOUND. & PLINTH	Stepped laterite foundation. Plinth in coursed laterite - exposed and pointed.

8.0 TRANSFORMATION					
8.1	FORM	None			
8.2	STRUCTURE	None			
8.3	FINISHES	None			
9.0 PRESENT STATUS					
9.1	STRUC. STABILITY	Fair (but roof needs urgent repairs and regular maintenance)

9.2	MAINTENANCE	Fair			
10.0 REMARKS					
10.1	CONSERVATION & DEVELOPMENT	The bungalow originally very rich in treatment and detailing now needs proper maintenance. Ideal for residential use or adaptive re-use as a guest house. Attached extensions and additions should not be allowed as they may affect the architectural integrity and the grandeur of the structure. Detached additions on the site should have considerable regard for the existing structures and formal landscape.

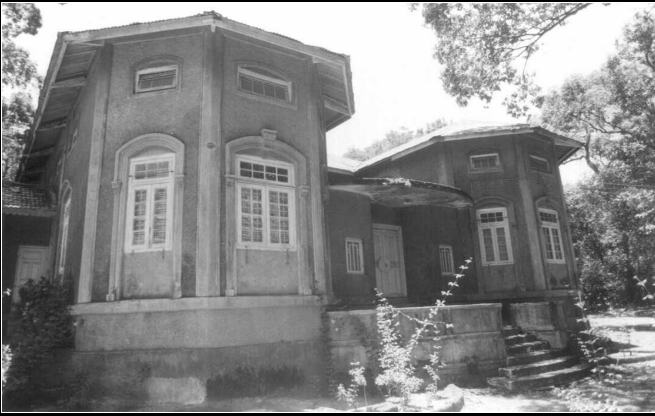
LOCATION		PIN	MH/RA/410102/G-05/(0)/2000	SPRINGWOOD

CARD	G-05/(0)
				GRADE	II-B
				ZONE	ARTIST POINT
				ZONE REF.	G 05
				CO-ORD.	H,15-16
				PLOT #	46
				SURVEY #	58

6.5	REFERENCES	Municipal Records / Map (1903-04) / DP 1987 / Books on Matheran / Field Surveys			
7.0 ARCHITECTURAL SYSTEMS IN THE STRUCTURE					
7.1	FOUND. & PLINTH	Stepped laterite foundation. Plinth in coursed laterite - rough cast plastered and painted.

10.0 REMARKS					
10.1	CONSERVATION & DEVELOPMENT	<p>The only structure in Matheran treated in Art Deco style, representing the development of a particular period. It hold moderate importance as a landmark located at a strategic nodal location. Ideal for residential use or adaptive re-use as a guest house. Needs structural maintenance. Attached extensions should not be allowed. Very little scope for detached extensions, except on the northern and south western corners of the site.</p>

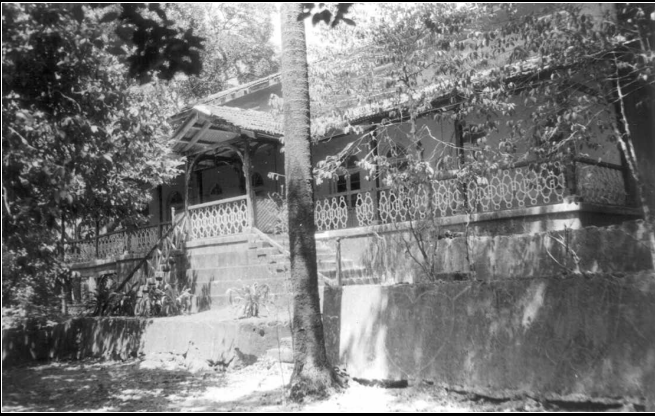
LOCATION		PIN	MH/RA/410102/G-06/(0)/2000	EDEN HALL

CARD	G-06/(0)
				GRADE	II-B
				ZONE	ARTIST POINT
				ZONE REF.	G 06
				CO-ORD.	H,16
				PLOT #	138
				SURVEY #	59

6.5	REFERENCES	Municipal Records / Map (1903-04) / DP 1987 / Books on Matheran / Field Surveys			
7.0 ARCHITECTURAL SYSTEMS IN THE STRUCTURE					
7.1	FOUND. & PLINTH	Stepped laterite foundation. Plinth in coursed laterite - exposed and pointed.

10.0 REMARKS					
10.1	CONSERVATION & DEVELOPMENT	A well maintained structure offering an interesting view into its plot from the Kasturba Gandhi road. Ideal for residential use or adaptive re-use as a guest house. No scope for attached or detached extensions.

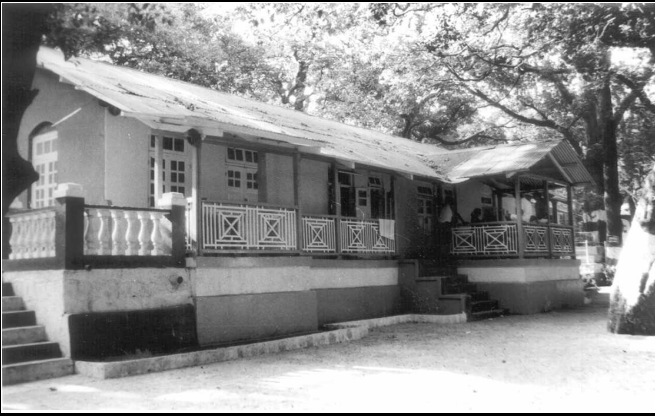
LOCATION		PIN	MH/RA/410102/G-07/(0)/2000	PREETI HOTEL

CARD	G-07/(0)	
			GRADE	II-B	
			ZONE	ARTIST POINT	
			ZONE REF.	G 07	
			CO-ORD.	H,16-17	
			PLOT #	183, 182	
			SURVEY #	60, 61

6.5	REFERENCES	Municipal Records / Map (1903-04) / DP 1987 / Books on Matheran / Field Surveys			
7.0 ARCHITECTURAL SYSTEMS IN THE STRUCTURE					
7.1	FOUND. & PLINTH	Stepped laterite foundation. Plinth in coursed laterite - plastered and painted.

10.1	CONSERVATION & DEVELOPMENT	A well maintained site, where the original structures have been preserved and used for a new function as a hotel. New structures added in the property blend satisfactorily with the old in spite of the use of new materials and detailing, however, the compound wall with the bulky balustrades and contrasting colours appears harsh in the quaint setting. No scope for further additions or extensions.

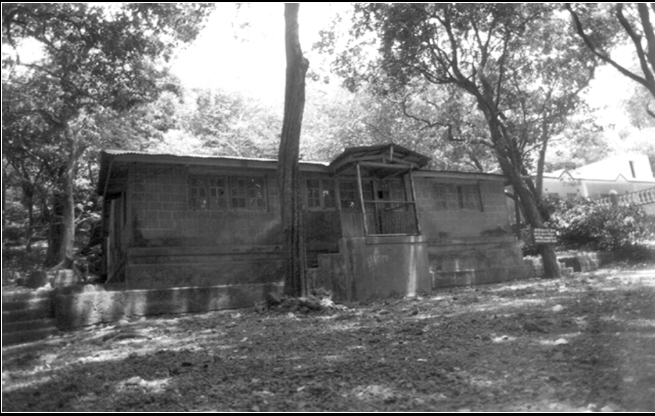
LOCATION	PIN	MH/RA/410102/G-08/(0)/2000	VINAYAK ASHRAM

CARD	G-08/(0)
			GRADE	III
			ZONE	ARTIST POINT
			ZONE REF.	G 08
			CO-ORD.	H,17
			PLOT #	181
			SURVEY #	63

6.5	REFERENCES	Municipal Records / Map (1903-04) / DP 1987 / Books on Matheran / Field Surveys		
7.0	ARCHITECTURAL SYSTEMS IN THE STRUCTURE			
7.1	FOUND. & PLINTH	Stepped laterite foundation. Plinth in coursed laterite - exposed and pointed.

9.0	PRESENT STATUS			
9.1	STRUC. STABILITY	Fair		
9.2	MAINTENANCE	Fair		
10.0	REMARKS			
10.1	CONSERVATION & DEVELOPMENT	A small structure representative of the townscape character of Matheran and is part of a conservation area. The site is relatively bare with no signs of landscaping. Attached or detached extensions may be permitted provided the front façade of the structure is not obstructed and the additions and extensions are in harmony with the old structure in terms of form, scale and treatment.

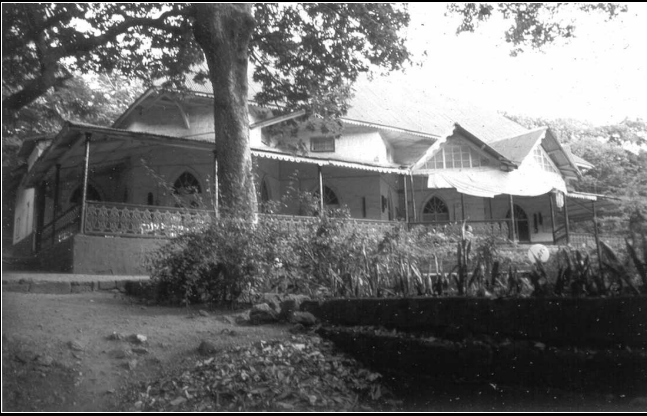
LOCATION		PIN	MH/RA/410102/G-09/(0)/2000	ASHOK HOTEL

CARD	G-09/(0)
				GRADE	II-B
				ZONE	ARTIST POINT
				ZONE REF.	G 09
				CO-ORD.	F,16
				PLOT #	28
				SURVEY #	69

6.5	REFERENCES	Municipal Records / Map (1903-04) / DP 1987 / Books on Matheran / Field Surveys			
7.0 ARCHITECTURAL SYSTEMS IN THE STRUCTURE					
7.1	FOUND. & PLINTH	Stepped laterite foundation. Plinth in coursed laterite - exposed and pointed.

9.2	MAINTENANCE	Good			
10.0 REMARKS					
10.1	CONSERVATION & DEVELOPMENT	The building has a unique planform and has maintained its historic integrity in spite of the change of use. No attached extensions and additions should be permitted. Detached additions may be permitted but only such that do not obstruct the historic views of the structure and its front facade from the front garden and the road and that are in harmony with the form, scale and treatment of the original structure and respect the surrounding landscape.

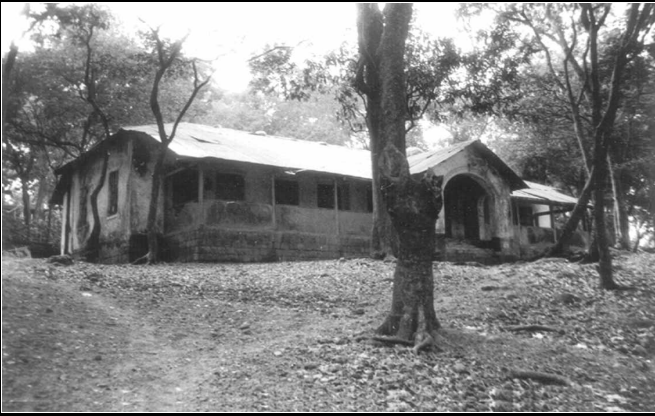
LOCATION		PIN	MH/RA/410102/H-01/(0)/2000	GOVERNMENT GODOWN

CARD	H-01/(0)
				GRADE	III
				ZONE	BAZAAR
				ZONE REF.	H 01
				CO-ORD.	H,16
				PLOT #	BP 218
				SURVEY #	57

6.5	REFERENCES	Municipal Records / Map (1903-04) / DP 1987 / Books on Matheran / Field Surveys			
7.0 ARCHITECTURAL SYSTEMS IN THE STRUCTURE					
7.1	FOUND. & PLINTH	Stepped laterite foundation. Plinth in coursed laterite - exposed.

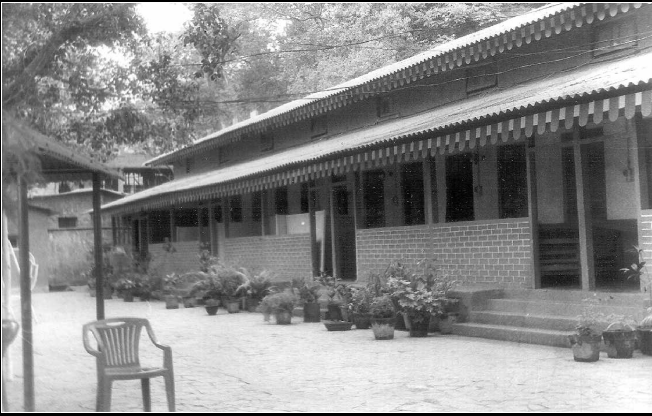
LOCATION		PIN	MH/RA/410102/H-03/(0)/2000	DIWADKAR LODGING AND BOARDING

CARD		H-03/(0)
			GRADE		III
			ZONE		BAZAAR
			ZONE REF.		H 03
			CO-ORD.		H,17
			PLOT #		BP 242, BP 243
			SURVEY #		114, 113, 501

6.5	REFERENCES	Municipal Records / Map (1903-04) / DP 1987 / Books on Matheran / Field Surveys			
7.0 ARCHITECTURAL SYSTEMS IN THE STRUCTURE					
7.1	FOUND. & PLINTH	Stepped laterite foundation. Plinth in coursed laterite - plastered and painted.

7.2	WALLS	Loadbearing in coursed laterite, plastered and painted externally and internally.			
7.3	FLOOR	Modern replacement			
7.4	ROOF	TW purlin rafter roof structure with G. I. sheets roofing.

8.1	FORM	Verandah railings replaced by brick masonry.			
8.2	STRUCTURE	None			
8.3	FINISHES	Plastering and painting of walls.			
9.0 PRESENT STATUS					
9.1	STRUC. STABILITY	None

9.2	MAINTENANCE	None			
10.0 REMARKS					
10.1	CONSERVATION & DEVELOPMENT	Located at an important nodal location, a well maintained building and plot contributing significantly to the character of an identified conservation area and to the townscape as a whole. No scope for attached or detached additions. Ideal for current use.

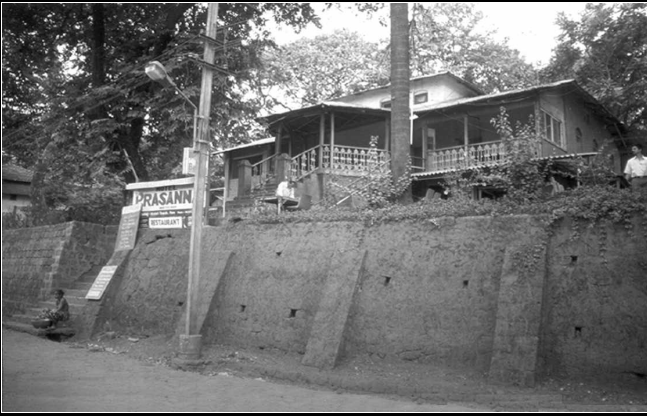
LOCATION	PIN	MH/RA/410102/H-04/(0)/2000	HOTEL PRASANNA

CARD	H-04/(0)
			GRADE	II-B
			ZONE	BAZAAR
			ZONE REF.	H 04
			CO-ORD.	H,18
			PLOT #	BP 9
			SURVEY #	118

6.5	REFERENCES	Municipal Records / Map (1903-04) / DP 1987 / Books on Matheran / Field Surveys		
7.0	ARCHITECTURAL SYSTEMS IN THE STRUCTURE			
7.1	FOUND. & PLINTH	Stepped laterite foundation. Plinth in coursed laterite - exposed and pointed.

8.3	FINISHES	Plastering and painting of walls.		
9.0	PRESENT STATUS			
9.1	STRUC. STABILITY	Fair		
9.2	MAINTENANCE	Fair		
10.0	REMARKS			
10.1	CONSERVATION & DEVELOPMENT	Significant character of built form and setting contributes to the streetscape of the conservation area and the townscape. No attached or detached extensions or additions to be permitted in the forecourt space as this may hamper the historic relationship of the structure to the street. Detached additions may be allowed in the side and rear open spaces provided they relate sensitively to the main structure in form, scale and treatment.

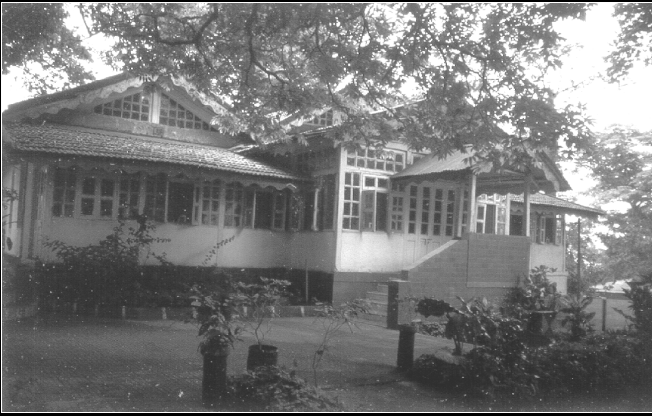
LOCATION		PIN	MH/RA/410102/H-05/(0)/2000	RAILWAY REST HOUSE

CARD		H-05/(0)	
		GRADE		II-B	
		ZONE		BAZAAR	
		ZONE REF.		H 05	
		CO-ORD.		H,18	
		PLOT #			
		SURVEY #

6.5	REFERENCES	Municipal Records / Map (1903-04) / DP 1987 / Books on Matheran / Field Surveys			
7.0		ARCHITECTURAL SYSTEMS IN THE STRUCTURE			
7.1	FOUND. & PLINTH	Stepped laterite foundation. Plinth in coursed laterite - plastered and painted.

10.0		REMARKS			
10.1	CONSERVATION & DEVELOPMENT	Well maintained buildings and landscape contributing significantly to the conservation area and the townscape. No scope for attached or detached additions or extensions.

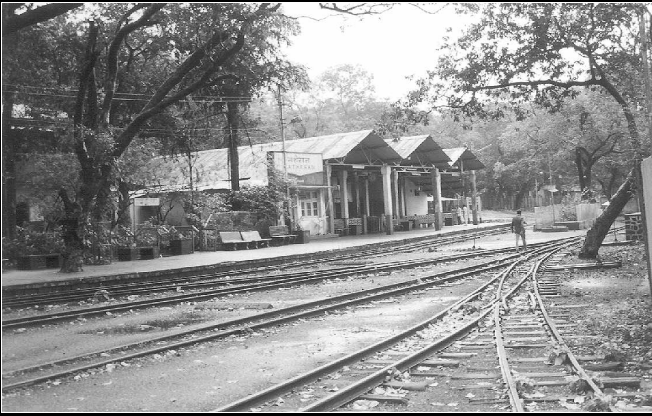
LOCATION		PIN	MH/RA/410102/H-06/(0)/2000	MATHERAN RAILWAY STATION

CARD		H-06/(0)	
		GRADE		II-B	
		ZONE		BAZAAR	
		ZONE REF.		H 06	
		CO-ORD.		H-I,18	
		PLOT #			
		SURVEY #

6.5	REFERENCES	Municipal Records / Map (1903-04) / DP 1987 / Books on Matheran / Field Surveys			
7.0 ARCHITECTURAL SYSTEMS IN THE STRUCTURE					
7.1	FOUND. & PLINTH	Stepped laterite foundation. Plinth in coursed laterite - exposed and pointed.

9.2	MAINTENANCE	Unsatisfactory			
10.0 REMARKS					
10.1	CONSERVATION & DEVELOPMENT	<p>Large site with potential unexploited. Prime location of the railway station and the old structures existing till date have immense scope to develop as a vibrant socio-functional node, if revitalised with sensitive planning and management. The old structures need urgent repairs as well as regular maintenance.</p>

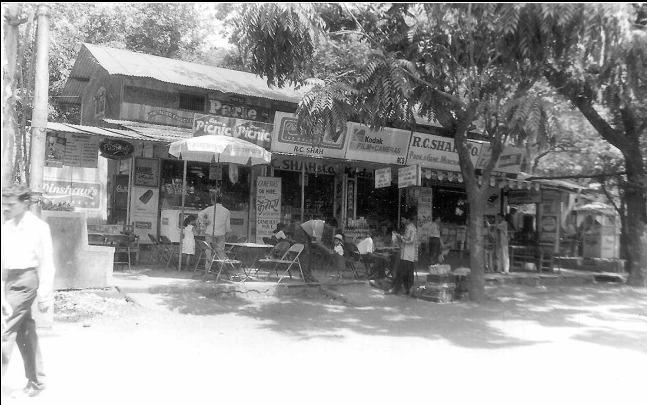
LOCATION		PIN	MH/RA/410102/H-07/(0)/2000	YASHODA BHUVAN

CARD		H-07/(0)	
		GRADE		III	
		ZONE		BAZAAR	
		ZONE REF.		H 07	
		CO-ORD.		H,18	
		PLOT #		BP 178A, BP 178B	
		SURVEY #		154, 155

6.5	REFERENCES	Municipal Records / Map (1903-04) / DP 1987 / Books on Matheran / Field Surveys			
7.0		ARCHITECTURAL SYSTEMS IN THE STRUCTURE			
7.1	FOUND. & PLINTH	Stepped laterite foundation. Plinth in coursed laterite - exposed and pointed.

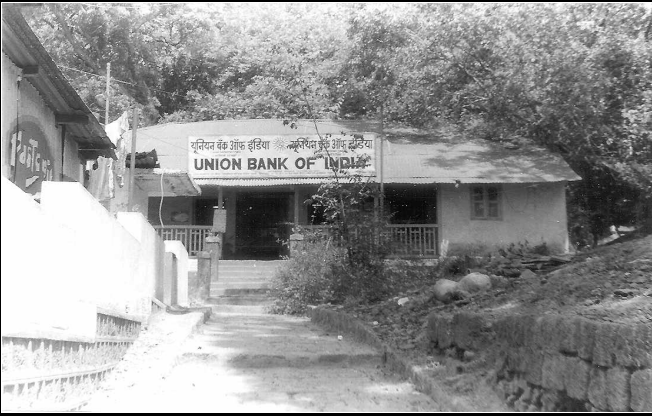
LOCATION		PIN	MH/RA/410102/H-09/(0)/2000	UNION BANK

CARD		H-09/(0)
			GRADE		II-B
			ZONE		BAZAAR
			ZONE REF.		H 09
			CO-ORD.		H,18
			PLOT #		BP 8
			SURVEY #		157

6.5	REFERENCES	Municipal Records / Map (1903-04) / DP 1987 / Books on Matheran / Field Surveys			
7.0 ARCHITECTURAL SYSTEMS IN THE STRUCTURE					
7.1	FOUND. & PLINTH	Stepped laterite foundation. Plinth in coursed laterite - exposed and pointed.

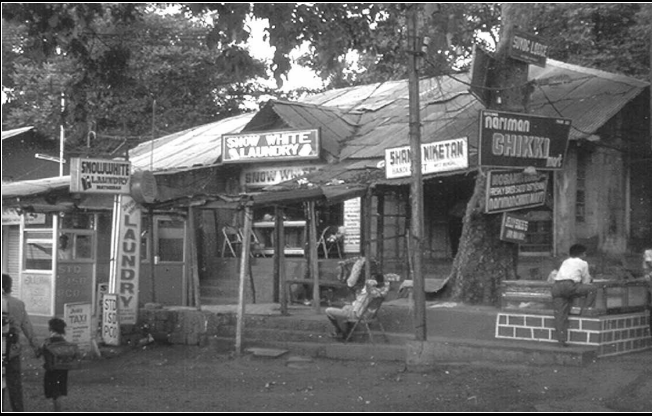
LOCATION		PIN	MH/RA/410102/H-11/(0)/2000	SNOW WHITE LAUNDRY

CARD	H-11/(0)
				GRADE	III
				ZONE	BAZAAR
				ZONE REF.	H 11
				CO-ORD.	H,19
				PLOT #	BP 12B
				SURVEY #	164B

6.5	REFERENCES	Municipal Records / Map (1903-04) / DP 1987 / Books on Matheran / Field Surveys			
7.0 ARCHITECTURAL SYSTEMS IN THE STRUCTURE					
7.1	FOUND. & PLINTH	Stepped laterite foundation. Plinth in coursed laterite - exposed and pointed.

7.6	STEPS	Coursed laterite construction, plastered.			
7.7	DECO. ELEMENTS & INTERIORS	Stained glass panels in the gable end over the main entrance.			
8.0 TRANSFORMATION

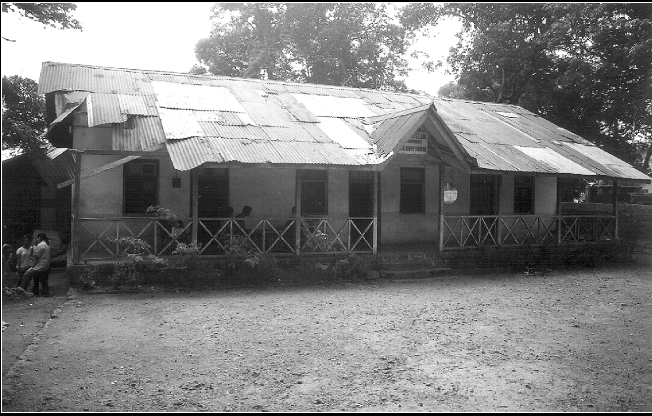
LOCATION		PIN	MH/RA/410102/H-13/(0)/2000	PHILLIPS CLUB HOLIDAY HOME

CARD	H-13/(0)
				GRADE	II-B
				ZONE	BAZAAR
				ZONE REF.	H 13
				CO-ORD.	H,19
				PLOT #	143
				SURVEY #	165

6.5	REFERENCES	Municipal Records / Map (1903-04) / DP 1987 / Books on Matheran / Field Surveys			
7.0 ARCHITECTURAL SYSTEMS IN THE STRUCTURE					
7.1	FOUND. & PLINTH	Stepped laterite foundation. Plinth in coursed laterite - exposed and pointed.

9.0 PRESENT STATUS					
9.1	STRUC. STABILITY	Fair			
9.2	MAINTENANCE	Fair			
10.0 REMARKS					
10.1	CONSERVATION & DEVELOPMENT	Representative of built form typology and setting of Matheran plots. No additions or extensions to be allowed in the front open space. The structure needs regular maintenance and upkeep.

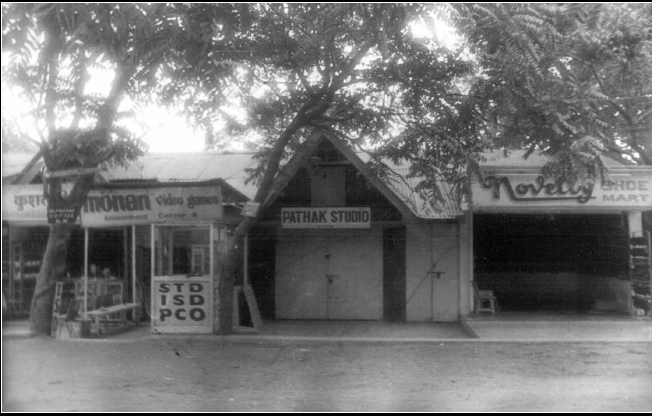
LOCATION	PIN	MH/RA/410102/H-14/(0)/2000	KUSHAL NIKETAN

CARD	H-14/(0)
			GRADE	III
			ZONE	BAZAAR
			ZONE REF.	H 14
			CO-ORD.	H,19
			PLOT #	BP 19
			SURVEY #	295

6.5	REFERENCES	Municipal Records / Map (1903-04) / DP 1987 / Books on Matheran / Field Surveys		
7.0	ARCHITECTURAL SYSTEMS IN THE STRUCTURE			
7.1	FOUND. & PLINTH	Stepped laterite foundation. Plinth in coursed laterite - exposed and pointed.

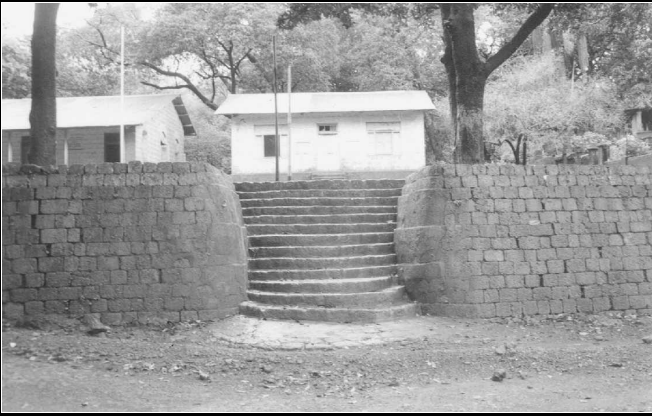
LOCATION		PIN	MH/RA/410102/H-19/(0)/2000	HUTATMA KOTWAL VYAYAM MANDIR

CARD	H-19/(0)
				GRADE	III
				ZONE	BAZAAR
				ZONE REF.	H 19
				CO-ORD.	H,20
				PLOT #	BP 231
				SURVEY #	172

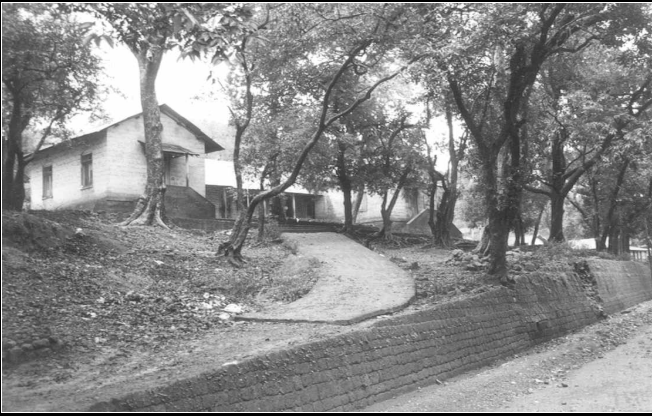
CARD	H-21/(0)
				GRADE	II-B
				ZONE	BAZAAR
				ZONE REF.	H 21
				CO-ORD.	H,20
				PLOT #	BP 179
				SURVEY #	174

1.0 NAME OF THE PROPERTY					
1.1	NAME	GOOLRAJ SINGHANEE MARATHI VERNACULAR SCHOOL			
1.2	HISTORIC NAME	GOOLRAJ SINGHANEE MARATHI VERNACULAR SCHOOL			
1.3	BUILT IN	1898

6.5	REFERENCES	Municipal Records / Map (1903-04) / DP 1987 / Books on Matheran / Field Surveys			
7.0 ARCHITECTURAL SYSTEMS IN THE STRUCTURE					
7.1	FOUND. & PLINTH	Stepped laterite foundation. Plinth in coursed laterite - exposed and pointed.

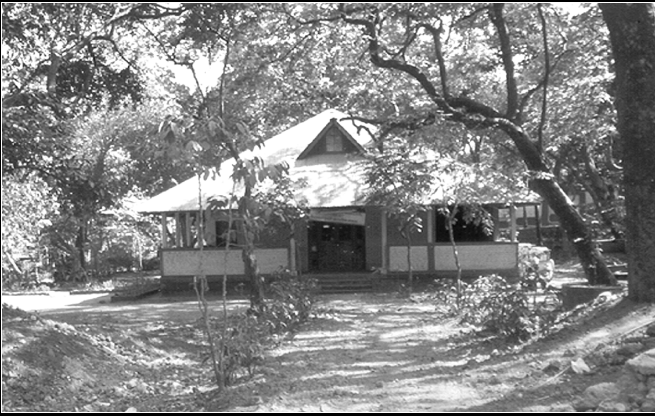
CARD	H-23/(0)
				GRADE	II-A
				ZONE	BAZAAR
				ZONE REF.	H 23
				CO-ORD.	H,21
				PLOT #	BP 176
				SURVEY #	178

1.0 NAME OF THE PROPERTY					
1.1	NAME	KARSANDAS MULJI LIBRARY			
1.2	HISTORIC NAME	KARSANDAS MULJI LIBRARY			
1.3	BUILT IN	1897			
2.0 AREA (SQ. MTS.)

6.5	REFERENCES	Municipal Records / Map (1903-04) / DP 1987 / Books on Matheran / Field Surveys			
7.0 ARCHITECTURAL SYSTEMS IN THE STRUCTURE					
7.1	FOUND. & PLINTH	Stepped laterite foundation. Plinth in coursed laterite - exposed and pointed with projecting plinth course.

8.3	FINISHES	Plastering and painting of walls.			
9.0 PRESENT STATUS					
9.1	STRUC. STABILITY	Fair			
9.2	MAINTENANCE	Fair			
10.0 REMARKS					
10.1	CONSERVATION & DEVELOPMENT	Excellent setting at a strategic nodal location. The structure has landmark value but its potential seems rather under-utilised. The surroundings of the structure needs to be reorganised and maintained. Encroachments surrounding the plot obstructing the view of the structures must be objected to.

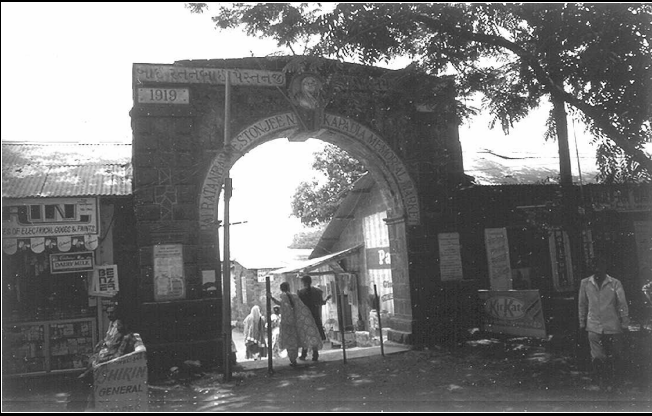
CARD	H-24/(0)
			GRADE	II-B
			ZONE	BAZAAR
			ZONE REF.	H 24
			CO-ORD.	H-I,19
			PLOT #	BP 169, BP 170
			SURVEY #	288, 287

1.0	NAME OF THE PROPERTY			
1.1	NAME	KAPADIA MARKET		
1.2	HISTORIC NAME	KAPADIA MARKET		
1.3	BUILT IN	1919		
2.0	AREA (SQ. MTS.)			
2.1	PLOT AREA	5120.80 + 374.60

6.5	REFERENCES	Municipal Records / Map (1903-04) / DP 1987 / Books on Matheran / Field Surveys		
7.0	ARCHITECTURAL SYSTEMS IN THE STRUCTURE			
7.1	FOUND. & PLINTH	Stepped laterite foundation. Plinth in coursed laterite - exposed and pointed with rusticated laterite blocks.

7.2	WALLS	Loadbearing in coursed laterite, exposed and painted with rusticated quoins.		
7.3	FLOOR			
7.4	ROOF	TW purlin rafter roof structure with G.I. sheets roofing.

7.7	DECO. ELEMENTS & INTERIORS	Entrance archway constructed in coursed rubble with decorative keystone which has the bust of the founder of the market inset.

8.0	TRANSFORMATION			
8.1	FORM	None		
8.2	STRUCTURE	Timber members of the roof structure replaced by steel members in some locations.		
8.3	FINISHES	None

9.0	PRESENT STATUS			
9.1	STRUC. STABILITY	Good		
9.2	MAINTENANCE	Unsatisfactory		
10.0	REMARKS			
10.1	CONSERVATION & DEVELOPMENT	Holds great potential for conservation and future use. The structure has a landmark value and has maintained its historic integrity. A management plan to recognise informal and formal shopping within the market is essential.

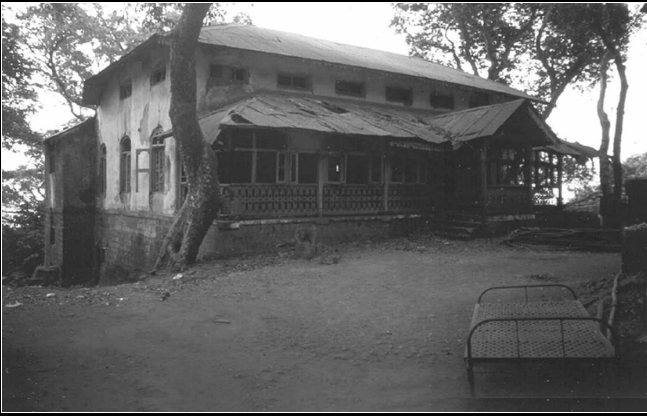
CARD	H-25/(0)
			GRADE	III
			ZONE	BAZAAR
			ZONE REF.	H 25
			CO-ORD.	H,20
			PLOT #	BP 6
			SURVEY #	284

1.0	NAME OF THE PROPERTY			
1.1	NAME	ABDUL REHMAN ALI HOUSE		
1.2	HISTORIC NAME	ABDUL REHMAN ALI HOUSE		
1.3	BUILT IN	1900 - 1945		
2.0	AREA (SQ. MTS.)			
2.1	PLOT AREA	910.50

6.5	REFERENCES	Municipal Records / Map (1903-04) / DP 1987 / Books on Matheran / Field Surveys		
7.0	ARCHITECTURAL SYSTEMS IN THE STRUCTURE			
7.1	FOUND. & PLINTH	Stepped laterite foundation. Plinth in coursed laterite - exposed and pointed.

9.2	MAINTENANCE	Poor		
10.0	REMARKS			
10.1	CONSERVATION & DEVELOPMENT	A unique structure in terms of planform and detailing. Holds potential for conservation and adaptive re-use. Measures to be taken to ensure the view of the façade of this structure. No scope for additions and extensions.

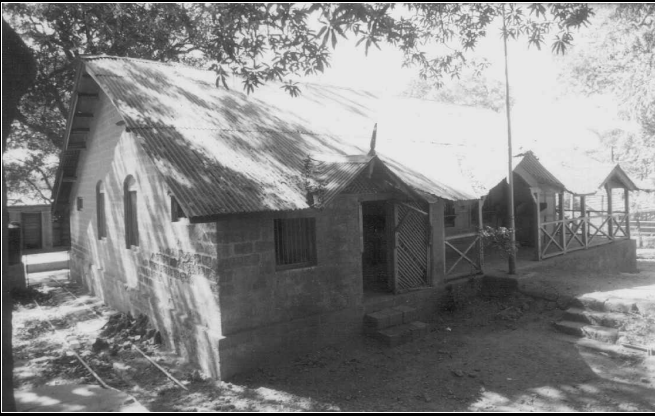
CARD	H-26/(0)
				GRADE	II-B
				ZONE	BAZAAR
				ZONE REF.	H 26
				CO-ORD.	H,20
				PLOT #	BP 172
				SURVEY #	283

1.0 NAME OF THE PROPERTY					
1.1	NAME	POST OFFICE			
1.2	HISTORIC NAME	POST OFFICE			
1.3	BUILT IN	1868			
2.0 AREA (SQ. MTS.)					
2.1	PLOT AREA	2124.60

6.1	ARCHITECTURAL DESCRIPTION	The layout consists of the main building, an annexe structure in the rear and government staff quarters which are now in a dilapidated condition. The buildings are situated on a plot along the eastern edge of Matheran, gradually sloping eastwards, substantially setback from the road and bound by a low compound wall. The west facing single storeyed main building has simple linear planform with rooms in a row and a part front verandah. The gable ended pitched roof is intercepted in front by three gable ended projections - the central one being larger than the other two to emphasize the entrance.

6.5	REFERENCES	Municipal Records / Map (1903-04) / DP 1987 / Books on Matheran / Field Surveys			
7.0 ARCHITECTURAL SYSTEMS IN THE STRUCTURE					
7.1	FOUND. & PLINTH	Stepped laterite foundation. Plinth in coursed laterite - exposed and pointed with projecting plinth course.

8.3	FINISHES	Timber railing replaced by concrete railing.			
9.0 PRESENT STATUS					
9.1	STRUC. STABILITY	Fair			
9.2	MAINTENANCE	Fair			
10.0 REMARKS

10.1	CONSERVATION & DEVELOPMENT	One of the oldest structures designed for infrastructural use, contributing to the townscape. Old timber railings have been recently replaced by incongruous concrete balustrade which appears very much out of place. The site holds potential for public or government use.

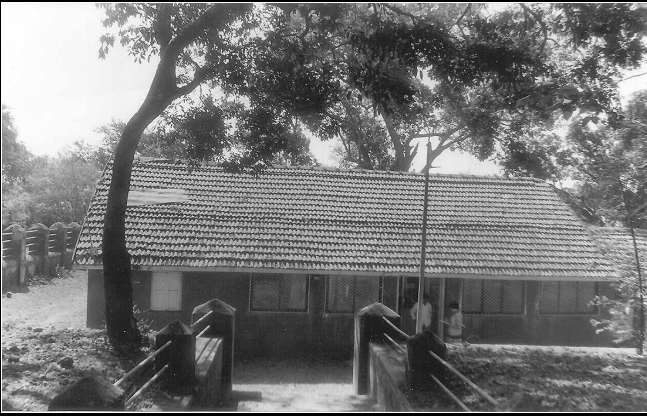
CARD	H-27/(0)
				GRADE	III
				ZONE	BAZAAR
				ZONE REF.	H 27
				CO-ORD.	H,20
				PLOT #	BP 173
				SURVEY #	282

1.0 NAME OF THE PROPERTY					
1.1	NAME	TELEPHONE EXCHANGE			
1.2	HISTORIC NAME	TELEPHONE EXCHANGE			
1.3	BUILT IN	1900 - 1945			
2.0 AREA (SQ. MTS.)					
2.1	PLOT AREA	1264.70

6.5	REFERENCES	Municipal Records / Map (1903-04) / DP 1987 / Books on Matheran / Field Surveys			
7.0 ARCHITECTURAL SYSTEMS IN THE STRUCTURE					
7.1	FOUND. & PLINTH	Stepped laterite foundation. Plinth in coursed laterite - exposed and pointed.

8.0 TRANSFORMATION					
8.1	FORM	None			
8.2	STRUCTURE	None			
8.3	FINISHES	Plastering and painting of walls and original timber windows replaced by aluminium windows.

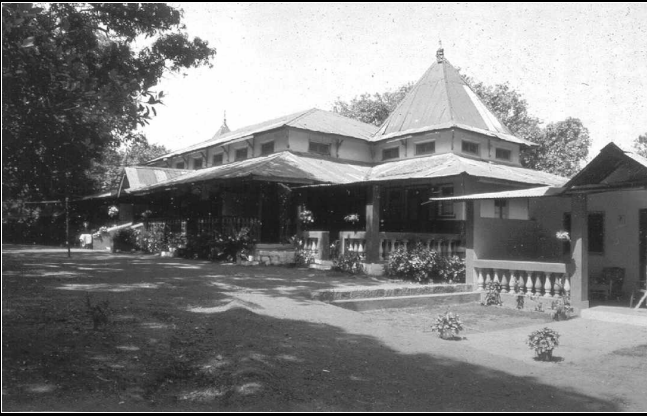
CARD	H-29/(0)	
			GRADE	II-B	
			ZONE	BAZAAR	
			ZONE REF.	H 29	
			CO-ORD.	H,21	
			PLOT #	BP 4	
			SURVEY #	280

1.0 NAME OF THE PROPERTY					
1.1	NAME	HOTEL LAXMI			
1.2	HISTORIC NAME	LAXMI HINDU HOTEL			
1.3	BUILT IN	1909			
2.0 AREA (SQ. MTS.)					
2.1	PLOT AREA	3743.30

6.5	REFERENCES	Municipal Records / Map (1903-04) / DP 1987 / Books on Matheran / Field Surveys			
7.0 ARCHITECTURAL SYSTEMS IN THE STRUCTURE					
7.1	FOUND. & PLINTH	Stepped laterite foundation. Plinth in coursed laterite - exposed and pointed.

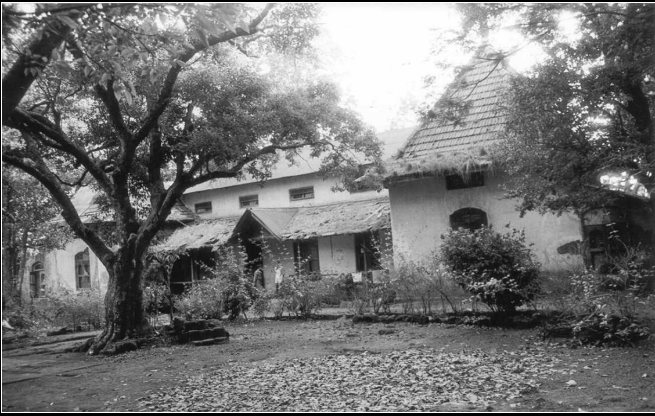
CARD	J-01/(0)
			GRADE	III
			ZONE	LOUISA POINT
			ZONE REF.	J 01
			CO-ORD.	B,16
			PLOT #	29
			SURVEY #	84

1.0	NAME OF THE PROPERTY			
1.1	NAME	EWART LODGE		
1.2	HISTORIC NAME	EWART LODGE		
1.3	BUILT IN	1854 - 1867		
2.0	AREA (SQ. MTS.)			
2.1	PLOT AREA	9535.40

6.5	REFERENCES	Municipal Records / Map (1903-04) / DP 1987 / Books on Matheran / Field Surveys		
7.0	ARCHITECTURAL SYSTEMS IN THE STRUCTURE			
7.1	FOUND. & PLINTH	Stepped laterite foundation. Plinth in laterite partly exposed and pointed and partly plastered and painted.

9.1	STRUC. STABILITY	Unstable - Roof collapsed partly and visible settlement of verandah plinth.		
9.2	MAINTENANCE	Extremely poor.		
10.0	REMARKS			
10.1	CONSERVATION & DEVELOPMENT	Significant structure with unique furniture and detailing. It is deteriorating due to sheer negligence. The structure can be restored as the envelope is fairly stable. Adaptive re-use as private lodging may be allowed to ensure its maintenance. No scope for additions on site.

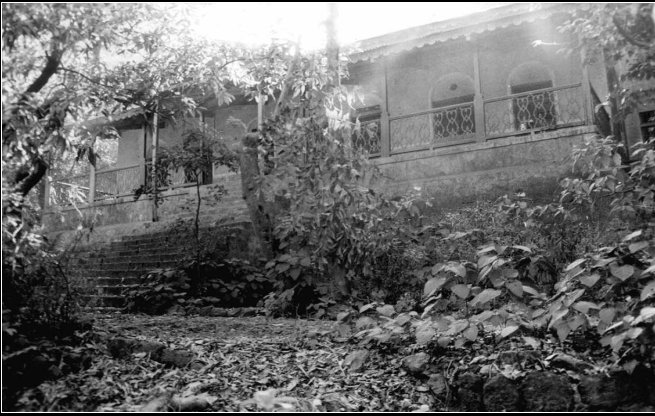
CARD		J-03/(0)
		GRADE		III
		ZONE		LOUISA POINT
		ZONE REF.		J 03
		CO-ORD.		D,18
		PLOT #		151
		SURVEY #		88

1.0	NAME OF THE PROPERTY			
1.1	NAME	GREENWOOD		
1.2	HISTORIC NAME	GREENWOOD		
1.3	BUILT IN	1854 -1900		
2.0	AREA (SQ. MTS.)			
2.1	PLOT AREA	13220.20		
2.2	BUILT-UP AREA	512.87 + 93.50

6.5	REFERENCES	Municipal Records / Map (1903-04) / DP 1987 / Books on Matheran / Field Surveys		
7.0	ARCHITECTURAL SYSTEMS IN THE STRUCTURE			
7.1	FOUND. & PLINTH	Stepped laterite found. Plinth in coursed laterite - exposed and heavily buttressed

8.2	STRUCTURE	Plinth strengthened by heavy buttresses.		
8.3	FINISHES	Plastering and painting external walls.		
9.0	PRESENT STATUS			
9.1	STRUC. STABILITY	Unstable because of vertical cracks extending from plinth to roof.

9.2	MAINTENANCE	Extremely poor.		
10.0	REMARKS			
10.1	CONSERVATION & DEVELOPMENT	Though the structure has a sound architectural character and historic value, its present structural condition may not permit adaptive re-use without major renovation. Attached or detached add-ons may be permitted retaining the original building.

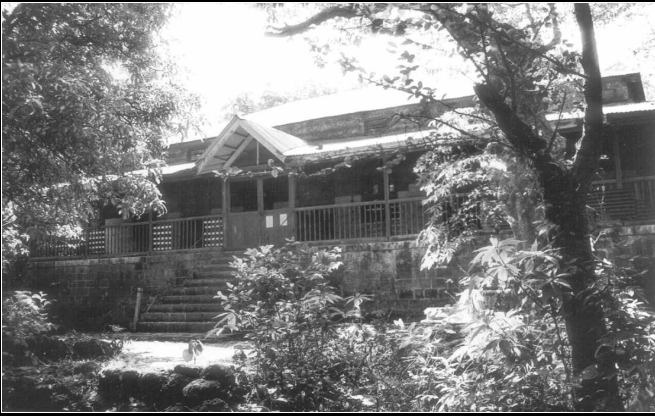
CARD	J-04/(0)	
			GRADE	II-B	
			ZONE	LOUISA POINT	
			ZONE REF.	J 04	
			CO-ORD.	D,18	
			PLOT #	152	
			SURVEY #	89

1.0 NAME OF THE PROPERTY					
1.1	NAME	KHUSHROO LODGE			
1.2	HISTORIC NAME	NEW KRISHNA LODGE			
1.3	BUILT IN	1854 - 1900			
2.0 AREA (SQ. MTS.)					
2.1	PLOT AREA	7238.50

6.5	REFERENCES	Municipal Records / Map (1903-04) / DP 1987 / Books on Matheran / Field Surveys			
7.0 ARCHITECTURAL SYSTEMS IN THE STRUCTURE					
7.1	FOUND. & PLINTH	Stepped laterite foundation. Plinth in coursed laterite - exposed and pointed.

9.1	STRUC. STABILITY	Fair			
9.2	MAINTENANCE	Fair			
10.0 REMARKS					
10.1	CONSERVATION & DEVELOPMENT	Presently the property is being used as camping resort and is developed for adventure sports. This activity is suitable for the place, however, care must be taken to ensure that further developments on the site do not involve tree cutting or other activities detrimental to the forest cover and natural topography of the area.

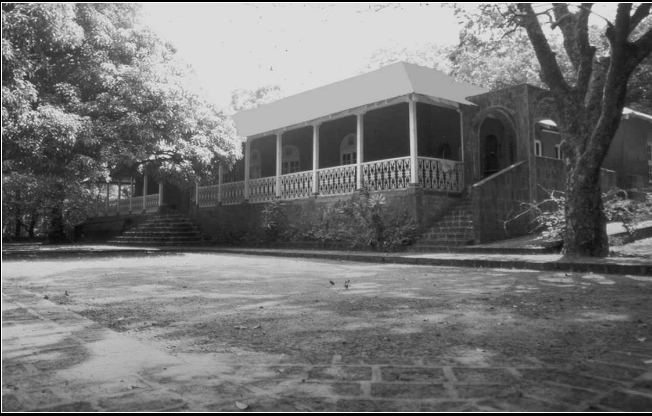
CARD	J-05/(0)	
			GRADE	II-B	
			ZONE	LOUISA POINT	
			ZONE REF.	J 05	
			CO-ORD.	D,19	
			PLOT #	18	
			SURVEY #	130

1.0 NAME OF THE PROPERTY					
1.1	NAME	ROBERTSON'S BUNGALOW			
1.2	HISTORIC NAME	ATRINILAYA / RROBERTSON'S BUNGALOW / THE GRANGE			
1.3	BUILT IN	Prior to 1867

6.5	REFERENCES	Municipal Records / Map (1903-04) / DP 1987 / Books on Matheran / Field Surveys			
7.0 ARCHITECTURAL SYSTEMS IN THE STRUCTURE					
7.1	FOUND. & PLINTH	Stepped laterite foundation. Plinth in coursed laterite exposed and pointed.

8.1	FORM	Entrance portico added. Landscaping and tree house developed later.			
8.2	STRUCTURE	Plinth consolidated at some locations.			
8.3	FINISHES	Pointing done at a later date. Mangalore tile roofing replaced by G.I. sheets.

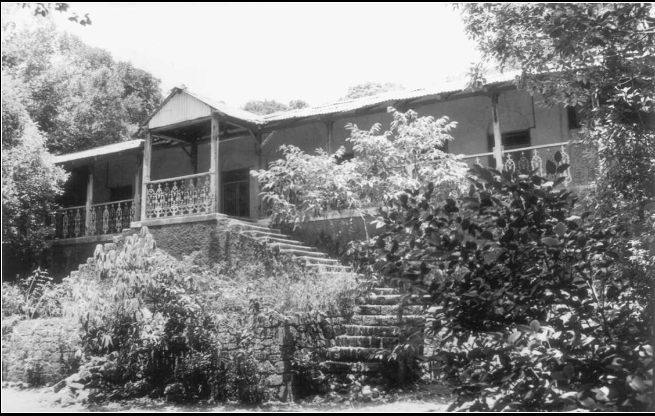
CARD	J-07/(0)
			GRADE	II-B
			ZONE	LOUISA POINT
			ZONE REF.	J 07
			CO-ORD.	D,20
			PLOT #	45
			SURVEY #	132

1.0	NAME OF THE PROPERTY			
1.1	NAME	RUBY HALL		
1.2	HISTORIC NAME	RUBY HALL		
1.3	BUILT IN	1854 - 1900		
2.0	AREA (SQ. MTS.)			
2.1	PLOT AREA	6070.30		
2.2	BUILT-UP AREA	628.00

6.5	REFERENCES	Municipal Records / Map (1903-04) / DP 1987 / Books on Matheran / Field Surveys		
7.0	ARCHITECTURAL SYSTEMS IN THE STRUCTURE			
7.1	FOUND. & PLINTH	Stepped laterite foundation. Plinth in coursed laterite - plastered and painted.

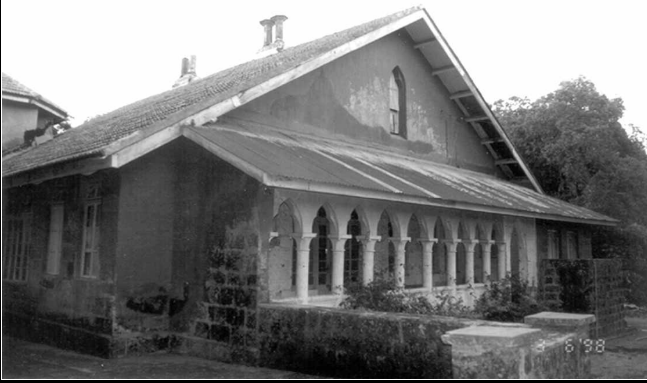
CARD	K-01/(0)
			GRADE	II-A
			ZONE	RUGBY
			ZONE REF.	K 01
			CO-ORD.	F,17
			PLOT #	15A, 15B
			SURVEY #	100, 99

1.0	NAME OF THE PROPERTY			
1.1	NAME	READYMONEY LODGE		
1.2	HISTORIC NAME	STONEHENGE		
1.3	BUILT IN	1853		
2.0	AREA (SQ. MTS.)			
2.1	PLOT AREA	14857.50 + 8294.10

6.5	REFERENCES	Municipal Records / Map (1903-04) / DP 1987 / Books on Matheran / Field Surveys		
7.0	ARCHITECTURAL SYSTEMS IN THE STRUCTURE			
7.1	FOUND. & PLINTH	Stepped laterite foundation. Plinth in coursed laterite - exposed and pointed.

10.0	REMARKS			
10.1	CONSERVATION & DEVELOPMENT	Has immense historical importance as one of the first five structures built in Matheran and the most authentically preserved property with a large amount of Gothic influence. The setting of the structure with planned areas for horse riding and other activities is also equally important. No attached additions should be allowed and detached additions should respect the form, scale and treatment of the existing building and its landscape.

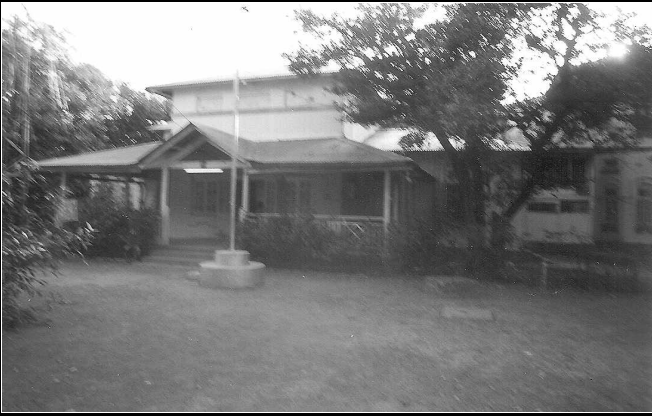
CARD	K-02/(0)	
		GRADE	II-B	
		ZONE	RUGBY	
		ZONE REF.	K 02	
		CO-ORD.	F,18	
		PLOT #	13A	
		SURVEY #	102

1.0	NAME OF THE PROPERTY			
1.1	NAME	SEA VIEW (POLICE WIRELESS OFFICE)		
1.2	HISTORIC NAME	SEA VIEW		
1.3	BUILT IN	1854 - 1900		
2.0	AREA (SQ. MTS.)			
2.1	PLOT AREA	10055.80

6.5	REFERENCES	Municipal Records / Map (1903-04) / DP 1987 / Books on Matheran / Field Surveys		
7.0	ARCHITECTURAL SYSTEMS IN THE STRUCTURE			
7.1	FOUND. & PLINTH	Stepped laterite foundation. Plinth in coursed laterite - plastered and painted.

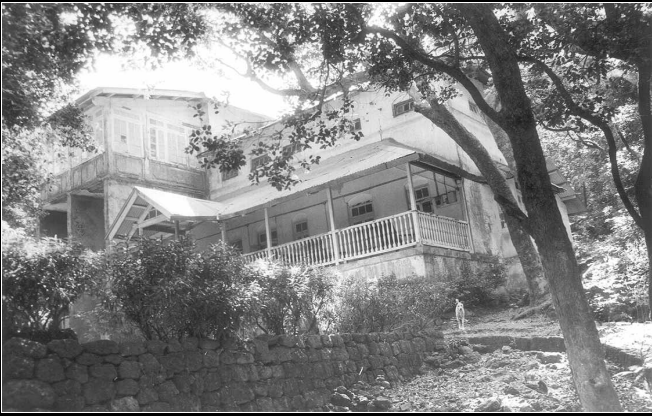
CARD	K-04/(0)
			GRADE	III
			ZONE	RUGBY
			ZONE REF.	K 04
			CO-ORD.	E,19
			PLOT #	207
			SURVEY #	92

1.0	NAME OF THE PROPERTY			
1.1	NAME	SOMERSET		
1.2	HISTORIC NAME	SUMMERSEAT		
1.3	BUILT IN	1901 - 1945		
2.0	AREA (SQ. MTS.)			
2.1	PLOT AREA	1188.80		
2.2	BUILT-UP AREA	311.87

6.5	REFERENCES	Municipal Records / Map (1903-04) / DP 1987 / Books on Matheran / Field Surveys		
7.0	ARCHITECTURAL SYSTEMS IN THE STRUCTURE			
7.1	FOUND. & PLINTH	Stepped laterite foundation. Plinth in coursed laterite - plastered and painted.

8.2	STRUCTURE	Addition of concrete columns to support first floor.		
8.3	FINISHES	Plastering and painting of walls.		
9.0	PRESENT STATUS			
9.1	STRUC. STABILITY	Needs structural repair.

9.2	MAINTENANCE	Poor		
10.0	REMARKS			
10.1	CONSERVATION & DEVELOPMENT	<p>Insensitive addition of the first floor to a historic structure destroying the original intended form and scale of the built form resulting in the loss historic integrity. No scope for further additions or extensions. The old building needs maintenance and structural repairs.</p>

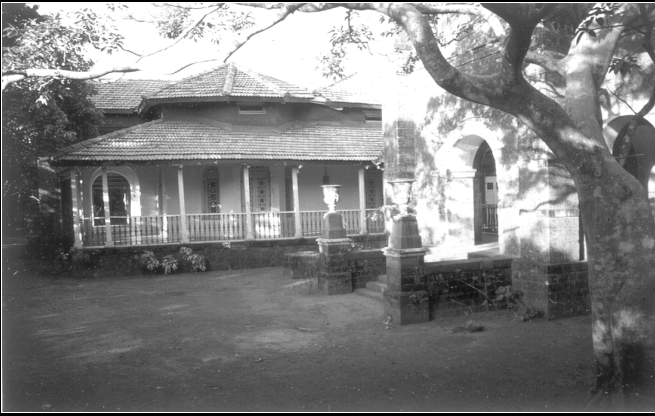
CARD		K-05/(0)
			GRADE		II-A
			ZONE		RUGBY
			ZONE REF.		K 05
			CO-ORD.		E-F,19
			PLOT #		13
			SURVEY #		103

1.0 NAME OF THE PROPERTY					
1.1	NAME	TOUR PETIT			
1.2	HISTORIC NAME	WALKER'S COTTAGE			
1.3	BUILT IN	Walker's Cottage (before 1858) / Yum Yum (1880's) / Tower and central portion (1900)

6.5	REFERENCES	Municipal Records / Map (1903-04) / DP 1987 / Books on Matheran / Field Surveys			
7.0 ARCHITECTURAL SYSTEMS IN THE STRUCTURE					
7.1	FOUND. & PLINTH	Stepped laterite foundation. Plinth in coursed laterite - exposed and pointed.

9.2	MAINTENANCE	Fair			
10.0 REMARKS					
10.1	CONSERVATION & DEVELOPMENT	Unique planform and architectural character. A landmark building contributing to the skyline of Matheran. Needs urgent structural repairs and maintenance especially the access and roof structure of the viewing tower. Ideal for use as a holiday home. Attached additions should not be permitted.

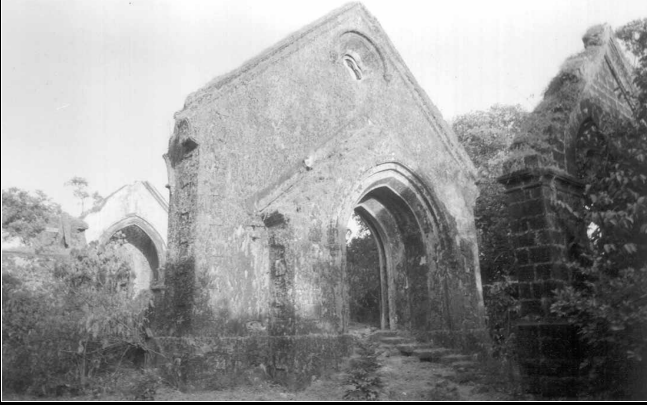
CARD	K-06/(0)
				GRADE	II-A
				ZONE	RUGBY
				ZONE REF.	K 06
				CO-ORD.	G,19
				PLOT #	20
				SURVEY #	106

1.0 NAME OF THE PROPERTY					
1.1	NAME	CHURCH OF ENGLAND (ST. PAUL'S CHURCH)			
1.2	HISTORIC NAME	CHURCH OF ENGLAND (ST. PAUL'S CHURCH)			
1.3	BUILT IN	Foundation stone laid in 1858. Consecration in 1865.

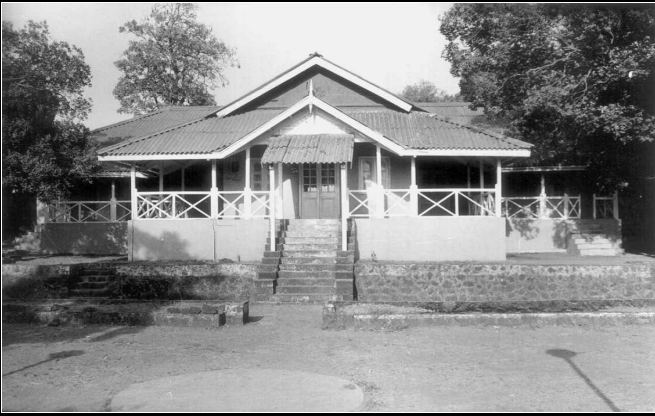
CARD		K-08/(0)	
		GRADE		II-B	
		ZONE		RUGBY	
		ZONE REF.		K 08	
		CO-ORD.		G,19	
		PLOT #		19	
		SURVEY #		125

1.0 NAME OF THE PROPERTY					
1.1	NAME	THE MOUNT (GOVERNMENT REST HOUSE)			
1.2	HISTORIC NAME	THE MOUNT (SUPERINTENDENT'S HOUSE)			
1.3	BUILT IN	1854 - 1865

9.2	MAINTENANCE	Good			
10.0 REMARKS					
10.1	CONSERVATION & DEVELOPMENT	<p>A well maintained structure under the possession of the Government. Attached additions and extensions should not be permitted to preserve the uniqueness of its form. Detached additions may be permitted provided they do not obstruct the view of the facade from the foreground, they maintain the pattern of the historic landscape and relate to the old structure sensitively.</p>

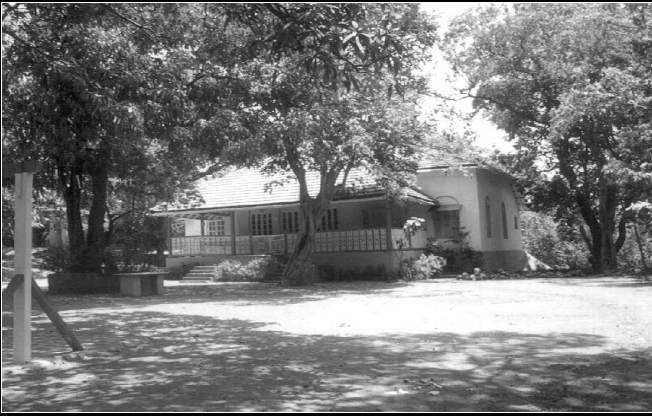
CARD	K-09/(0)
			GRADE	II-B
			ZONE	RUGBY
			ZONE REF.	K 09
			CO-ORD.	G,20
			PLOT #	62
			SURVEY #	126

1.0	NAME OF THE PROPERTY			
1.1	NAME	GULNAR COTTAGE		
1.2	HISTORIC NAME	ROZARIO COTTAGE		
1.3	BUILT IN	1854 - 1900		
2.0	AREA (SQ. MTS.)			
2.1	PLOT AREA	14168.10

8.3	FINISHES	Plastering and painting of walls.		
9.0	PRESENT STATUS			
9.1	STRUC. STABILITY	Fair		
9.2	MAINTENANCE	Good		
10.0	REMARKS			
10.1	CONSERVATION & DEVELOPMENT	<p>Well maintained structure with modest proportions and significant architectural character. Ideal for residential use. However, the property is being developed for a hotel involving massive RCC construction of ground + 2 upper storeys. Future developments must ensure unobstructed view of the old structure and relate sensitively to it.</p>

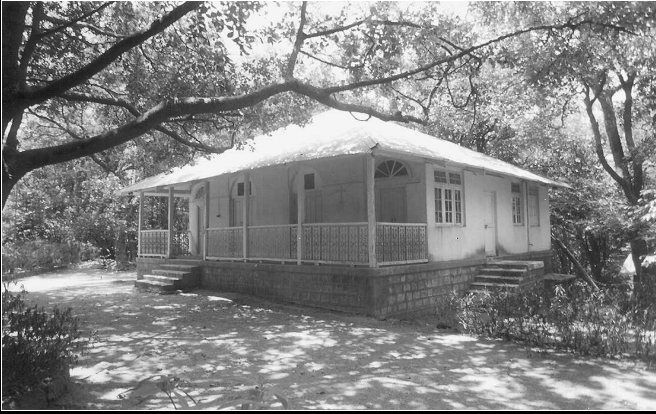
CARD	K-10/(0)	
			GRADE	III	
			ZONE	RUGBY	
			ZONE REF.	K 10	
			CO-ORD.	G,20	
			PLOT #	135	
			SURVEY #	127

1.0 NAME OF THE PROPERTY					
1.1	NAME	MATRU SMRITI			
1.2	HISTORIC NAME				
1.3	BUILT IN	1901 - 1945			
2.0 AREA (SQ. MTS.)					
2.1	PLOT AREA	5651.20			
2.2	BUILT-UP AREA	182.75

8.3	FINISHES	Plastering and painting of walls.			
9.0 PRESENT STATUS					
9.1	STRUC. STABILITY	Fair			
9.2	MAINTENANCE	Good			
10.0 REMARKS					
10.1	CONSERVATION & DEVELOPMENT	Representative of built form character of small cottage in Matheran. The structure can continue its present use as a residential building. Attached add-ons are not advisable. Detached additions should relate with the original structure sensitively in terms of form, scale and treatment.

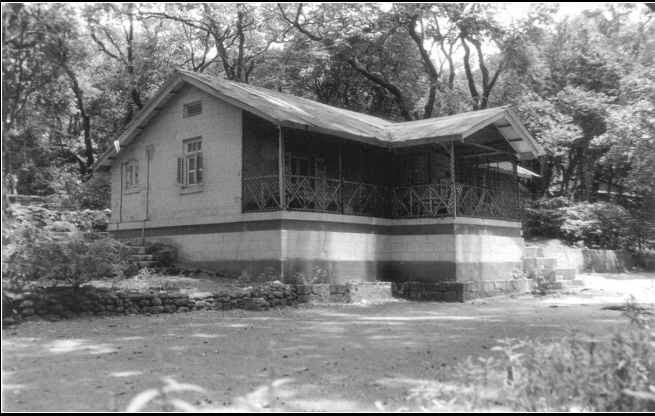
CARD	K-11/(0)
			GRADE	III
			ZONE	RUGBY
			ZONE REF.	K 11
			CO-ORD.	H,17
			PLOT #	180
			SURVEY #	110

1.0	NAME OF THE PROPERTY			
1.1	NAME	LAXMI VILLA		
1.2	HISTORIC NAME	LAXMI VILLA		
1.3	BUILT IN	1901 - 1945		
2.0	AREA (SQ. MTS.)			
2.1	PLOT AREA	1236.60

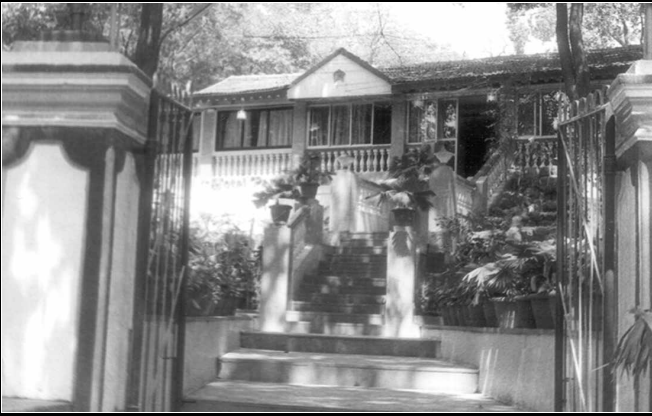
LOCATION	PIN	MH/RA/410102/K-13/(0)/2000	PANORAMA HOTEL

CARD	K-13/(0)	
		GRADE	III	
		ZONE	RUGBY	
		ZONE REF.	K 13	
		CO-ORD.	H,18	
		PLOT #	178	
		SURVEY #	119

1.0	NAME OF THE PROPERTY			
1.1	NAME	PANORAMA HOTEL		
1.2	HISTORIC NAME	MEHER VILLE		
1.3	BUILT IN	1901 - 1945		
2.0	AREA (SQ. MTS.)			
2.1	PLOT AREA	2634.10

6.5	REFERENCES	Municipal Records / Map (1903-04) / DP 1987 / Books on Matheran / Field Surveys		
7.0	ARCHITECTURAL SYSTEMS IN THE STRUCTURE			
7.1	FOUND. & PLINTH	Stepped laterite foundation. Plinth in coursed laterite - plastered and painted.

8.2	STRUCTURE	None		
8.3	FINISHES	Plastering and painting of walls and original railing of verandah replaced by concrete railing.		
9.0	PRESENT STATUS

9.1	STRUC. STABILITY	Fair		
9.2	MAINTENANCE	Fair		
10.0	REMARKS			
10.1	CONSERVATION & DEVELOPMENT	<p>Historic integrity is lost due to insensitive alterations to the original bungalow and a totally incongruous addition of a new building in the foreground which encroaches upon the required front open space and hence alters the historic setting of the plots in this area. Such developments may set a dangerous precedent for others to follow leading to a complete loss of townscape character and hence must be discouraged.</p>

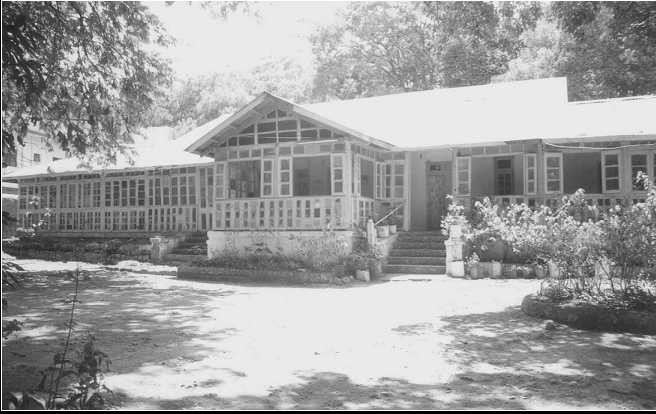
LOCATION	PIN	MH/RA/410102/K-14/(0)/2000	GULSHAN HOTEL

CARD	K-14/(0)		
	GRADE	II-B		
	ZONE	RUGBY		
	ZONE REF.	K 14		
	CO-ORD.	H,18		
	PLOT #	177		
	SURVEY #	120

1.0	NAME OF THE PROPERTY			
1.1	NAME	GULSHAN HOTEL		
1.2	HISTORIC NAME	GULSHAN		
1.3	BUILT IN	1901 - 1945		
2.0	AREA (SQ. MTS.)			
2.1	PLOT AREA	2431.50		
2.2	BUILT-UP AREA	359.52

6.5	REFERENCES	Municipal Records / Map (1903-04) / DP 1987 / Books on Matheran / Field Surveys		
7.0	ARCHITECTURAL SYSTEMS IN THE STRUCTURE			
7.1	FOUND. & PLINTH	Stepped laterite foundation. Plinth in coursed laterite - plastered and painted.

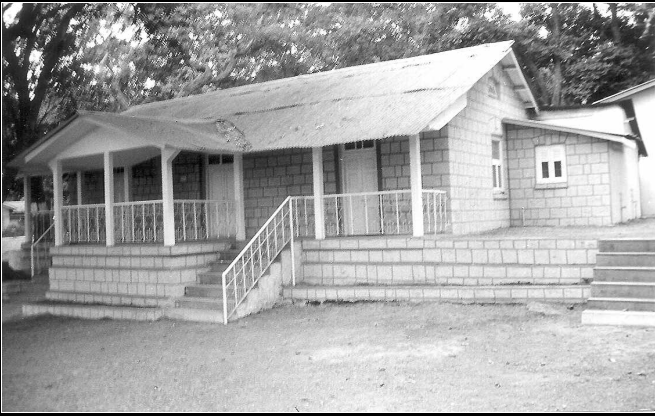
LOCATION		PIN	MH/RA/410102/K-16/(0)/2000	SONAM HOTEL

CARD	K-16/(0)
				GRADE	III
				ZONE	RUGBY
				ZONE REF.	K 16
				CO-ORD.	H,19
				PLOT #	174
				SURVEY #	150

1.0 NAME OF THE PROPERTY					
1.1	NAME	SONAM HOTEL			
1.2	HISTORIC NAME	NANDANVAN			
1.3	BUILT IN	1901 - 1945			
2.0 AREA (SQ. MTS.)					
2.1	PLOT AREA	1264.70

6.5	REFERENCES	Municipal Records / Map (1903-04) / DP 1987 / Books on Matheran / Field Surveys			
7.0 ARCHITECTURAL SYSTEMS IN THE STRUCTURE					
7.1	FOUND. & PLINTH	Stepped laterite foundation. Plinth in coursed laterite - plastered and painted.

8.0 TRANSFORMATION					
8.1	FORM	New building added in the rear as servants' quarters. Verandah added in the rear and plinth extended on the side.			
8.2	STRUCTURE	Timber posts, brackets and bargeboards of verandah replaced by new members in the same material.

8.3	FINISHES	Plastering and painting of walls. Railings replaced.			
9.0 PRESENT STATUS					
9.1	STRUC. STABILITY	Good			
9.2	MAINTENANCE	Good			
10.0 REMARKS
