MATHERAN:
A COMPREHENSIVE HERITAGE LISTING
PROPOSAL

FINAL REPORT
VOLUME III & IV

PROJECT CONSULTANT
K. UNWALLA ARCHITECTS

FOR
**M.M.R. HERITAGE CONSERVATION
SOCIETY**

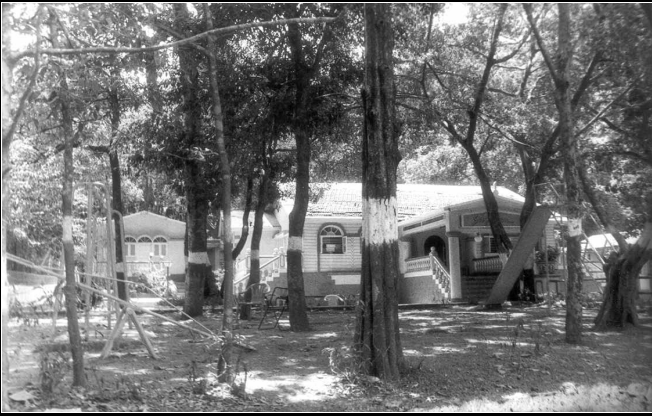
LOCATION		PIN	MH/RA/410102/K-18/(0)/2000	HOTEL SAHEBAN

CARD	K-18/(0)
				GRADE	III
				ZONE	RUGBY
				ZONE REF.	K 18
				CO-ORD.	H,19
				PLOT #	171
				SURVEY #	148

1.0 NAME OF THE PROPERTY					
1.1	NAME	HOTEL SAHEBAN			
1.2	HISTORIC NAME	SAILOR'S LODGE / AGBOTWALA'S BUNGALOW			
1.3	BUILT IN	1901-1945			
2.0 AREA (SQ. MTS.)

6.5	REFERENCES	Municipal Records / Map (1903-04) / DP 1987 / Books on Matheran / Field Surveys			
7.0 ARCHITECTURAL SYSTEMS IN THE STRUCTURE					
7.1	FOUND. & PLINTH	Stepped laterite foundation. Plinth in coursed laterite plastered and painted.

7.2	WALLS	Loadbearing in coursed laterite plastered & painted externally & internally. Extensions in RCC & brick masonry.			
7.3	FLOOR	Lime concrete floor with ceramic tiles (modern replacement).

8.1	FORM	Verandah extended by using RCC columns and slabs.			
8.2	STRUCTURE	Internal alterations to suit modified functions.			
8.3	FINISHES	Plastering and painting of walls and flooring replaced.

9.0 PRESENT STATUS					
9.1	STRUC. STABILITY	Good			
9.2	MAINTENANCE	Good			
10.0 REMARKS					
10.1	CONSERVATION & DEVELOPMENT	Significant as part of Kasturba Gandhi road precinct. Fairly decent example of adaptive re-use and new additions in relation to the existing old structure. No scope for further additions.

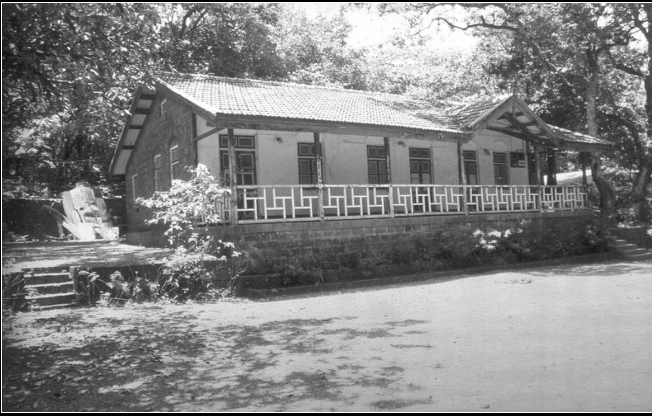
LOCATION	PIN	MH/RA/410102/K-19/(0)/2000	LUCKY LODGE

CARD	K-19/(0)
			GRADE	II-B
			ZONE	RUGBY
			ZONE REF.	K 19
			CO-ORD.	H,19
			PLOT #	170
			SURVEY #	147

1.0	NAME OF THE PROPERTY			
1.1	NAME	LUCKY LODGE		
1.2	HISTORIC NAME	LUCKY LODGE		
1.3	BUILT IN	1901 - 1945		
2.0	AREA (SQ. MTS.)			
2.1	PLOT AREA	1454.30

6.5	REFERENCES	Municipal Records / Map (1903-04) / DP 1987 / Books on Matheran / Field Surveys		
7.0	ARCHITECTURAL SYSTEMS IN THE STRUCTURE			
7.1	FOUND. & PLINTH	Stepped laterite foundation. Plinth in coursed laterite - exposed and pointed.

7.4	ROOF	TW purlin rafter roof structure with Manglore tiles roofing on G.I. sheets.		
7.5	OPENINGS	Semicircular relieving arched openings with rectangular TW frames, glazed (frosted glass) casement shutters for windows, part glazed, part timber louvered and part timber panelled shutters for doors and rectangular glazed ventilators. High level glazed ventilator on the gable end wall.

10.0	REMARKS			
10.1	CONSERVATION & DEVELOPMENT	The structure and its setting contribute to the character of the conservation area. Detached additions may be permitted in the side and rear open spaces provided they relate sensitively to the main structure in form, scale and treatment.

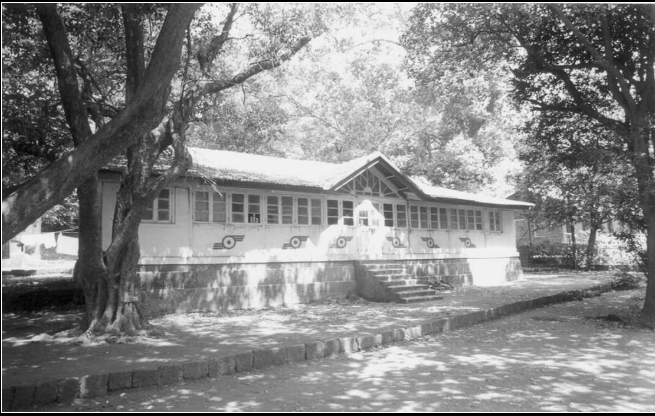
LOCATION		PIN	MH/RA/410102/K-20/(0)/2000	HYDRI COTTAGE

CARD	K-20/(0)
				GRADE	II-B
				ZONE	RUGBY
				ZONE REF.	K 20
				CO-ORD.	H,20
				PLOT #	169
				SURVEY #	146

1.0 NAME OF THE PROPERTY					
1.1	NAME	HYDRI COTTAGE			
1.2	HISTORIC NAME	HYDRI COTTAGE			
1.3	BUILT IN	1901 - 1945			
2.0 AREA (SQ. MTS.)					
2.1	PLOT AREA	1972.00

6.5	REFERENCES	Municipal Records / Map (1903-04) / DP 1987 / Books on Matheran / Field Surveys			
7.0 ARCHITECTURAL SYSTEMS IN THE STRUCTURE					
7.1	FOUND. & PLINTH	Stepped laterite foundation. Plinth in coursed laterite - exposed and pointed.

9.2	MAINTENANCE	Good			
10.0 REMARKS					
10.1	CONSERVATION & DEVELOPMENT	The structure and its setting contribute to the character of the conservation area. Detached additions may be permitted in the side and rear open spaces provided they relate sensitively to the main structure in form, scale and treatment.

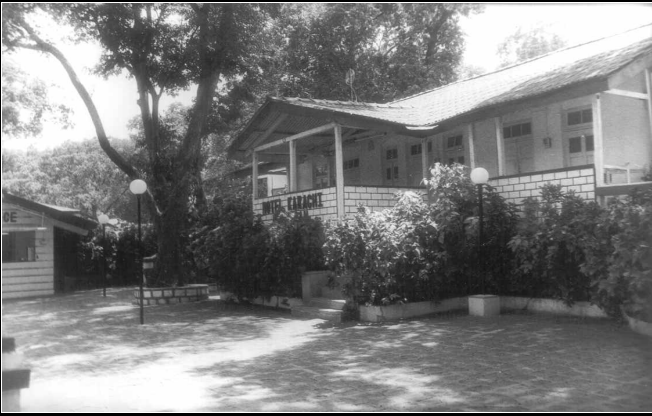
LOCATION		PIN	MH/RA/410102/K-21/(0)/2000	KARACHI HOTEL

CARD	K-21/(0)	
			GRADE	III	
			ZONE	RUGBY	
			ZONE REF.	K 21	
			CO-ORD.	H,20	
			PLOT #	168	
			SURVEY #	145

1.0 NAME OF THE PROPERTY					
1.1	NAME	KARACHI HOTEL			
1.2	HISTORIC NAME	ADAM LODGE			
1.3	BUILT IN	1901 - 1945			
2.0 AREA (SQ. MTS.)					
2.1	PLOT AREA	2158.00

6.5	REFERENCES	Municipal Records / Map (1903-04) / DP 1987 / Books on Matheran / Field Surveys			
7.0 ARCHITECTURAL SYSTEMS IN THE STRUCTURE					
7.1	FOUND. & PLINTH	Stepped laterite foundation. Plinth in coursed laterite - plastered and painted.

8.3	FINISHES	Plastering and painting of walls and railing of verandah replaced by brick masonry parapet wall.			
9.0 PRESENT STATUS					
9.1	STRUC. STABILITY	Fair

9.2	MAINTENANCE	Good			
10.0 REMARKS					
10.1	CONSERVATION & DEVELOPMENT	<p>The well maintained main structure has a commanding position at a height from the road level and contributes to the character of the conservation area. The large RCC structure with a flat roof, on the northern end of the plot is totally incongruous with the old building and adversely affects the visual integrity of the plot. No scope for further additions.</p>

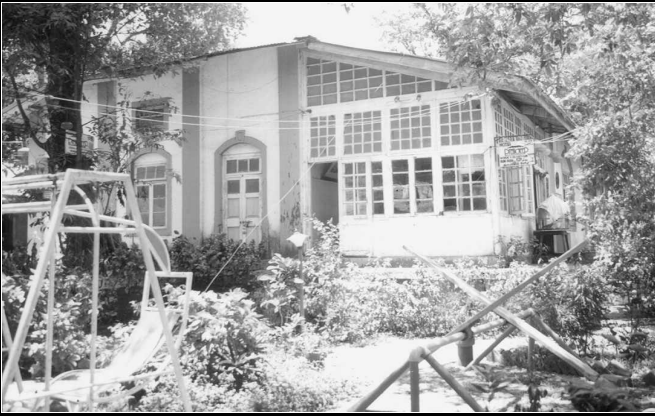
LOCATION		PIN	MH/RA/410102/K-22/(0)/2000	PREMDEEP RESORTS

CARD	K-22/(0)
				GRADE	III
				ZONE	RUGBY
				ZONE REF.	K 22
				CO-ORD.	H,20
				PLOT #	63B
				SURVEY #	144

1.0	NAME OF THE PROPERTY				
1.1	NAME	PREMDEEP RESORTS			
1.2	HISTORIC NAME	THE PALMS			
1.3	BUILT IN	1901 - 1945			
2.0	AREA (SQ. MTS.)				
2.1	PLOT AREA	1805.20

6.5	REFERENCES	Municipal Records / Map (1903-04) / DP 1987 / Books on Matheran / Field Surveys			
7.0	ARCHITECTURAL SYSTEMS IN THE STRUCTURE				
7.1	FOUND. & PLINTH	Stepped laterite foundation. Plinth in coursed laterite - plastered and painted.

9.2	MAINTENANCE	Fair			
10.0	REMARKS				
10.1	CONSERVATION & DEVELOPMENT	A unique typology, built form and setting contributing to the character of the conservation area. Buildings added on the site relate satisfactorily to the old structure. No scope for further additions and extensions on site.

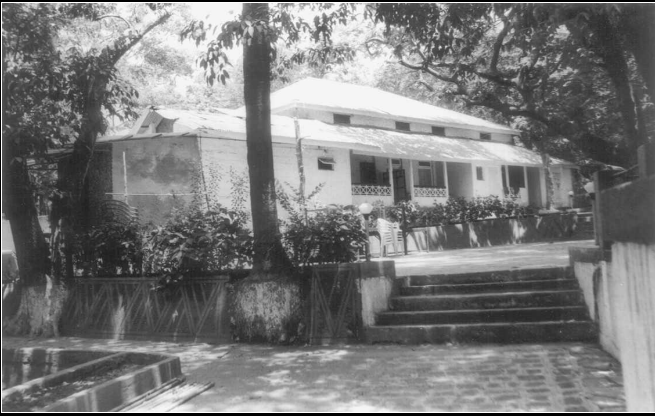
LOCATION		PIN	MH/RA/410102/K-23/(0)/2000	RIVIERA HOTEL

CARD	K-23/(0)	
			GRADE	II-B	
			ZONE	RUGBY	
			ZONE REF.	K 23	
			CO-ORD.	G-H,20-21	
			PLOT #	63A	
			SURVEY #	143

1.0 NAME OF THE PROPERTY					
1.1	NAME	RIVIERA HOTEL			
1.2	HISTORIC NAME	PART OF PINTO'S INTERNATIONAL / ALEXANDRA HOTEL / SAVOY HOTEL / PART OF REGAL HOTEL

6.5	REFERENCES	Municipal Records / Map (1903-04) / DP 1987 / Books on Matheran / Field Surveys			
7.0 ARCHITECTURAL SYSTEMS IN THE STRUCTURE					
7.1	FOUND. & PLINTH	Stepped laterite foundation. Plinth in coursed laterite - some painted and some plastered and painted.

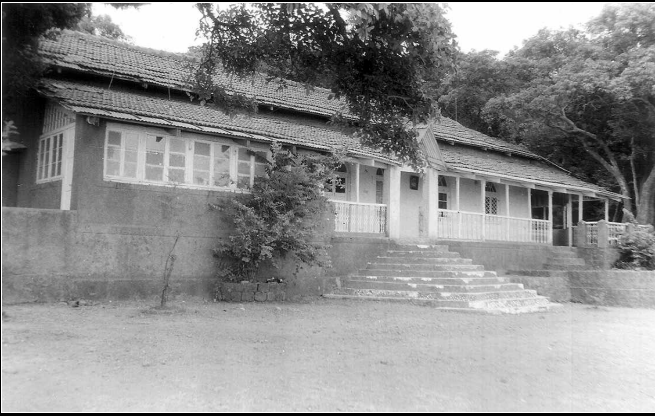
LOCATION		PIN	MH/RA/410102/L-01/(0)/2000	KEEPSAKE

CARD	L-01/(0)
				GRADE	II-B
				ZONE	BRIGHTLANDS
				ZONE REF.	L 01
				CO-ORD.	C-D,22
				PLOT #	32A, 32B
				SURVEY #	186,185

1.0 NAME OF THE PROPERTY					
1.1	NAME	KEEPSAKE			
1.2	HISTORIC NAME	POONA PAYING GUEST HOUSE			
1.3	BUILT IN	1854 - 1900			
2.0 AREA (SQ. MTS.)					
2.1	PLOT AREA	7472.00 +7486.7

6.5	REFERENCES	Municipal Records / Map (1903-04) / DP 1987 / Books on Matheran / Field Surveys			
7.0 ARCHITECTURAL SYSTEMS IN THE STRUCTURE					
7.1	FOUND. & PLINTH	Stepped laterite foundation. Plinth in coursed laterite - plastered and painted.

9.1	STRUC. STABILITY	Fair			
9.2	MAINTENANCE	Fair			
10.0 REMARKS					
10.1	CONSERVATION & DEVELOPMENT	Landmark location and impressive planform. The structure and its surrounding need regular maintenance. Present use is conducive to the structures. Detached additions on the site should not obstruct the view from the main structures and should relate sensitively to all the buildings and the forest cover existing on the site.

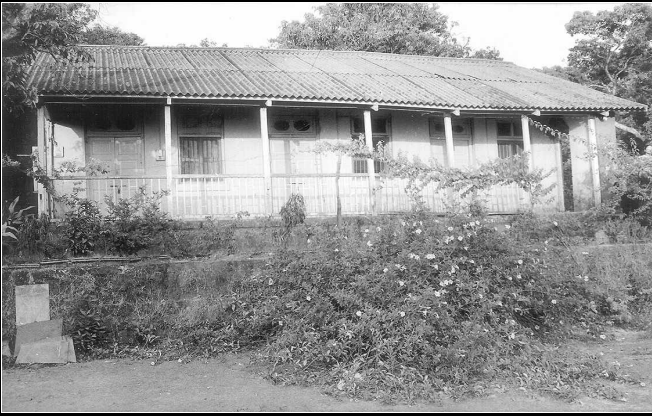
LOCATION		PIN	MH/RA/410102/L-02/(0)/2000	SETHNA COTTAGE

CARD	L-02/(0)
				GRADE	III
				ZONE	BRIGHTLANDS
				ZONE REF.	L 02
				CO-ORD.	D,12
				PLOT #	217
				SURVEY #	184

1.0 NAME OF THE PROPERTY					
1.1	NAME	SETHNA COTTAGE			
1.2	HISTORIC NAME	SETHNA COTTAGE			
1.3	BUILT IN	1901 - 1945			
2.0 AREA (SQ. MTS.)					
2.1	PLOT AREA	3163.30

6.5	REFERENCES	Municipal Records / Map (1903-04) / DP 1987 / Books on Matheran / Field Surveys			
7.0 ARCHITECTURAL SYSTEMS IN THE STRUCTURE					
7.1	FOUND. & PLINTH	Stepped laterite foundation. Plinth in coursed laterite - exposed and pointed.

8.3	FINISHES	Plastering and painting of walls.			
9.0 PRESENT STATUS					
9.1	STRUC. STABILITY	Fair			
9.2	MAINTENANCE	Fair			
10.0 REMARKS					
10.1	CONSERVATION & DEVELOPMENT	A conspicuous landmark along the western edge of the hill. The bungalow has no remarkable architectural qualities. The ancillary block has potential for conservation and future use.

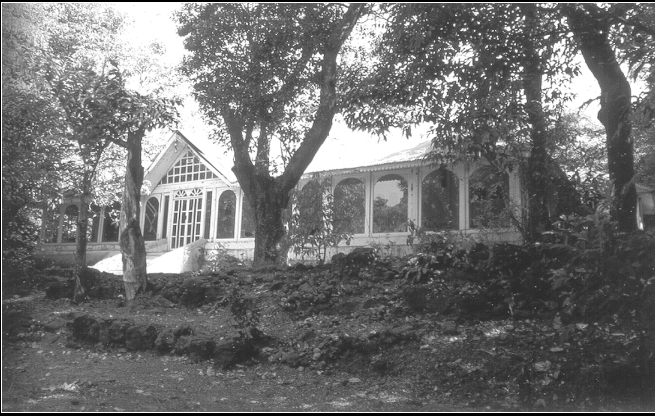
LOCATION	PIN	MH/RA/410102/L-03/(0)/2000	MADHU'S FOREST LODGE

CARD	L-03/(0)	
		GRADE	II-B	
		ZONE	BRIGHTLANDS	
		ZONE REF.	L 03	
		CO-ORD.	D,21	
		PLOT #	26	
		SURVEY #	183

1.0	NAME OF THE PROPERTY			
1.1	NAME	MADHU'S FOREST LODGE		
1.2	HISTORIC NAME	FOREST LODGE		
1.3	BUILT IN	1854 - 1867		
2.0	AREA (SQ. MTS.)			
2.1	PLOT AREA	21768.40

6.5	REFERENCES	Municipal Records / Map (1903-04) / DP 1987 / Books on Matheran / Field Surveys		
7.0	ARCHITECTURAL SYSTEMS IN THE STRUCTURE			
7.1	FOUND. & PLINTH	Stepped laterite foundation. Plinth in coursed laterite - plastered and painted.

10.1	CONSERVATION & DEVELOPMENT	Excellent structure and setting representing a unique character. The view of the façade from its foreground and from the road must remain unobstructed. Detached extensions may be provided in the north and west of the structure, provided they relate to it sensitively in terms of form, scale and treatment.

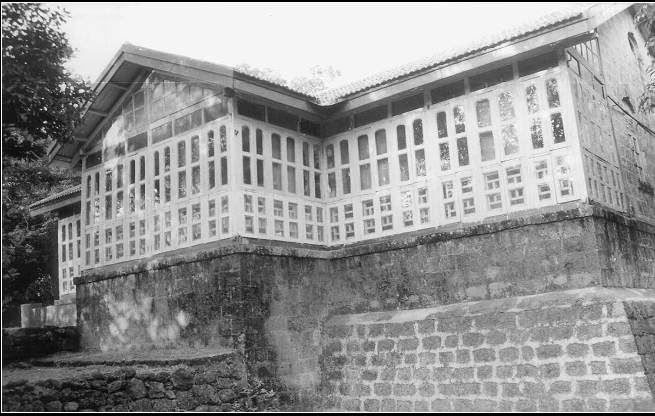
LOCATION	PIN	MH/RA/410102/L-04/(0)/2000	EVERGREEN

CARD	L-04/(0)
			GRADE	II-B
			ZONE	BRIGHTLANDS
			ZONE REF.	L 04
			CO-ORD.	D,20
			PLOT #	205
			SURVEY #	133

1.0	NAME OF THE PROPERTY			
1.1	NAME	EVERGREEN		
1.2	HISTORIC NAME	EVERGREEN		
1.3	BUILT IN	1901 - 1945		
2.0	AREA (SQ. MTS.)			
2.1	PLOT AREA	1711.50		
2.2	BUILT-UP AREA	277.77

6.5	REFERENCES	Municipal Records / Map (1903-04) / DP 1987 / Books on Matheran / Field Surveys		
7.0	ARCHITECTURAL SYSTEMS IN THE STRUCTURE			
7.1	FOUND. & PLINTH	Stepped laterite foundation. Plinth in coursed laterite - exposed and pointed.

9.2	MAINTENANCE	Fair		
10.0	REMARKS			
10.1	CONSERVATION & DEVELOPMENT	Well maintained structure ideal for residential use. Attached extensions not desirable. Detached additions should not obstruct the view from the structure to the west and should relate sensitively to the existing building in form, scale and treatment.

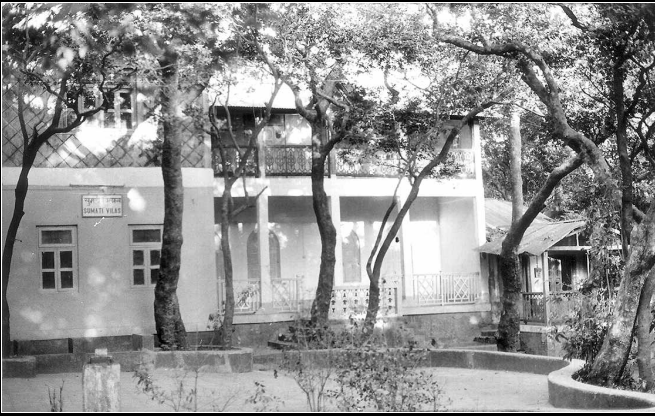
LOCATION	PIN	MH/RA/410102/L-05/(0)/2000	SUMATI VILAS

CARD	L-05/(0)
			GRADE	III
			ZONE	BRIGHTLANDS
			ZONE REF.	L 05
			CO-ORD.	D,20
			PLOT #	284
			SURVEY #	134

1.0	NAME OF THE PROPERTY			
1.1	NAME	SUMATI VILAS		
1.2	HISTORIC NAME	SUMATI VILAS		
1.3	BUILT IN	1901 - 1945		
2.0	AREA (SQ. MTS.)			
2.1	PLOT AREA	2073.60

6.5	REFERENCES	Municipal Records / Map (1903-04) / DP 1987 / Books on Matheran / Field Surveys		
7.0	ARCHITECTURAL SYSTEMS IN THE STRUCTURE			
7.1	FOUND. & PLINTH	Stepped laterite foundation. Plinth in coursed laterite - some exposed and pointed and some plastered and painted.

10.1	CONSERVATION & DEVELOPMENT	The double storeyed structure with its rather excessive ground floor height has unpleasant proportions and an over bearing colour scheme. No scope for further additions and extensions.

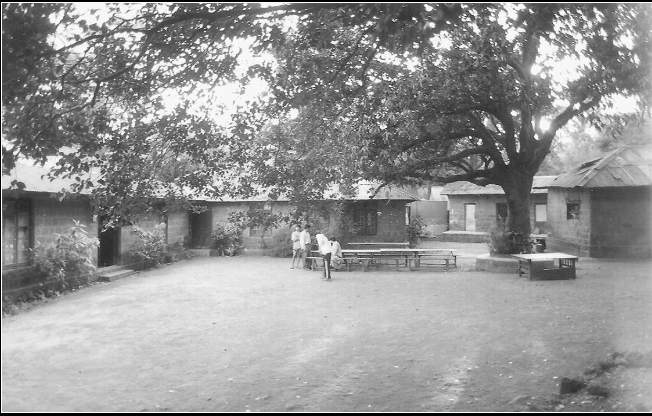
LOCATION		PIN	MH/RA/410102/L-06/(0)/2000	THE HERMITAGE

CARD	L-06/(0)	
			GRADE	II-B	
			ZONE	BRIGHTLANDS	
			ZONE REF.	L 06	
			CO-ORD.	D-E,20	
			PLOT #	10	
			SURVEY #	135

1.0 NAME OF THE PROPERTY					
1.1	NAME	THE HERMITAGE			
1.2	HISTORIC NAME	THE HERMITAGE AND ST. JOHN'S COTTAGE			
1.3	BUILT IN	1853			
2.0 AREA (SQ. MTS.)

6.5	REFERENCES	Municipal Records / Map (1903-04) / DP 1987 / Books on Matheran / Field Surveys			
7.0 ARCHITECTURAL SYSTEMS IN THE STRUCTURE					
7.1	FOUND. & PLINTH	Stepped laterite foundation. Plinth in coursed laterite - exposed and pointed.

9.2	MAINTENANCE	Fair			
10.0 REMARKS					
10.1	CONSERVATION & DEVELOPMENT	Being one of the first five properties developed in Matheran it holds immense historic significance and cultural value. The structure and its environs need regular maintenance. The chapel holds potential for conservation and meaningful public use. Overall the potential of the site is unexploited.

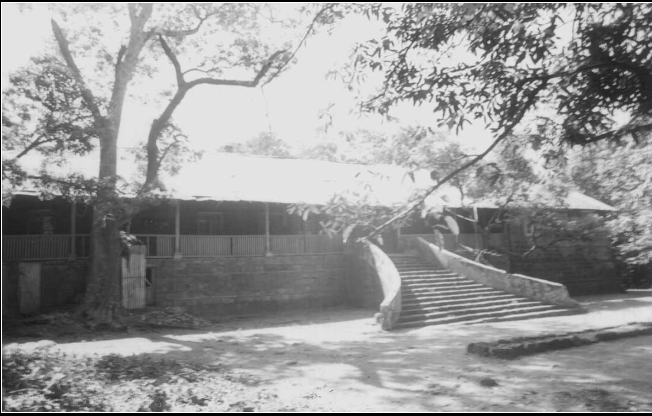
LOCATION		PIN	MH/RA/410102/L-07/(0)/2000	MARIA COTTAGE

CARD	L-07/(0)
				GRADE	II-B
				ZONE	BRIGHTLANDS
				ZONE REF.	L 07
				CO-ORD.	E-F,20
				PLOT #	38
				SURVEY #	129

1.0 NAME OF THE PROPERTY					
1.1	NAME	MARIA COTTAGE			
1.2	HISTORIC NAME	NAIRNE'S BUNGALOW			
1.3	BUILT IN	1854 - 1900			
2.0 AREA (SQ. MTS.)					
2.1	PLOT AREA	21751.90

6.5	REFERENCES	Municipal Records / Map (1903-04) / DP 1987 / Books on Matheran / Field Surveys			
7.0 ARCHITECTURAL SYSTEMS IN THE STRUCTURE					
7.1	FOUND. & PLINTH	Stepped laterite foundation. Plinth in coursed laterite - exposed and pointed.

10.0 REMARKS					
10.1	CONSERVATION & DEVELOPMENT	A structure of grand proportions with a unique design of flight of steps. The bungalow needs some structural repair and regular maintenance. Attached additions are not advisable. Currently one building is under construction on the site fairly distant from the main bungalow but future detached additions must respect the character of the existing building, visibility of its facade, foreground facade relationship and the existing forest cover.

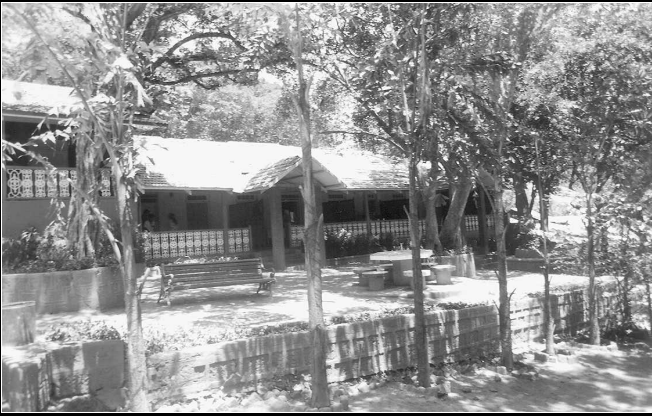
LOCATION	PIN	MH/RA/410102/L-08/(0)/2000	BRIGHTLANDS HOTEL

CARD	L-08/(0)
			GRADE	II-B
			ZONE	BRIGHTLANDS
			ZONE REF.	L 08
			CO-ORD.	F,20-21
			PLOT #	54A/1, 54A/2, 54A/3
			SURVEY #	137, 138, 136

1.0	NAME OF THE PROPERTY			
1.1	NAME	BRIGHTLANDS HOTEL		
1.2	HISTORIC NAME	THE WILDERNESS / ALBERT VICTOR HOTEL		
1.3	BUILT IN	1854 - 1867		
2.0	AREA (SQ. MTS.)

6.5	REFERENCES	Municipal Records / Map (1903-04) / DP 1987 / Books on Matheran / Field Surveys		
7.0	ARCHITECTURAL SYSTEMS IN THE STRUCTURE			
7.1	FOUND. & PLINTH	Stepped laterite foundation. Plinth in coursed laterite - plastered and painted.

10.1	CONSERVATION & DEVELOPMENT	Old structures and landscape in an excellent state of maintenance. The large, bulky double storeyed new buildings are completely incongruous with the old buildings in form, scale and treatment. New additions must be sensitive to the old buildings and layout in all these respects.

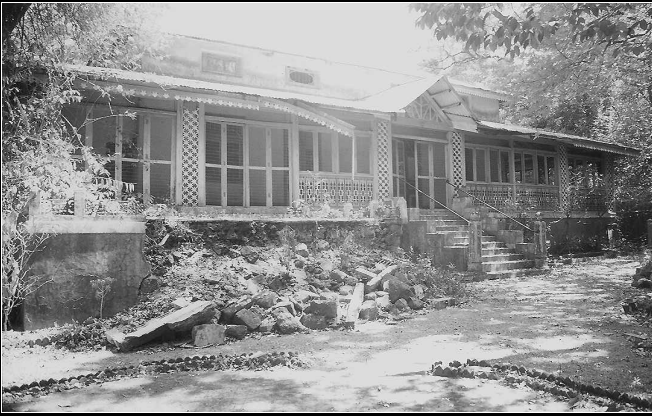
LOCATION		PIN	MH/RA/410102/L-09/(0)/2000	ROSHAN VILLA AND HOTEL PRASHANT

CARD	L-09/(0)
				GRADE	II-B
				ZONE	BRIGHTLANDS
				ZONE REF.	L 09
				CO-ORD.	F,21
				PLOT #	54B
				SURVEY #	182

1.0	NAME OF THE PROPERTY				
1.1	NAME	ROSHAN VILLA AND HOTEL PRASHANT			
1.2	HISTORIC NAME	ROSHAN VILLA / BURNSIDE			
1.3	BUILT IN	1854 - 1900			
2.0	AREA (SQ. MTS.)

6.5	REFERENCES	Municipal Records / Map (1903-04) / DP 1987 / Books on Matheran / Field Surveys			
7.0	ARCHITECTURAL SYSTEMS IN THE STRUCTURE				
7.1	FOUND. & PLINTH	Stepped laterite foundation. Plinth in coursed laterite - plastered and painted.

9.2	MAINTENANCE	Poor			
10.0	REMARKS				
10.1	CONSERVATION & DEVELOPMENT	Both, the main bungalow and hotel Prashant need regular maintenance. Both buildings directly face the road and are very close to it and therefore contribute to the townscape character. Additions on site must relate to the existing structures and forest cover sensitively. The ancillary buildings in the rear may be renovated and modified.

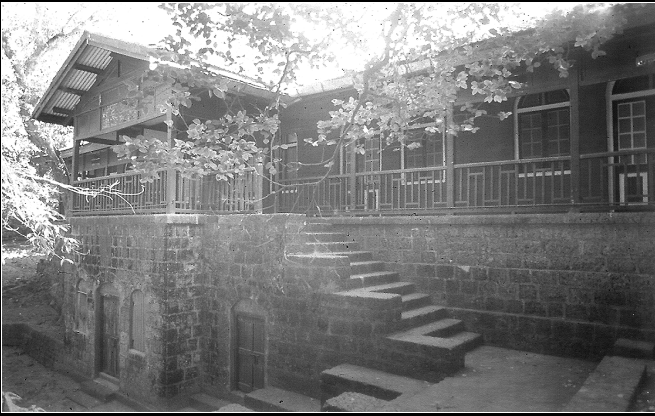
LOCATION		PIN	MH/RA/410102/L-10/(0)/2000	SAIFEE LODGE

CARD	L-10/(0)
				GRADE	II-B
				ZONE	BRIGHTLANDS
				ZONE REF.	L 10
				CO-ORD.	F,19
				PLOT #	167
				SURVEY #	105

1.0 NAME OF THE PROPERTY					
1.1	NAME	SAIFEE LODGE			
1.2	HISTORIC NAME	SAIFEE LODGE			
1.3	BUILT IN	1901 - 1945			
2.0 AREA (SQ. MTS.)					
2.1	PLOT AREA	2402.80

6.5	REFERENCES	Municipal Records / Map (1903-04) / DP 1987 / Books on Matheran / Field Surveys			
7.0 ARCHITECTURAL SYSTEMS IN THE STRUCTURE					
7.1	FOUND. & PLINTH	Stepped laterite foundation. Plinth in coursed laterite - exposed and pointed.

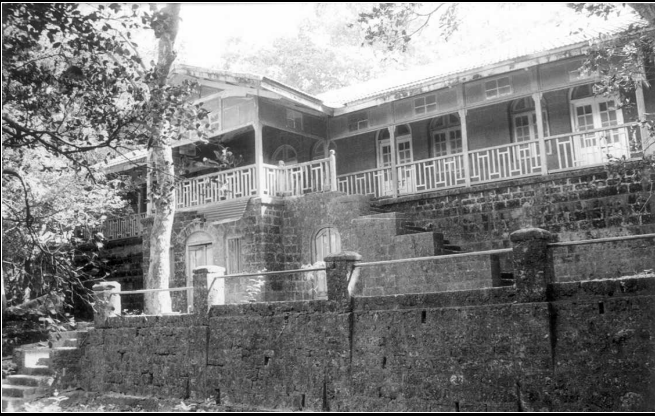
LOCATION	PIN	MH/RA/410102/L-12/(0)/2000	GIRIKUNJ

CARD	L-12/(0)
			GRADE	II-B
			ZONE	BRIGHTLANDS
			ZONE REF.	L 12
			CO-ORD.	F,20
			PLOT #	166
			SURVEY #	104

1.0	NAME OF THE PROPERTY			
1.1	NAME	GIRIKUNJ		
1.2	HISTORIC NAME	NASHEMAN-E-ZUBEDAH		
1.3	BUILT IN	1901 - 1945		
2.0	AREA (SQ. MTS.)			
2.1	PLOT AREA	1719.90

6.5	REFERENCES	Municipal Records / Map (1903-04) / DP 1987 / Books on Matheran / Field Surveys		
7.0	ARCHITECTURAL SYSTEMS IN THE STRUCTURE			
7.1	FOUND. & PLINTH	Stepped laterite foundation. Plinth in coursed laterite - exposed and pointed.

8.1	FORM	None		
8.2	STRUCTURE	None		
8.3	FINISHES	None		
9.0	PRESENT STATUS			
9.1	STRUC. STABILITY	Good		
9.2	MAINTENANCE	Good		
10.0	REMARKS			
10.1	CONSERVATION & DEVELOPMENT	Holds a large amount of significance in a group value as it is one of the three identical structures along this stretch of the road. Facade to foreground relationship of the structure must be maintained. Detached additions may be permitted in rear open spaces if they relate sensitively to the bungalow in form, scale and treatment.

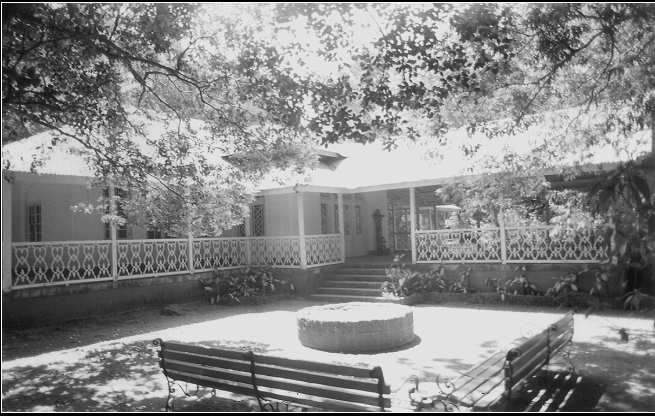
LOCATION		PIN	MH/RA/410102/L-13/(0)/2000	PRABAL HOUSE

CARD		L-13/(0)
			GRADE		II-B
			ZONE		BRIGHTLANDS
			ZONE REF.		L 13
			CO-ORD.		F,20
			PLOT #		39
			SURVEY #		142

1.0 NAME OF THE PROPERTY					
1.1	NAME	PRABAL HOUSE			
1.2	HISTORIC NAME	PRABUL HOUSE			
1.3	BUILT IN	1854 - 1867			
2.0 AREA (SQ. MTS.)					
2.1	PLOT AREA	15985.10

6.5	REFERENCES	Municipal Records / Map (1903-04) / DP 1987 / Books on Matheran / Field Surveys			
7.0 ARCHITECTURAL SYSTEMS IN THE STRUCTURE					
7.1	FOUND. & PLINTH	Stepped laterite foundation. Plinth in coursed laterite - plastered and painted.

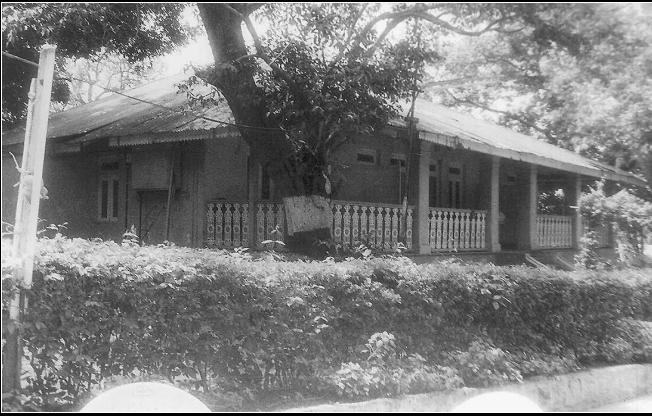
LOCATION		PIN	MH/RA/410102/L-14/(0)/2000	GUJARAT BHAVAN

CARD	L-14/(0)	
			GRADE	II-B	
			ZONE	BRIGHTLANDS	
			ZONE REF.	L 14	
			CO-ORD.	G,21	
			PLOT #	75	
			SURVEY #	140

1.0 NAME OF THE PROPERTY					
1.1	NAME	GUJARAT BHAVAN			
1.2	HISTORIC NAME	ARNOLD LODGE			
1.3	BUILT IN	1854 - 1900			
2.0 AREA (SQ. MTS.)					
2.1	PLOT AREA	7284.30

6.5	REFERENCES	Municipal Records / Map (1903-04) / DP 1987 / Books on Matheran / Field Surveys			
7.0 ARCHITECTURAL SYSTEMS IN THE STRUCTURE					
7.1	FOUND. & PLINTH	Stepped laterite foundation. Plinth in coursed laterite - plastered and painted.

10.1	CONSERVATION & DEVELOPMENT	The cohesiveness of the layout has been maintained in spite of the addition of the new building and the swimming pool. The new building is a good example of a modern addition on a historic site, which respects the existing topography and vegetation. The building is also sensitively designed in terms of its form and treatment. Future developments on the site should strictly follow this example.

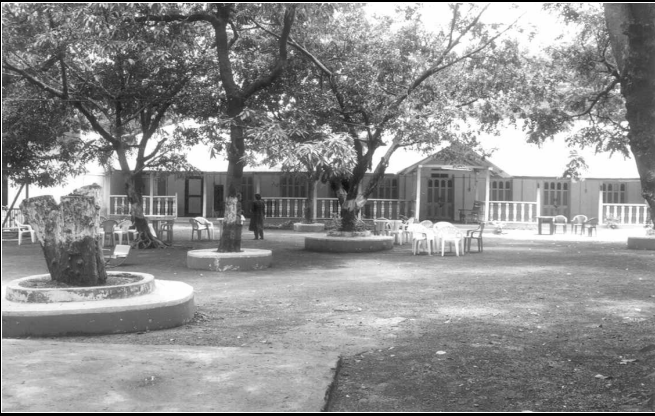
LOCATION		PIN	MH/RA/410102/L-15/(0)/2000	GULMOHUR HOTEL

CARD	L-15/(0)
				GRADE	II-B
				ZONE	BRIGHTLANDS
				ZONE REF.	L 15
				CO-ORD.	F-G,21
				PLOT #	36
				SURVEY #	139

1.0	NAME OF THE PROPERTY				
1.1	NAME	GULMOHUR HOTEL			
1.2	HISTORIC NAME	COXON'S LODGE / KALYANDAS LODGE / JAFFER MANZIL			
1.3	BUILT IN	1854 - 1900			
2.0	AREA (SQ. MTS.)

6.5	REFERENCES	Municipal Records / Map (1903-04) / DP 1987 / Books on Matheran / Field Surveys			
7.0	ARCHITECTURAL SYSTEMS IN THE STRUCTURE				
7.1	FOUND. & PLINTH	Stepped laterite foundation. Plinth in coursed laterite - exposed and painted.

10.1	CONSERVATION & DEVELOPMENT	Well conserved structure and environs with minimum interventions representative of the townscape character of Matheran. Attached or detached additions may be allowed provided they maintain the façade-foreground relationship of the main building, respect the existing forest cover on the site and relate sensitively to the existing building in terms of form, scale and treatment.

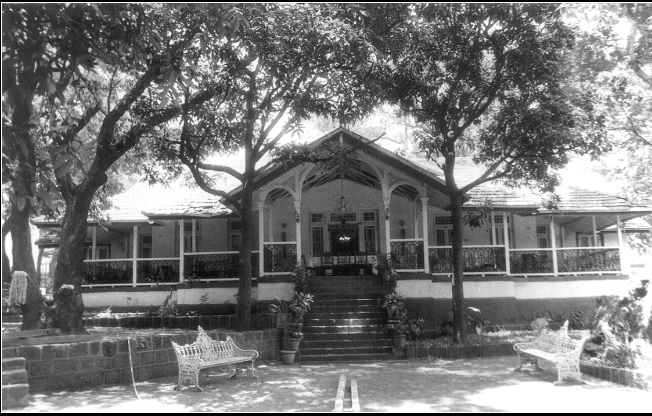
LOCATION	PIN	MH/RA/410102/L-16/(0)/2000	HOTEL ANANDRITZ

CARD	L-16/(0)
			GRADE	II-B
			ZONE	BRIGHTLANDS
			ZONE REF.	L 16
			CO-ORD.	G,21-22
			PLOT #	78
			SURVEY #	181

1.0	NAME OF THE PROPERTY			
1.1	NAME	HOTEL ANANDRITZ		
1.2	HISTORIC NAME	SUNNY SIDE BUNGALOW		
1.3	BUILT IN	1854 - 1900		
2.0	AREA (SQ. MTS.)			
2.1	PLOT AREA	8903.10

6.5	REFERENCES	Municipal Records / Map (1903-04) / DP 1987 / Books on Matheran / Field Surveys		
7.0	ARCHITECTURAL SYSTEMS IN THE STRUCTURE			
7.1	FOUND. & PLINTH	Stepped laterite foundation. Plinth in coursed laterite - pointed and painted.

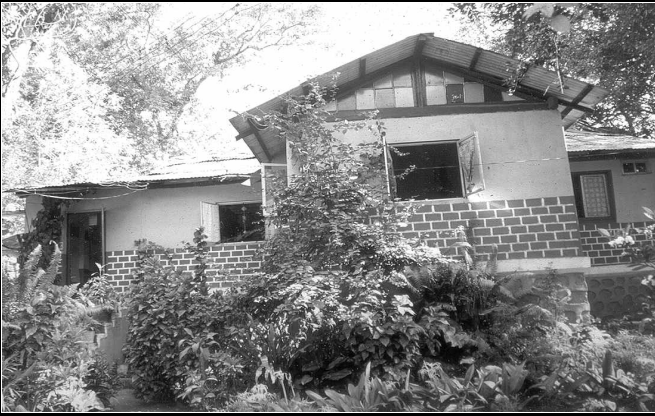
LOCATION		PIN	MH/RA/410102/L-18/(0)/2000	HOPE HALL HOTEL

CARD	L-18/(0)
				GRADE	II-B
				ZONE	BRIGHTLANDS
				ZONE REF.	L 18
				CO-ORD.	H,21-23
				PLOT #	77
				SURVEY #	179

1.0 NAME OF THE PROPERTY					
1.1	NAME	HOPE HALL HOTEL			
1.2	HISTORIC NAME	HOPE HALL HOTEL			
1.3	BUILT IN	1875			
2.0 AREA (SQ. MTS.)					
2.1	PLOT AREA	8599.60

6.5	REFERENCES	Municipal Records / Map (1903-04) / DP 1987 / Books on Matheran / Field Surveys			
7.0 ARCHITECTURAL SYSTEMS IN THE STRUCTURE					
7.1	FOUND. & PLINTH	Stepped laterite foundation. Plinth in coursed laterite - painted.

8.2	STRUCTURE	None			
8.3	FINISHES	Painting of walls.			
9.0 PRESENT STATUS					
9.1	STRUC. STABILITY	Good			
9.2	MAINTENANCE	Good			
10.0 REMARKS					
10.1	CONSERVATION & DEVELOPMENT	<p>Sensitively developed layout retaining the original buildings and natural vegetation on the site. Holds significance as one of the oldest hotels to be developed in Matheran. Detached additions may be allowed in the southern part of the plot provided they relate sensitively to the original buildings in form, scale and treatment and respect the natural topography and vegetation in the plot.</p>

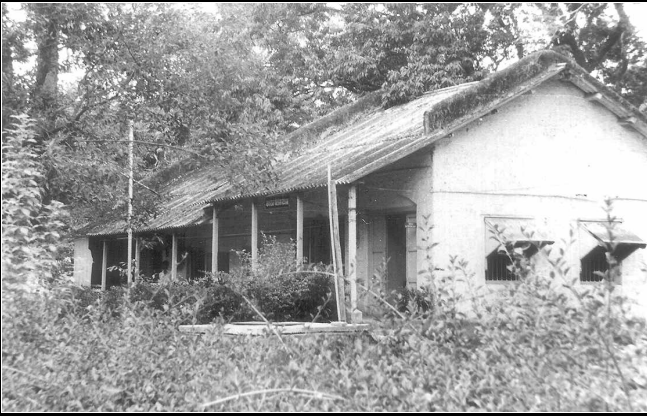
LOCATION		PIN	MH/RA/410102/L-19/(0)/2000	POLICE STATION

CARD	L-19/(0)
				GRADE	III
				ZONE	BRIGHTLANDS
				ZONE REF.	L 19
				CO-ORD.	G,21-22
				PLOT #	224
				SURVEY #	180

1.0 NAME OF THE PROPERTY					
1.1	NAME	POLICE STATION			
1.2	HISTORIC NAME	POLICE STATION			
1.3	BUILT IN	1901 - 1945			
2.0 AREA (SQ. MTS.)					
2.1	PLOT AREA	8751.40

6.5	REFERENCES	Municipal Records / Map (1903-04) / DP 1987 / Books on Matheran / Field Surveys			
7.0 ARCHITECTURAL SYSTEMS IN THE STRUCTURE					
7.1	FOUND. & PLINTH	Stepped laterite foundation. Plinth in coursed laterite - exposed and pointed.

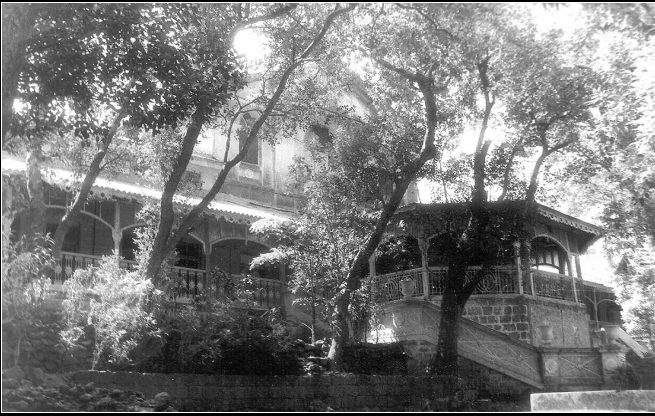
LOCATION	PIN	MH/RA/410102/M-01/(0)/2000	BARR HOUSE

CARD	M-01/(0)
			GRADE	II-A
			ZONE	CHARLOTTE LAKE
			ZONE REF.	M 01
			CO-ORD.	D,22
			PLOT #	84
			SURVEY #	260

1.0	NAME OF THE PROPERTY			
1.1	NAME	BARR HOUSE		
1.2	HISTORIC NAME	GENERAL H. BARR'S HOUSE		
1.3	BUILT IN	1853		
2.0	AREA (SQ. MTS.)			
2.1	PLOT AREA	22005.50

6.5	REFERENCES	Municipal Records / Map (1903-04) / DP 1987 / Books on Matheran / Field Surveys		
7.0	ARCHITECTURAL SYSTEMS IN THE STRUCTURE			
7.1	FOUND. & PLINTH	Stepped laterite foundation. Plinth in coursed laterite - exposed and pointed.

8.3	FINISHES	Plastering and painting of some walls.		
9.0	PRESENT STATUS			
9.1	STRUC. STABILITY	Fair		
9.2	MAINTENANCE	Fair		
10.0	REMARKS			
10.1	CONSERVATION & DEVELOPMENT	Holds immense historic importance being one of the first five buildings of Matheran. It has a unique and majestic character and setting. In spite of the number of interventions the structure has retained its historic integrity. It may be put to adaptive re-use to ensure regular maintenance of the building and its premises in the future.

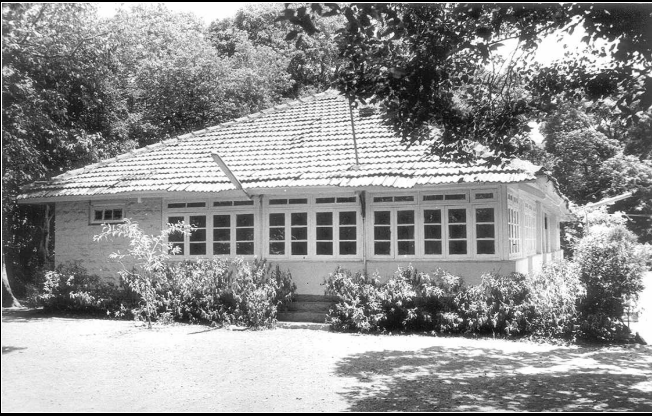
LOCATION		PIN	MH/RA/410102/M-02/(0)/2000	P.W.D. REST HOUSE

CARD	M-02/(0)
				GRADE	II-B
				ZONE	CHARLOTTE LAKE
				ZONE REF.	M 02
				CO-ORD.	D-E,21-22
				PLOT #	86
				SURVEY #	261

1.0 NAME OF THE PROPERTY					
1.1	NAME	P.W.D. REST HOUSE			
1.2	HISTORIC NAME	P.W.D. REST HOUSE			
1.3	BUILT IN	1854 - 1900			
2.0 AREA (SQ. MTS.)					
2.1	PLOT AREA	13816.20

6.5	REFERENCES	Municipal Records / Map (1903-04) / DP 1987 / Books on Matheran / Field Surveys			
7.0 ARCHITECTURAL SYSTEMS IN THE STRUCTURE					
7.1	FOUND. & PLINTH	Stepped laterite foundation. Plinth in coursed laterite - painted.

10.1	CONSERVATION & DEVELOPMENT	A well kept structure with a wide open foreground, contributing to the townscape character. Attached additions are not advisable. Detached additions may be permitted in the western and southern open spaces provided they relate sensitively to the existing building in form, scale and treatment.

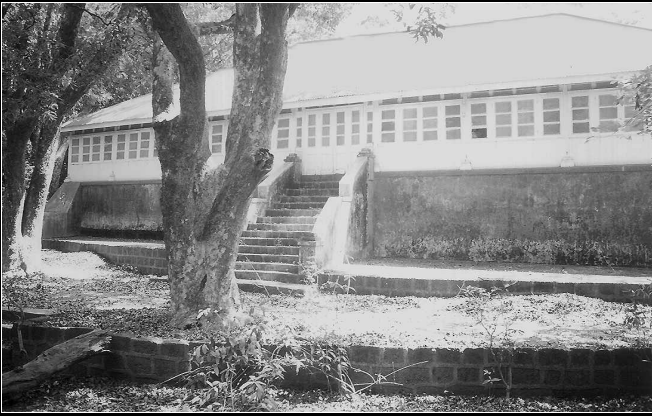
LOCATION	PIN	MH/RA/410102/M-03/(0)/2000	SATYA NIWAS

CARD	M-03/(0)	
		GRADE	II-B	
		ZONE	CHARLOTTE LAKE	
		ZONE REF.	M 03	
		CO-ORD.	F,21-22	
		PLOT #	55	
		SURVEY #	266

1.0	NAME OF THE PROPERTY			
1.1	NAME	SATYA NIWAS		
1.2	HISTORIC NAME	CAPRIERA		
1.3	BUILT IN	1854 - 1900		
2.0	AREA (SQ. MTS.)			
2.1	PLOT AREA	10447.40		
2.2	BUILT-UP AREA	525.90

6.5	REFERENCES	Municipal Records / Map (1903-04) / DP 1987 / Books on Matheran / Field Surveys		
7.0	ARCHITECTURAL SYSTEMS IN THE STRUCTURE			
7.1	FOUND. & PLINTH	Stepped laterite foundation. Plinth in coursed laterite - exposed and pointed.

8.3	FINISHES	Plastering and painting of walls.		
9.0	PRESENT STATUS			
9.1	STRUC. STABILITY	Fair		
9.2	MAINTENANCE	Fair		
10.0	REMARKS			
10.1	CONSERVATION & DEVELOPMENT	<p>The building has a good setting and an appearance that is quite unique for Matheran. Attached additions are not advisable. Detached additions may be allowed in the south-east part of the plot provided they relate sensitively to the existing building and respect the existing forest cover on the site.</p>

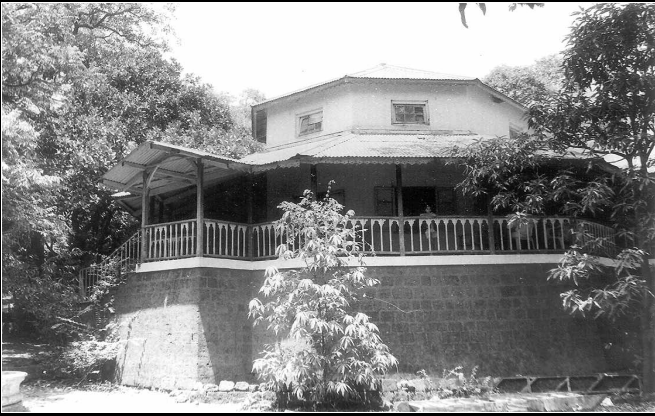
LOCATION	PIN	MH/RA/410102/M-04/(0)/2000	WEST END HOTEL

CARD	M-04/(0)
			GRADE	II-B
			ZONE	CHARLOTTE LAKE
			ZONE REF.	M 04
			CO-ORD.	F-G,22
			PLOT #	79
			SURVEY #	267

1.0	NAME OF THE PROPERTY			
1.1	NAME	WEST END HOTEL		
1.2	HISTORIC NAME	ALLADIN LODGE		
1.3	BUILT IN	1854 - 1900		
2.0	AREA (SQ. MTS.)			
2.1	PLOT AREA	6879.70

6.5	REFERENCES	Municipal Records / Map (1903-04) / DP 1987 / Books on Matheran / Field Surveys		
7.0	ARCHITECTURAL SYSTEMS IN THE STRUCTURE			
7.1	FOUND. & PLINTH	Stepped laterite foundation. Plinth in coursed laterite - exposed and pointed (main bungalow), painted (guest block).

8.3	FINISHES	Plastering and painting of walls.		
9.0	PRESENT STATUS			
9.1	STRUC. STABILITY	Good		
9.2	MAINTENANCE	Fair		
10.0	REMARKS			
10.1	CONSERVATION & DEVELOPMENT	Excellent built forms and setting representing the townscape character of Matheran. Attached additions are not advisable. Detached additions must not disturb the important views of the structures, they must respect the existing forest cover and relate sensitively to the existing buildings in form, scale and treatment.

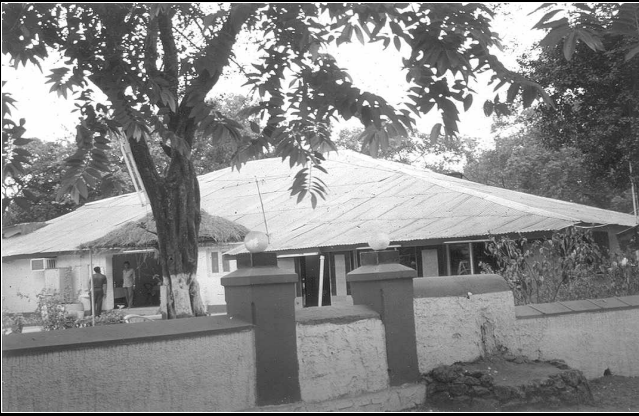
LOCATION		PIN	MH/RA/410102/M-05/(0)/2000	SURUCHI REDWOOD RESORT

CARD	M-05/(0)	
			GRADE	III	
			ZONE	CHARLOTTE LAKE	
			ZONE REF.	M 05	
			CO-ORD.	G,22	
			PLOT #	74	
				SURVEY #	268

1.0		NAME OF THE PROPERTY			
1.1	NAME	SURUCHI REDWOOD RESORT			
1.2	HISTORIC NAME	SYLVAN HOTEL / MARY LODGE			
1.3	BUILT IN	1854 - 1900			
2.0		AREA (SQ. MTS.)

6.5	REFERENCES	Municipal Records / Map (1903-04) / DP 1987 / Books on Matheran / Field Surveys			
7.0		ARCHITECTURAL SYSTEMS IN THE STRUCTURE			
7.1	FOUND. & PLINTH	Stepped laterite foundation. Plinth in coursed laterite - exposed and pointed.

9.0		PRESENT STATUS			
9.1	STRUC. STABILITY	Good			
9.2	MAINTENANCE	Good			
10.0		REMARKS			
10.1	CONSERVATION & DEVELOPMENT	Major interventions to the main building have affected its historic integrity, although, the overall skyline has been maintained. No scope for further additions and extensions.

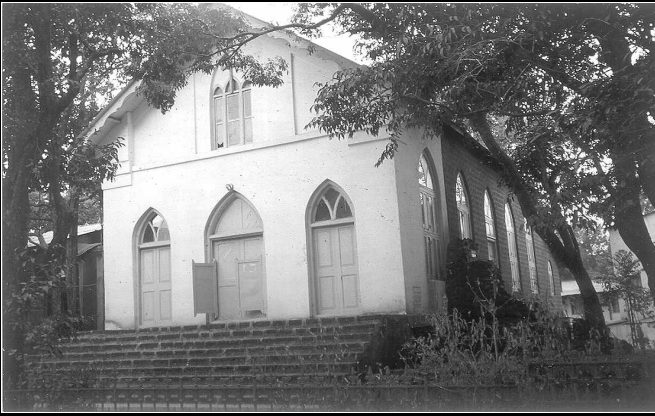
LOCATION		PIN	MH/RA/410102/M-06/(0)/2000	ROMAN CATHOLIC CHURCH & CEMETERY

CARD	M-06/(0)
				GRADE	II-A
				ZONE	CHARLOTTE LAKE
				ZONE REF.	M 06
				CO-ORD.	G,22
				PLOT #	137A, 137
				SURVEY #	253, 269

1.0 NAME OF THE PROPERTY					
1.1	NAME	ROMAN CATHOLIC CHURCH AND CEMETERY			
1.2	HISTORIC NAME	ROMAN CATHOLIC CHURCH AND CEMETERY			
1.3	BUILT IN	1861 / enlarged in 1872

6.5	REFERENCES	Municipal Records / Map (1903-04) / DP 1987 / Books on Matheran / Field Surveys			
7.0 ARCHITECTURAL SYSTEMS IN THE STRUCTURE					
7.1	FOUND. & PLINTH	Stepped laterite foundation. Plinth in coursed laterite - exposed and pointed.

9.2	MAINTENANCE	Church building - Good / Ancillary structures and site - Fair			
10.0 REMARKS					
10.1	CONSERVATION & DEVELOPMENT	An important religious building holding landmark value and social significance. The building has been renovated recently. Any interventions to the structure should be carried out sensitively. Little scope for additions and extensions. Ancillary areas need structural repairs and maintenance.

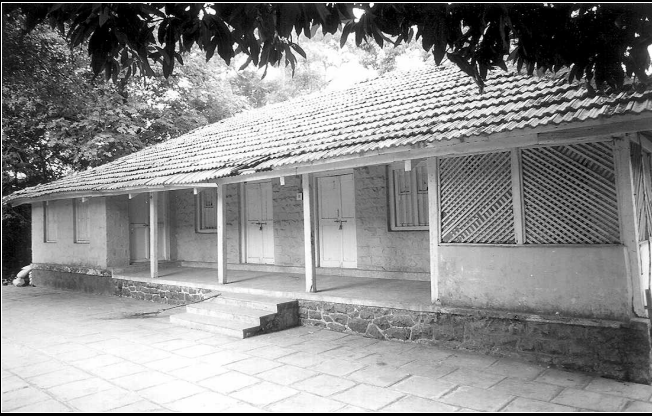
LOCATION		PIN	MH/RA/410102/M-07/(0)/2000	P.W.D. STORE

CARD	M-07/(0)
				GRADE	III
				ZONE	CHARLOTTE LAKE
				ZONE REF.	M 07
				CO-ORD.	G,23
				PLOT #	225
				SURVEY #	255

1.0		NAME OF THE PROPERTY			
1.1	NAME	P.W.D. STORE			
1.2	HISTORIC NAME	TENNIS COURT			
1.3	BUILT IN	1901 - 1945			
2.0		AREA (SQ. MTS.)			
2.1	PLOT AREA	2428.10

6.5	REFERENCES	Municipal Records / Map (1903-04) / DP 1987 / Books on Matheran / Field Surveys			
7.0		ARCHITECTURAL SYSTEMS IN THE STRUCTURE			
7.1	FOUND. & PLINTH	Stepped laterite foundation. Plinth in coursed laterite - exposed and pointed.

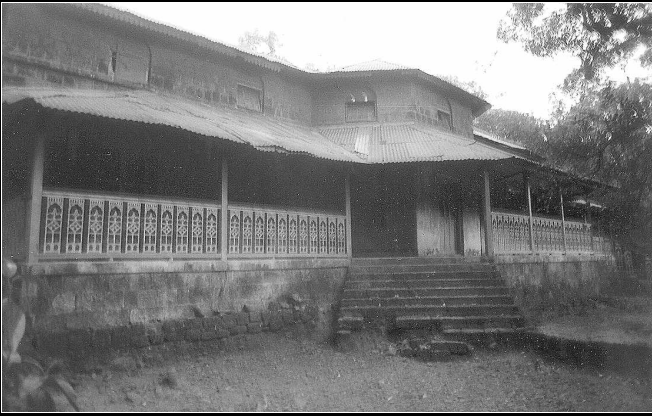
LOCATION	PIN	MH/RA/410102/M-09/(0)/2000	BANK OF INDIA HOLIDAY HOME

CARD	M-09/(0)
			GRADE	II-B
			ZONE	CHARLOTTE LAKE
			ZONE REF.	M 09
			CO-ORD.	F,22-23
			PLOT #	92
			SURVEY #	257

1.0	NAME OF THE PROPERTY			
1.1	NAME	BANK OF INDIA HOLIDAY HOME		
1.2	HISTORIC NAME	THE DELL		
1.3	BUILT IN	1854 - 1900		
2.0	AREA (SQ. MTS.)			
2.1	PLOT AREA	20234.30

6.5	REFERENCES	Municipal Records / Map (1903-04) / DP 1987 / Books on Matheran / Field Surveys		
7.0	ARCHITECTURAL SYSTEMS IN THE STRUCTURE			
7.1	FOUND. & PLINTH	Stepped laterite foundation. Plinth in coursed laterite - exposed and pointed.

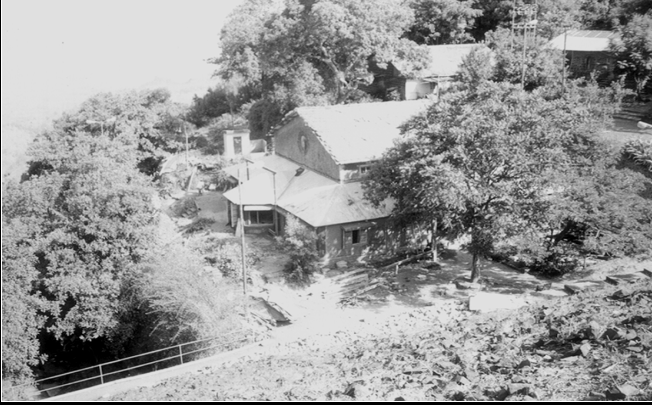
LOCATION		PIN	MH/RA/410102/M-11/(0)/2000	POWER HOUSE (CHARLOTTE LAKE)

CARD	M-11/(0)
				GRADE	II-B
				ZONE	CHARLOTTE LAKE
				ZONE REF.	M 11
				CO-ORD.	C,23
				PLOT #	287
				SURVEY #	258

1.0 NAME OF THE PROPERTY					
1.1	NAME	POWER HOUSE (CHARLOTTE LAKE)			
1.2	HISTORIC NAME	POWER HOUSE (CHARLOTTE LAKE)			
1.3	BUILT IN	1854 - 1900			
2.0 AREA (SQ. MTS.)

6.5	REFERENCES	Municipal Records / Map (1903-04) / DP 1987 / Books on Matheran / Field Surveys			
7.0 ARCHITECTURAL SYSTEMS IN THE STRUCTURE					
7.1	FOUND. & PLINTH	Stepped laterite foundation. Plinth in coursed laterite - exposed and pointed.

8.2	STRUCTURE	None			
8.3	FINISHES	Plastering and painting of walls and Manglore tile roof over verandah replaced by G.I. sheets.			
9.0 PRESENT STATUS

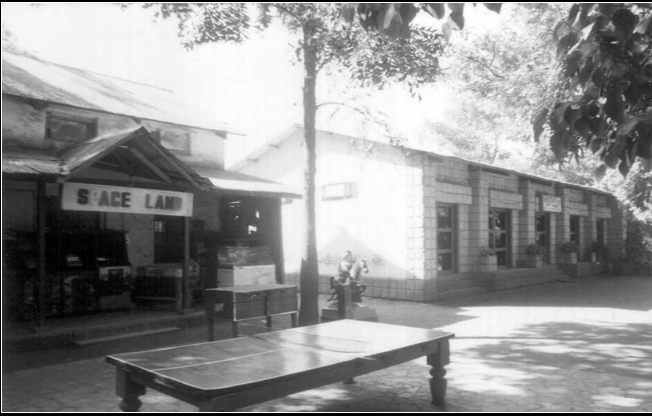
LOCATION		PIN	MH/RA/410102/N-01/(0)/2000	LORDS VIDEO PARLOUR

CARD	N-01/(0)
				GRADE	II-B
				ZONE	BYKE
				ZONE REF.	N 01
				CO-ORD.	H,21
				PLOT #	BP 1
				SURVEY #	276

1.0 NAME OF THE PROPERTY					
1.1	NAME	LORD'S VIDEO PARLOUR			
1.2	HISTORIC NAME	MATHERAN STORES / LORD'S STORES			
1.3	BUILT IN	1854 - 1900			
2.0 AREA (SQ. MTS.)

6.5	REFERENCES	Municipal Records / Map (1903-04) / DP 1987 / Books on Matheran / Field Surveys			
7.0 ARCHITECTURAL SYSTEMS IN THE STRUCTURE					
7.1	FOUND. & PLINTH	Stepped laterite foundation. Plinth in coursed laterite - exposed, pointed (parlour), stone clad, painted (restaurant).

9.0 PRESENT STATUS					
9.1	STRUC. STABILITY	Fair			
9.2	MAINTENANCE	Good - restaurant / Fair - video parlour			
10.0 REMARKS					
10.1	CONSERVATION & DEVELOPMENT	The video games parlour needs structural repairs and maintenance. The structures are representative of the original bazaar character of Matheran and contribute significantly to the streetscape. Non scope for additions and extensions except in the rear.

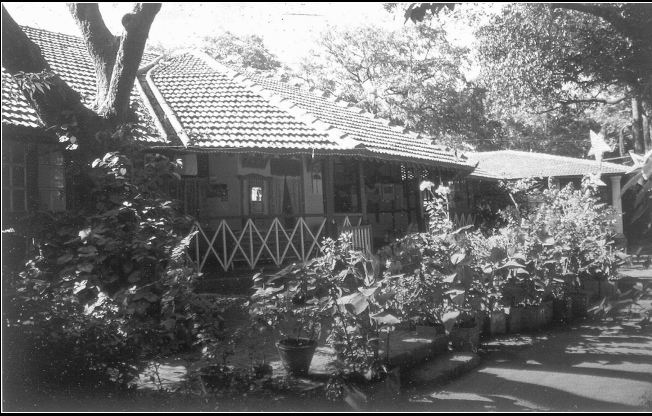
LOCATION		PIN	MH/RA/410102/N-02/(0)/2000	LORDS CENTRAL HOTEL

CARD	N-02/(0)
				GRADE	II-A
				ZONE	BYKE
				ZONE REF.	N 02
				CO-ORD.	H,21
				PLOT #	144, 145, BP 13
				SURVEY #	275, 273, 274

1.0 NAME OF THE PROPERTY					
1.1	NAME	LORDS CENTRAL HOTEL			
1.2	HISTORIC NAME	ALLIBHOY LODGE / SADAR LODGE (plt. no.144) / JACOB VILLA / GOMES BAKERY AND HOUSE (plt. no.145)

6.5	REFERENCES	Municipal Records / Map (1903-04) / DP 1987 / Books on Matheran / Field Surveys			
7.0 ARCHITECTURAL SYSTEMS IN THE STRUCTURE					
7.1	FOUND. & PLINTH	Stepped laterite foundation. Plinth in coursed laterite - pointed and painted with projecting plinth course.

8.2	STRUCTURE	None			
8.3	FINISHES	Plastering and painting of walls.			
9.0 PRESENT STATUS					
9.1	STRUC. STABILITY	Fair - All lodging and boarding building / Owner's bungalow - Needs structural repairs.

9.2	MAINTENANCE	Fair - All lodging and boarding building / Owner's bungalow - Needs structural repairs.			
10.0 REMARKS					
10.1	CONSERVATION & DEVELOPMENT	Excellent setting, well maintained structures (in their original state), sensitive landscaping and environment conscious management. The hotel is indeed the pride of Matheran. Contributes significantly to the townscape character, setting an ideal example for other hotels to follow. No scope for further additions and extensions.

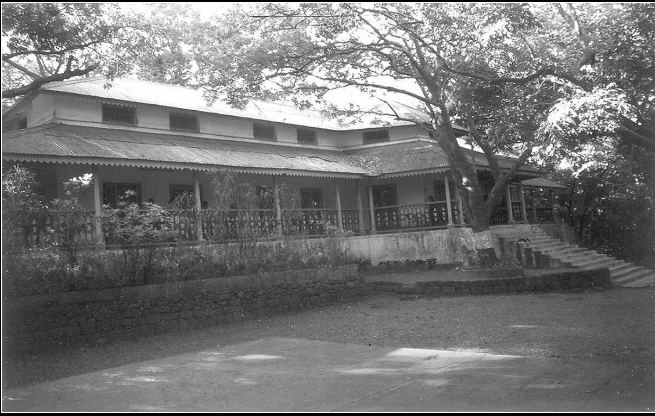
LOCATION		PIN	MH/RA/410102/N-03/(0)/2000	BOMBAY HOUSE HOLIDAY HOME

CARD	N-03/(0)
				GRADE	II-B
				ZONE	BYKE
				ZONE REF.	N 03
				CO-ORD.	H,22
				PLOT #	24
				SURVEY #	270

1.0 NAME OF THE PROPERTY					
1.1	NAME	BOMBAY HOUSE TATA'S HOLIDAY HOME			
1.2	HISTORIC NAME	SAND'S HOUSE / NEW SHIRINBAD / NEWTON'S BUNGALOW			
1.3	BUILT IN	1854 - 1900

6.5	REFERENCES	Municipal Records / Map (1903-04) / DP 1987 / Books on Matheran / Field Surveys			
7.0 ARCHITECTURAL SYSTEMS IN THE STRUCTURE					
7.1	FOUND. & PLINTH	Stepped laterite foundation. Plinth in coursed laterite - plastered and painted.

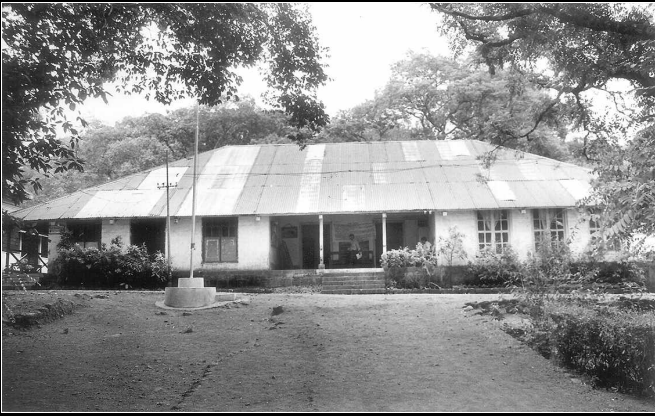
LOCATION		PIN	MH/RA/410102/N-05/(0)/2000	SUPERINTENDENT'S OFFICE

CARD	N-05/(0)
				GRADE	II-B
				ZONE	BYKE
				ZONE REF.	N 05
				CO-ORD.	G,23
				PLOT #	153B
				SURVEY #	251

1.0 NAME OF THE PROPERTY					
1.1	NAME	SUPERINTENDENT'S OFFICE AND STAFF QUARTERS			
1.2	HISTORIC NAME	SUPERINTENDENT'S OFFICE AND STAFF QUARTERS			
1.3	BUILT IN	1854 - 1900

6.5	REFERENCES	Municipal Records / Map (1903-04) / DP 1987 / Books on Matheran / Field Surveys			
7.0 ARCHITECTURAL SYSTEMS IN THE STRUCTURE					
7.1	FOUND. & PLINTH	Stepped laterite foundation. Plinth in coursed laterite - exposed and pointed.

9.1	STRUC. STABILITY	Fair			
9.2	MAINTENANCE	Fair			
10.0 REMARKS					
10.1	CONSERVATION & DEVELOPMENT	An informal administrative complex depicting the peculiar built form typology of Matheran. Additions to existing structures are not advisable. Detached additions may be permitted only in the eastern and southern open spaces provided they relate to the existing structures in form and scale and respect the existing forest cover.

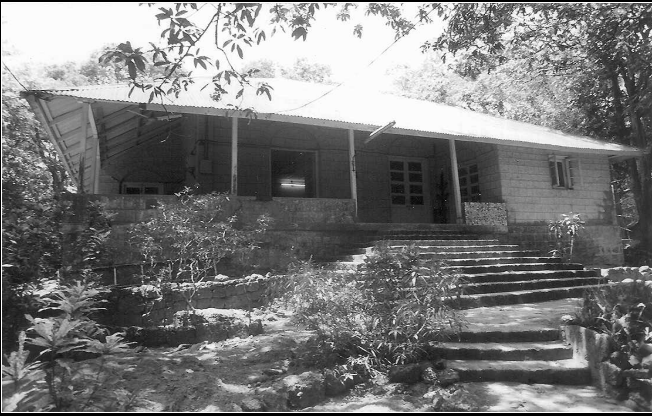
LOCATION		PIN	MH/RA/410102/N-06/(0)/2000	WALLACE BUNGALOW

CARD	N-06/(0)
				GRADE	II-B
				ZONE	BYKE
				ZONE REF.	N 06
				CO-ORD.	H,23
				PLOT #	4
				SURVEY #	247

1.0 NAME OF THE PROPERTY					
1.1	NAME	WALLACE BUNGALOW			
1.2	HISTORIC NAME	WALLACE BUNGALOW			
1.3	BUILT IN	1854 - 1900			
2.0 AREA (SQ. MTS.)					
2.1	PLOT AREA	21246.00

6.5	REFERENCES	Municipal Records / Map (1903-04) / DP 1987 / Books on Matheran / Field Surveys			
7.0 ARCHITECTURAL SYSTEMS IN THE STRUCTURE					
7.1	FOUND. & PLINTH	Stepped laterite foundation. Plinth in coursed laterite - exposed and pointed.

8.3	FINISHES	Painting and raised pointing of walls and verandah railing replaced by brick masonry parapet wall.			
9.0 PRESENT STATUS					
9.1	STRUC. STABILITY	Fair

9.2	MAINTENANCE	Fair			
10.0 REMARKS					
10.1	CONSERVATION & DEVELOPMENT	<p>Commanding location, excellent setting and historic landscaping surviving till date. The main bungalow requires regular maintenance and upkeep. The changes in the finishes of the structure have not been carried out very sensitively. Attached additions are not advisable. Detached additions may be permitted in the south and south-west of the structure provided they relate sensitively to the existing building and respect the forest cover.</p>

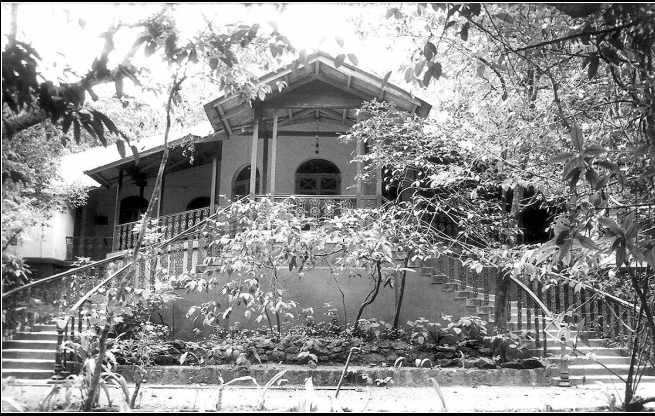
LOCATION		PIN	MH/RA/410102/N-07/(0)/2000	KEKI LODGE

CARD	N-07/(0)	
			GRADE	II-B	
			ZONE	BYKE	
			ZONE REF.	N 07	
			CO-ORD.	G,24	
			PLOT #	147	
			SURVEY #	250

1.0 NAME OF THE PROPERTY					
1.1	NAME	KEKI LODGE			
1.2	HISTORIC NAME	KITTY LODGE			
1.3	BUILT IN	1854 - 1900			
2.0 AREA (SQ. MTS.)					
2.1	PLOT AREA	4932.10

6.5	REFERENCES	Municipal Records / Map (1903-04) / DP 1987 / Books on Matheran / Field Surveys			
7.0 ARCHITECTURAL SYSTEMS IN THE STRUCTURE					
7.1	FOUND. & PLINTH	Stepped laterite foundation. Plinth in coursed laterite - plastered and painted.

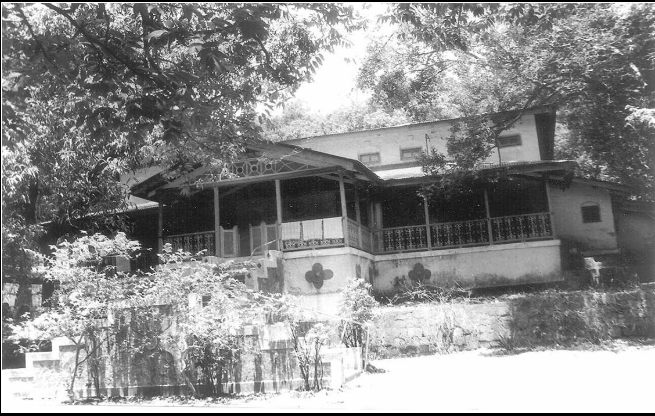
LOCATION	PIN	MH/RA/410102/N-09/(0)/2000	NERAL VILLA

6.5	REFERENCES	Municipal Records / Map (1903-04) / DP 1987 / Books on Matheran / Field Surveys		
7.0	ARCHITECTURAL SYSTEMS IN THE STRUCTURE			
7.1	FOUND. & PLINTH	Stepped laterite foundation. Plinth in coursed laterite - exposed and pointed.

9.2	MAINTENANCE	Fair		
10.0	REMARKS			
10.1	CONSERVATION & DEVELOPMENT	A well maintained structure with a wide foreground and contributing to the townscape character of Matheran. Attached additions are not advisable. Detached additions should not be permitted in the foreground. These may be permitted in the west provided they relate sensitively to the existing structure in form, scale and treatment and respect the existing forest cover.

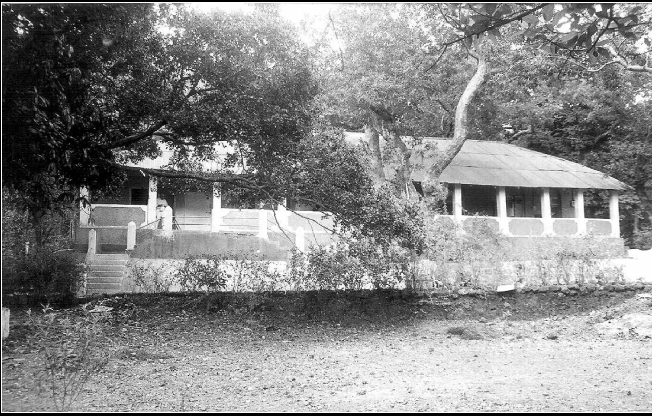
LOCATION	PIN	MH/RA/410102/N-10/(0)/2000	HOTEL GIRIVIHAR

6.5	REFERENCES	Municipal Records / Map (1903-04) / DP 1987 / Books on Matheran / Field Surveys		
7.0	ARCHITECTURAL SYSTEMS IN THE STRUCTURE			
7.1	FOUND. & PLINTH	Stepped laterite foundation. Plinth in coursed laterite - plastered and painted.

8.0	TRANSFORMATION			
8.1	FORM	None		
8.2	STRUCTURE	Timber posts in verandah replaced by masonry piers.		
8.3	FINISHES	Railing of verandah replaced by masonry parapet walls and plastering and painting of walls.

9.0	PRESENT STATUS			
9.1	STRUC. STABILITY	Fair		
9.2	MAINTENANCE	Unsatisfactory		
10.0	REMARKS			
10.1	CONSERVATION & DEVELOPMENT	A historically significant building complex representing the local typology but major changes in the finishes have affected the historic integrity. The structures require regular maintenance and upkeep. Detached additions are not advisable in the foreground of the buildings.

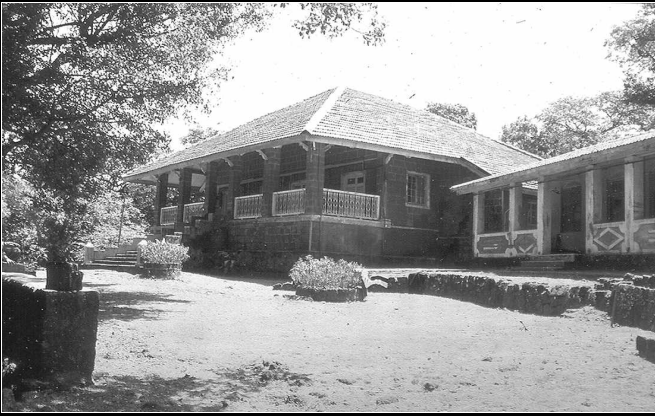
LOCATION		PIN	MH/RA/410102/N-11/(0)/2000	PARADISE LODGE

6.5	REFERENCES	Municipal Records / Map (1903-04) / DP 1987 / Books on Matheran / Field Surveys			
7.0 ARCHITECTURAL SYSTEMS IN THE STRUCTURE					
7.1	FOUND. & PLINTH	Stepped laterite foundation. Plinth in coursed laterite - exposed and pointed with a projecting course on the top.

10.0 REMARKS					
10.1	CONSERVATION & DEVELOPMENT	Excellent building with outstanding architectural value. Attached additions are not advisable. Detached additions may be permitted only in the open space in the east and south of the bungalow, provided they relate sensitively to the bungalow in terms of form, scale and treatment and respect the existing forest cover on the site.

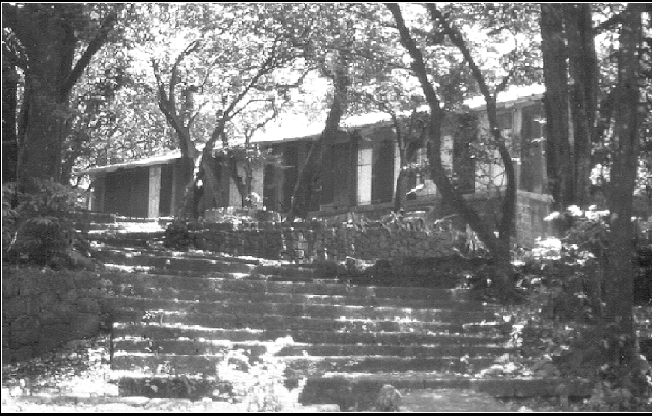
LOCATION		PIN	MH/RA/410102/N-12/(0)/2000	BOMBAY DYEING HOLIDAY HOME

6.5	REFERENCES	Municipal Records / Map (1903-04) / DP 1987 / Books on Matheran / Field Surveys			
7.0 ARCHITECTURAL SYSTEMS IN THE STRUCTURE					
7.1	FOUND. & PLINTH	Stepped laterite foundation. Plinth in coursed laterite - exposed and pointed.

8.1	FORM	None			
8.2	STRUCTURE	None			
8.3	FINISHES	None			
9.0 PRESENT STATUS					
9.1	STRUC. STABILITY	Fair			
9.2	MAINTENANCE	Poor			
10.0 REMARKS					
10.1	CONSERVATION & DEVELOPMENT	A well planned complex and one of the most beautiful layouts in Matheran where natural and manmade landscape features are very well integrated. But unfortunately not very well maintained and presently not in active use. If the structures are maintained it holds immense potential for future use. Detached additions may be permitted provided they relate sensitively to the old buildings and respect the existing forest cover.
