MATHERAN:
A COMPREHENSIVE HERITAGE LISTING
PROPOSAL

FINAL REPORT
VOLUME III & IV

PROJECT CONSULTANT
K. UNWALLA ARCHITECTS

FOR
**M.M.R. HERITAGE CONSERVATION
SOCIETY**

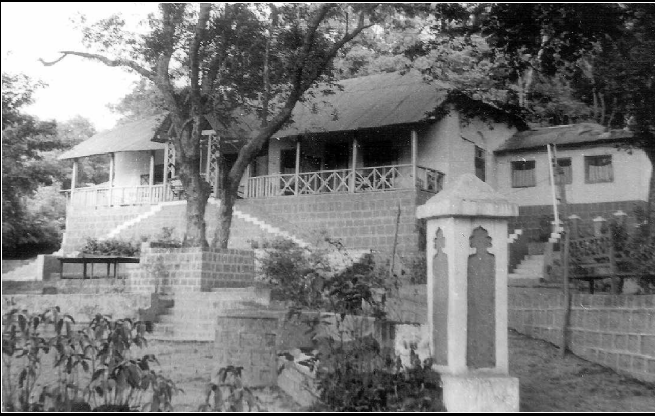
LOCATION		PIN	MH/RA/410102/N-13/(0)/2000	HOTEL SHIRIN

6.5	REFERENCES	Municipal Records / Map (1903-04) / DP 1987 / Books on Matheran / Field Surveys			
7.0	ARCHITECTURAL SYSTEMS IN THE STRUCTURE				
7.1	FOUND. & PLINTH	Stepped laterite foundation. Plinth in coursed laterite - exposed and pointed.

8.0	TRANSFORMATION				
8.1	FORM	Rear verandah enclosed for hotel use.			
8.2	STRUCTURE	None			
8.3	FINISHES	Plastering and painting of walls and original railing has been replaced in parts.

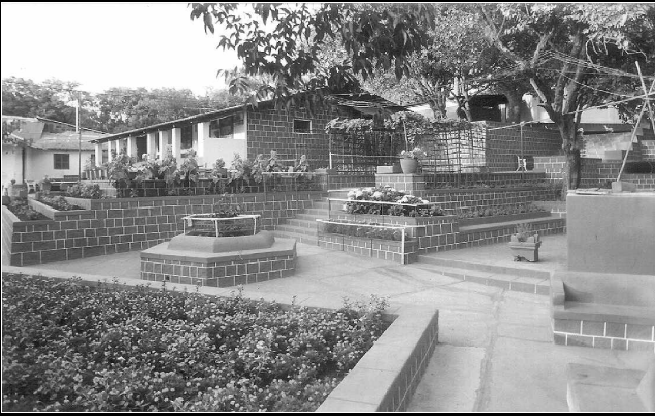
LOCATION		PIN	MH/RA/410102/N-15/(0)/2000	MANEKLAL TERRACE

6.5	REFERENCES	Municipal Records / Map (1903-04) / DP 1987 / Books on Matheran / Field Surveys			
7.0 ARCHITECTURAL SYSTEMS IN THE STRUCTURE					
7.1	FOUND. & PLINTH	Stepped laterite foundation. Plinth in coursed laterite - painted with red cement paint with white pointing lines.

9.0 PRESENT STATUS					
9.1	STRUC. STABILITY	Good			
9.2	MAINTENANCE	Good			
10.0 REMARKS					
10.1	CONSERVATION & DEVELOPMENT	<p>A very well maintained, well designed and neatly kept landscape on terraces with a good setting of the buildings on the terraces. The natural although extensively paved is very organic and blends well with the natural surrounding. A good example of a holiday home in a place like Matheran. New additions should relate sensitively to the existing built form typology and the landscape.</p>

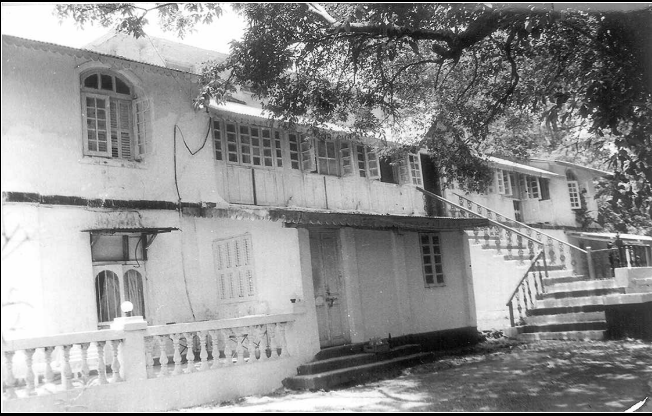
LOCATION		PIN	MH/RA/410102/N-16/(0)/2000	HOTEL ALEXANDER

6.5	REFERENCES	Municipal Records / Map (1903-04) / DP 1987 / Books on Matheran / Field Surveys			
7.0 ARCHITECTURAL SYSTEMS IN THE STRUCTURE					
7.1	FOUND. & PLINTH	Stepped laterite foundation. Plinth in coursed laterite - partly painted and partly plastered and painted.

10.0 REMARKS					
10.1	CONSERVATION & DEVELOPMENT	<p>The main bungalow needs repairs and regular maintenance. The building with its high plinth assumes a great height and being associated with the Alexander point holds landmark value. The large number of new additions on the site are highly incongruous with the old building as well as with the surrounding in terms of form and colour scheme. No scope for future developments.</p>

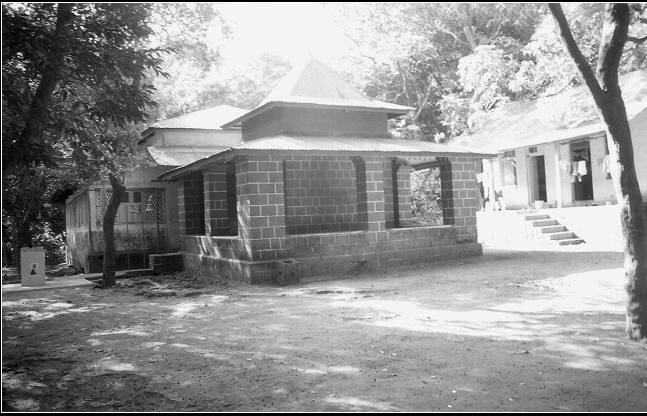
LOCATION		PIN	MH/RA/410102/P-01/(0)/2000	PISARNATH MANDIR

6.5	REFERENCES	Municipal Records / Map (1903-04) / DP 1987 / Books on Matheran / Field Surveys			
7.0 ARCHITECTURAL SYSTEMS IN THE STRUCTURE					
7.1	FOUND. & PLINTH	Stepped laterite foundation. Plinth in coursed laterite - exposed, pointed and dressed.

9.1	STRUC. STABILITY	Fair			
9.2	MAINTENANCE	Fair			
10.0 REMARKS					
10.1	CONSERVATION & DEVELOPMENT	A significant structure of social relevance holding a landmark value by being associated with an important location adjacent to Charlotte lake. The structure represents the local built form typology. Its elaborate entranceway and façade to foreground relationship needs to be preserved. Additions on the site should respect this relationship, should relate sensitively to the original building and should not damage the existing forest cover.

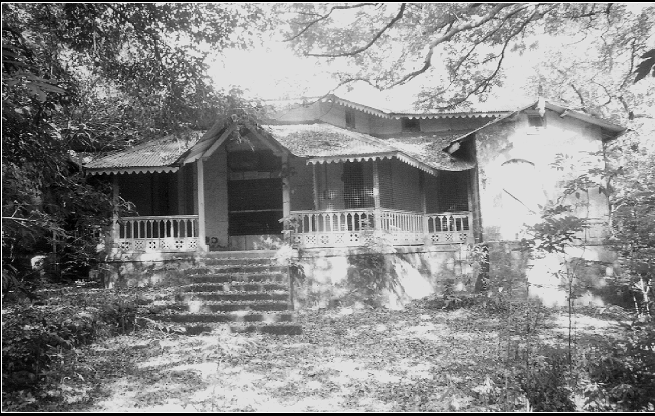
LOCATION		PIN	MH/RA/410102/P-02/(0)/2000	WEST GRANGE

6.5	REFERENCES	Municipal Records / Map (1903-04) / DP 1987 / Books on Matheran / Field Surveys			
7.0 ARCHITECTURAL SYSTEMS IN THE STRUCTURE					
7.1	FOUND. & PLINTH	Stepped laterite foundation. Plinth in coursed laterite - exposed.

10.0 REMARKS					
10.1	CONSERVATION & DEVELOPMENT	<p>The building has a strategic location with a commanding view but is presently in a state of neglect. The structure and the site hold potential for future use as a residence or corporate guest house. New additions on the site must relate sensitively to the existing building in form, scale and treatment and respect the dense forest cover.</p>

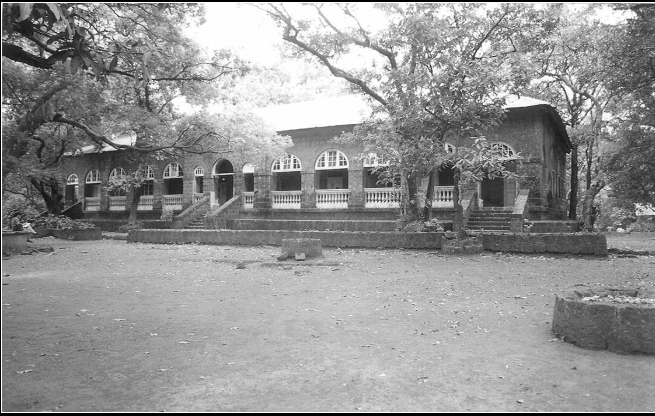
LOCATION		PIN	MH/RA/410102/P-03/(0)/2000	FOUNTAIN LODGE

6.5	REFERENCES	Municipal Records / Map (1903-04) / DP 1987 / Books on Matheran / Field Surveys			
7.0	ARCHITECTURAL SYSTEMS IN THE STRUCTURE				
7.1	FOUND. & PLINTH	Stepped laterite foundation. Plinth in coursed laterite - stepped, exposed and pointed.

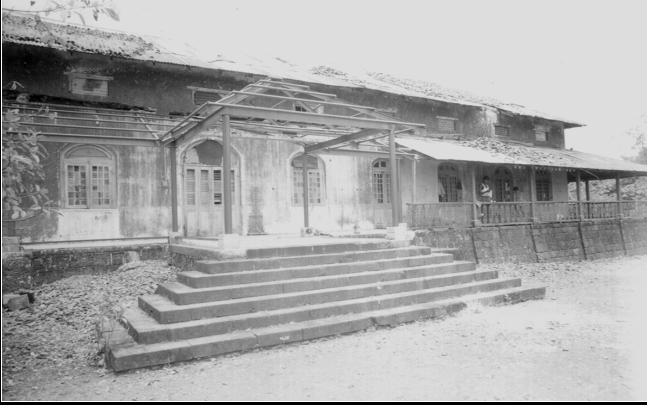
LOCATION		PIN	MH/RA/410102/P-05/(0)/2000	BYRAMJEE HOUSE

6.5	REFERENCES	Municipal Records / Map (1903-04) / DP 1987 / Books on Matheran / Field Surveys			
7.0		ARCHITECTURAL SYSTEMS IN THE STRUCTURE			
7.1	FOUND. & PLINTH	Stepped laterite foundation. Plinth in coursed laterite - exposed with vertical projecting courses like buttresses.

8.0		TRANSFORMATION			
8.1	FORM	None			
8.2	STRUCTURE	Verandah timber roof structure partly replaced by steel members.			
8.3	FINISHES	Plastering and painting of walls.

9.0		PRESENT STATUS			
9.1	STRUC. STABILITY	Fair			
9.2	MAINTENANCE	Poor			
10.0		REMARKS			
10.1	CONSERVATION & DEVELOPMENT	<p>Remarkable setting and grand interiors with elaborate furniture symbolic of the lifestyle and the social status of the owners in the historic period. The structure holds great potential to be developed as a corporate guest house which will also ensure its regular maintenance. New additions on the site should not disturb the facade to foreground relationship in the west and should relate sensitively to the it in form, scale and treatment.</p>

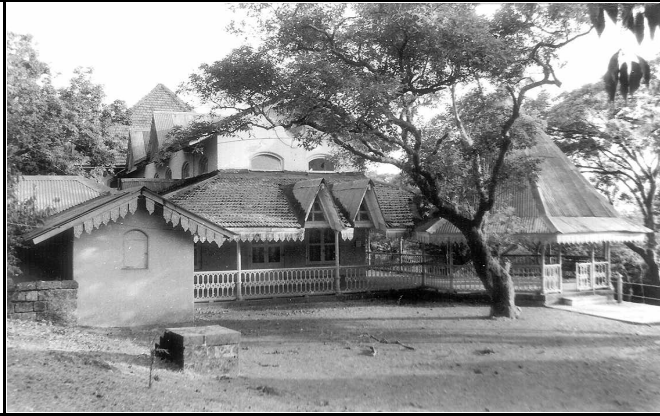
LOCATION		PIN	MH/RA/410102/P-06/(0)/2000	GULESTAN

6.5	REFERENCES	Municipal Records / Map (1903-04) / DP 1987 / Books on Matheran / Field Surveys			
7.0 ARCHITECTURAL SYSTEMS IN THE STRUCTURE					
7.1	FOUND. & PLINTH	Stepped laterite foundation. Plinth in coursed laterite - exposed & tapering (broad at the base and narrow at the top).

10.1	CONSERVATION & DEVELOPMENT	<p>The longest and the most grand building in Matheran, holding immense architectural significance. Ideal for residential use or use as a guest house. Attached additions not to be permitted. Detached additions may be permitted only in the south provided they realte sensitively to teh main building in form, scale and treatment and respect the existing forest cover.</p>

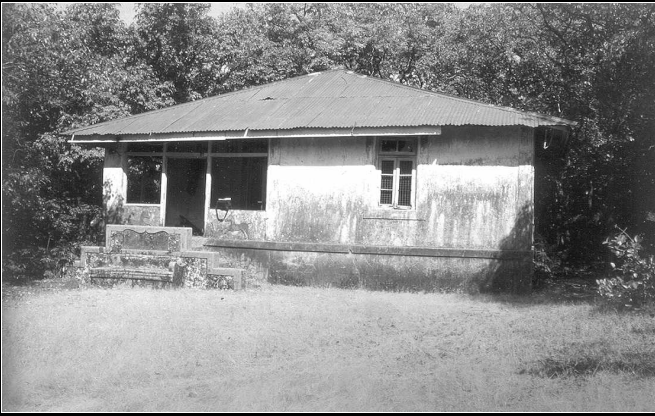
LOCATION		PIN	MH/RA/410102/P-08/(0)/2000	INDU KUTIR

6.5	REFERENCES	Municipal Records / Map (1903-04) / DP 1987 / Books on Matheran / Field Surveys			
7.0 ARCHITECTURAL SYSTEMS IN THE STRUCTURE					
7.1	FOUND. & PLINTH	Stepped laterite foundation. Plinth in coursed laterite - plastered and painted with projecting plinth course.

9.2	MAINTENANCE	Fair			
10.0 REMARKS					
10.1	CONSERVATION & DEVELOPMENT	<p>The buildings are structurally in a sound condition and can continue their present use or be put to adaptive re-use. Attached additions should not be permitted. Detached additions may be permitted on the site provided the pathway from the entrance and the layout is retained.</p>

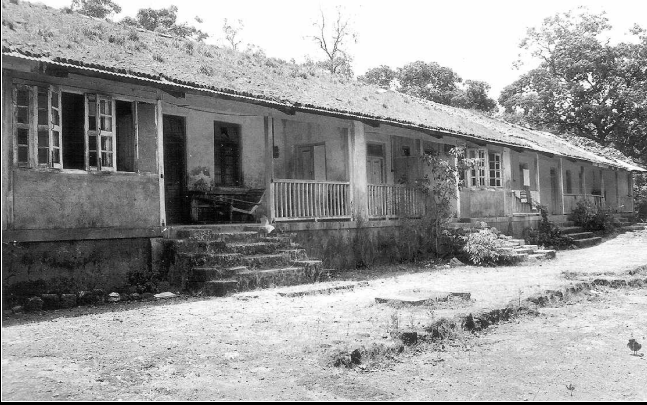
LOCATION	PIN	MH/RA/410102/P-07/(0)/2000	SHARDA VILLA

6.5	REFERENCES	Municipal Records / Map (1903-04) / DP 1987 / Books on Matheran / Field Surveys		
7.0	ARCHITECTURAL SYSTEMS IN THE STRUCTURE			
7.1	FOUND. & PLINTH	Stepped laterite foundation. Plinth in coursed laterite - exposed with projecting plinth course at the top.

10.0	REMARKS			
10.1	CONSERVATION & DEVELOPMENT	The independent building on the south is in a ruinous condition and may demolished for reconstruction. The other two buildings are structurally sound but they need regular maintenance. Detached additions on the site may be permitted provided they relate sensitively to the existing layout and the built forms and respect the forest cover on the site.

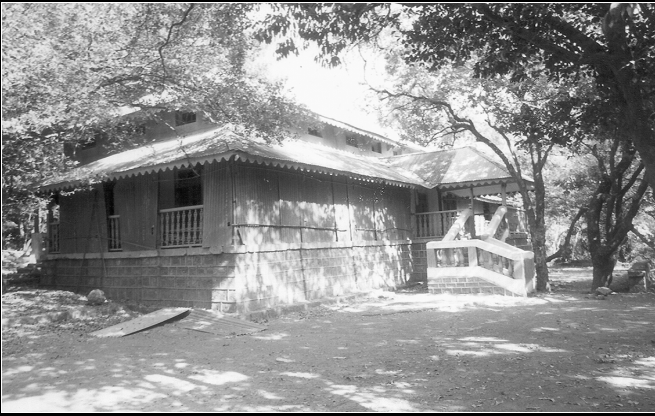
LOCATION		PIN	MH/RA/410102/P-10/(0)/2000	SHERA COTTAGE

6.5	REFERENCES	Municipal Records / Map (1903-04) / DP 1987 / Books on Matheran / Field Surveys			
7.0 ARCHITECTURAL SYSTEMS IN THE STRUCTURE					
7.1	FOUND. & PLINTH	Stepped laterite foundation. Plinth in coursed laterite - exposed and raised pointed.

8.0 TRANSFORMATION					
8.1	FORM	None			
8.2	STRUCTURE	None			
8.3	FINISHES	Plastering & painting. Original balustrade on entrance steps & railing on rear verandah replaced by the same in RCC.

9.0 PRESENT STATUS					
9.1	STRUC. STABILITY	Fair			
9.2	MAINTENANCE	Fair			
10.0 REMARKS					
10.1	CONSERVATION & DEVELOPMENT	<p>The building represents the built form typology of Matheran but the addition of the new RCC balustrade on the entrance steps and RCC railing along the rear verandah is completely incongruous in scale and treatment. This very prominent addition adversely affects the architectural value and the historic integrity of the bungalow. No scope for further additions and extensions.</p>

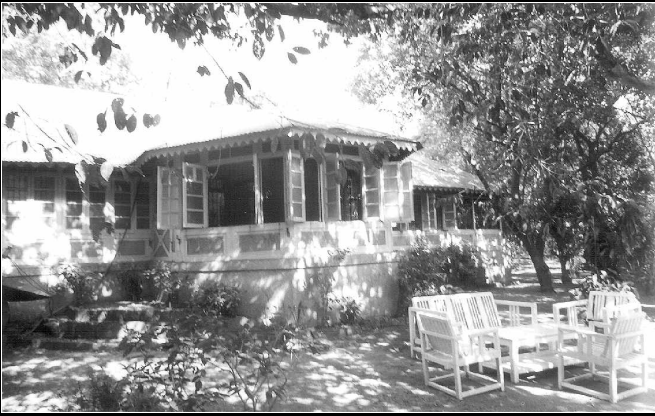
LOCATION		PIN	MH/RA/410102/P-11/(0)/2000	BELVEDERE LODGE

6.5	REFERENCES	Municipal Records / Map (1903-04) / DP 1987 / Books on Matheran / Field Surveys			
7.0 ARCHITECTURAL SYSTEMS IN THE STRUCTURE					
7.1	FOUND. & PLINTH	Stepped laterite foundation. Plinth in coursed laterite - plastered and painted.

8.3	FINISHES	Plastering and painting of walls.			
9.0 PRESENT STATUS					
9.1	STRUC. STABILITY	Fair			
9.2	MAINTENANCE	Good			
10.0 REMARKS					
10.1	CONSERVATION & DEVELOPMENT	Well maintained structure and setting contributing to the townscape character. Its significance lies in its association with important natural view point. There is little scope additions and extensions on the site.

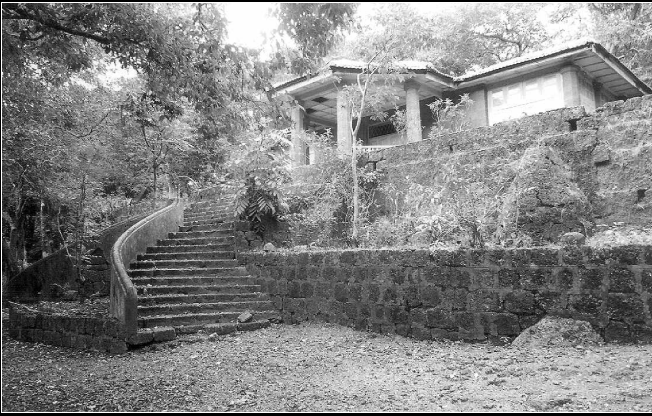
LOCATION		PIN	MH/RA/410102/Q-01/(0)/2000	ANNIE VILLA

6.5	REFERENCES	Municipal Records / Map (1903-04) / DP 1987 / Books on Matheran / Field Surveys			
7.0 ARCHITECTURAL SYSTEMS IN THE STRUCTURE					
7.1	FOUND. & PLINTH	Stepped laterite foundation. Plinth in coursed laterite - exposed and pointed.

8.0 TRANSFORMATION					
8.1	FORM	None			
8.2	STRUCTURE	Guest block - RCC columns have replaced the original columns for structural strengthening.			
8.3	FINISHES	None

9.0 PRESENT STATUS					
9.1	STRUC. STABILITY	Fair			
9.2	MAINTENANCE	Good			
10.0 REMARKS					
10.1	CONSERVATION & DEVELOPMENT	Excellent setting and historic landscape tailored for the topography. The built form and setting significantly contribute to the townscape character. No additions are advisable in the foreground of the building. Existing ancillary structures may be modified and put to adaptive re-use if necessary.

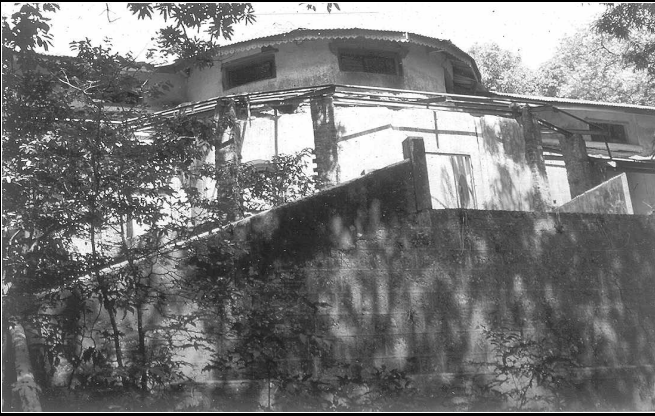
LOCATION		PIN	MH/RA/410102/Q-02/(0)/2000	WADIA LODGE

6.5	REFERENCES	Municipal Records / Map (1903-04) / DP 1987 / Books on Matheran / Field Surveys			
7.0 ARCHITECTURAL SYSTEMS IN THE STRUCTURE					
7.1	FOUND. & PLINTH	Stepped laterite foundation. Plinth in coursed laterite - exposed and pointed.

7.7	DECO. ELEMENTS & INTERIORS	Decorative leaded (stained) glass on the entrance door.			
8.0 TRANSFORMATION					
8.1	FORM	None			
8.2	STRUCTURE	Timber posts in verandah replaced by masonry piers and timber roof structure replaced by steel structural system.

8.3	FINISHES	None			
9.0 PRESENT STATUS					
9.1	STRUC. STABILITY	Fair			
9.2	MAINTENANCE	Very Poor			
10.0 REMARKS					
10.1	CONSERVATION & DEVELOPMENT	<p>The structure and its setting holds great potential for conservation and meaningful future use. The bungalow is in urgent need of structural strengthening, repairs and maintenance. Detached additions may be permitted to the south of the structure, provided they relate sensitively to it in form and scale.</p>

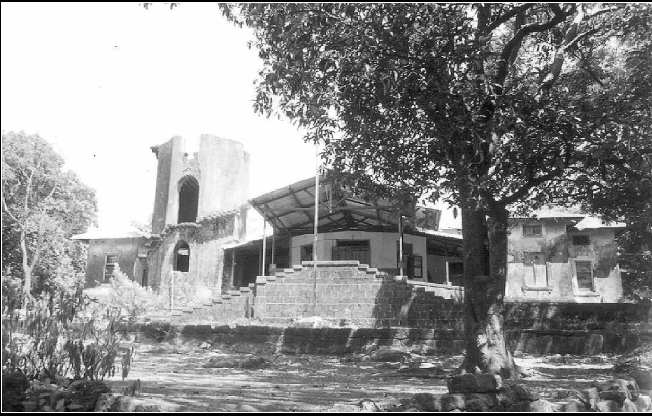
LOCATION		PIN	MH/RA/410102/Q-03/(0)/2000	SARASWATI MANDIR SCHOOL

CARD	Q-03/(0)
				GRADE	II-B
				ZONE	OLYMPIA
				ZONE REF.	Q 03
				CO-ORD.	G,26-27
				PLOT #	1
				SURVEY #	241

1.0 NAME OF THE PROPERTY					
1.1	NAME	SARASWATI MANDIR SCHOOL			
1.2	HISTORIC NAME	CASTLE HILL AND BASCOBEL			
1.3	BUILT IN	1867 - 1877			
2.0 AREA (SQ. MTS.)

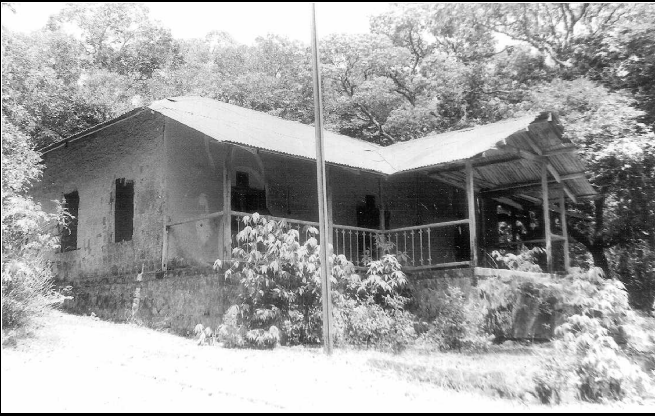
LOCATION	PIN	MH/RA/410102/Q-04/(0)/2000	FLORENCE LODGE

6.5	REFERENCES	Municipal Records / Map (1903-04) / DP 1987 / Books on Matheran / Field Surveys		
7.0	ARCHITECTURAL SYSTEMS IN THE STRUCTURE			
7.1	FOUND. & PLINTH	Stepped laterite foundation. Plinth in coursed laterite - plastered and painted.

10.0	REMARKS			
10.1	CONSERVATION & DEVELOPMENT	Structures and setting represent the townscape character of Matheran but presently are in a dilapidated condition and a very poor state of maintenance. The site holds potential for conservation and adaptive re-use in the future.

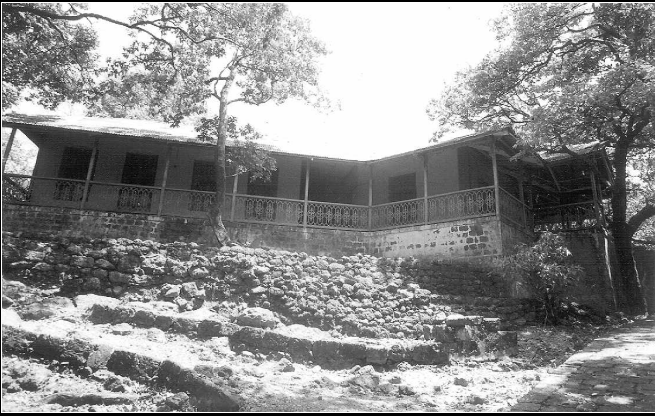
LOCATION		PIN	MH/RA/410102/Q-05/(0)/2000	MOUNT PABNEY

6.5	REFERENCES	Municipal Records / Map (1903-04) / DP 1987 / Books on Matheran / Field Surveys			
7.0 ARCHITECTURAL SYSTEMS IN THE STRUCTURE					
7.1	FOUND. & PLINTH	Stepped laterite foundation. Plinth in coursed laterite - exposed and pointed.

10.0 REMARKS					
10.1	CONSERVATION & DEVELOPMENT	<p>The structure and its setting contribute to the townscape character with a unique planform and significant architectural value. Attached additions are not advisable. The structure holds potential for continuing its present use or conducive adaptive re-use. Detached additions may be allowed in the north and north-west provided they relate sensitively to the bungalow in form, scale and treatment and respect the existing forest cover.</p>

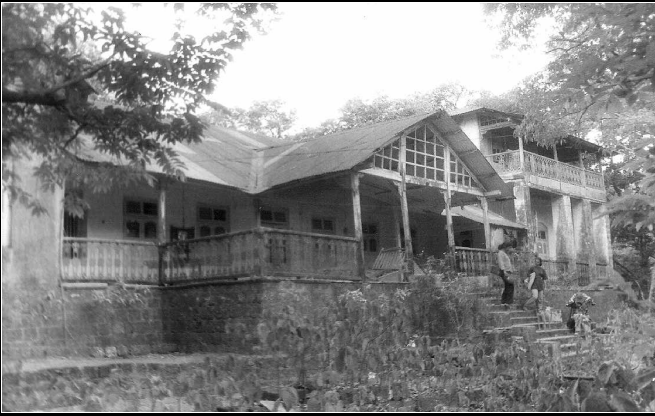
LOCATION		PIN	MH/RA/410102/Q-07/(0)/2000	UNDERWOOD LODGE

6.5	REFERENCES	Municipal Records / Map (1903-04) / DP 1987 / Books on Matheran / Field Surveys			
7.0 ARCHITECTURAL SYSTEMS IN THE STRUCTURE					
7.1	FOUND. & PLINTH	Stepped laterite foundation. Plinth in coursed laterite - exposed and pointed.

8.0 TRANSFORMATION					
8.1	FORM	None			
8.2	STRUCTURE	Original posts in the verandah of the guest block have been replaced by laterite masonry piers.

8.3	FINISHES	Plastering and painting of walls.			
9.0 PRESENT STATUS					
9.1	STRUC. STABILITY	Fair			
9.2	MAINTENANCE	Unsatisfactory			
10.0 REMARKS					
10.1	CONSERVATION & DEVELOPMENT	<p>The site and structure have significant architectural value and historic integrity but the structure is in need of structural repairs and regular maintenance and the landscape needs refurbishing. It holds potential for future use as a residence or other adaptive re-use conducive to the structure. No scope for additions and extensions.</p>

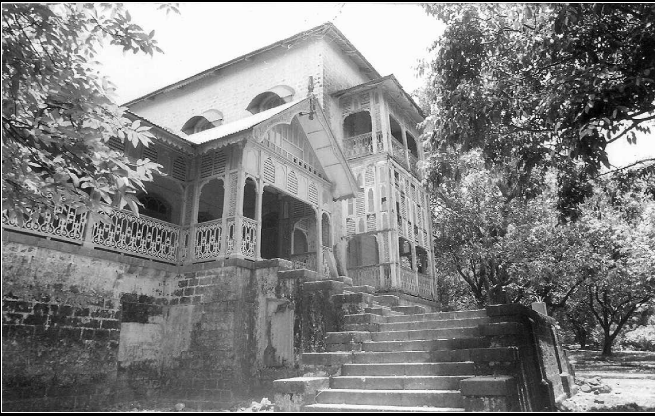
LOCATION		PIN	MH/RA/410102/Q-09/(0)/2000	PASTA HOUSE

6.5	REFERENCES	Municipal Records / Map (1903-04) / DP 1987 / Books on Matheran / Field Surveys			
7.0 ARCHITECTURAL SYSTEMS IN THE STRUCTURE					
7.1	FOUND. & PLINTH	Stepped laterite foundation. Plinth in coursed laterite - exposed and pointed.

9.2	MAINTENANCE	Excellent			
10.0 REMARKS					
10.1	CONSERVATION & DEVELOPMENT	<p>One of the most well maintained buildings with unique architectural qualities in terms of façade treatment, skilful craftsmanship in timber work and finishes retained till date. Its current residential use is conducive but adaptive re-use may be permitted provided the setting of the buildings and the layout remains undisturbed. No scope for further additions and extensions. Its commendable maintenance is a good example for others to follow.</p>

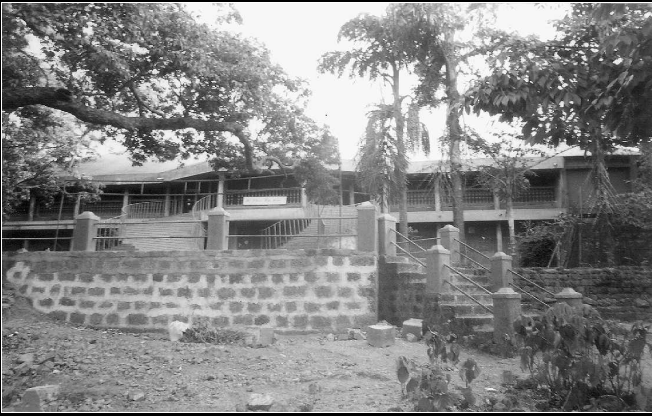
LOCATION		PIN	MH/RA/410102/Q-10/(0)/2000	ST. XAVIER'S SCHOOL

6.5	REFERENCES	Municipal Records / Map (1903-04) / DP 1987 / Books on Matheran / Field Surveys			
7.0 ARCHITECTURAL SYSTEMS IN THE STRUCTURE					
7.1	FOUND. & PLINTH	Stepped laterite foundation. Plinth in coursed laterite - plastered and painted.

9.0 PRESENT STATUS					
9.1	STRUC. STABILITY	Good			
9.2	MAINTENANCE	Good			
10.0 REMARKS					
10.1	CONSERVATION & DEVELOPMENT	<p>The historic integrity of the building has been lost to some extent due to the addition of a complete RCC envelope to the it to support the new RCC roof. The new attached wing in the rear north-west is cohesive with the original building in form, scale, treatment and colour scheme. Future additions and extensions should follow this example.</p>

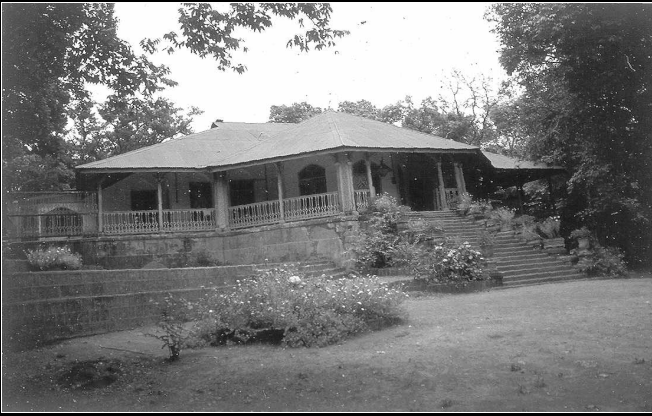
LOCATION		PIN	MH/RA/410102/Q-11/(0)/2000	DASWOOD

6.5	REFERENCES	Municipal Records / Map (1903-04) / DP 1987 / Books on Matheran / Field Surveys			
7.0 ARCHITECTURAL SYSTEMS IN THE STRUCTURE					
7.1	FOUND. & PLINTH	Stepped laterite foundation. Plinth in coursed laterite - exposed and pointed.

10.0 REMARKS					
10.1	CONSERVATION & DEVELOPMENT	<p>The remarkably grand structure contributes to the townscape character. The property is well maintained and in active use. Detached additions may be allowed provided they retain the existing setting of the buildings and landscape, their facade to foreground relationship and relate sensitively to the existing buildings in form, scale and treatment.</p>

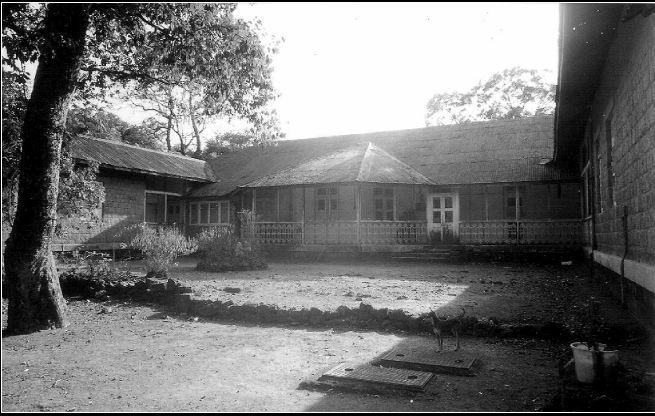
LOCATION	PIN	MH/RA/410102/Q-12/(0)/2000	RUSTOM VILLA

6.5	REFERENCES	Municipal Records / Map (1903-04) / DP 1987 / Books on Matheran / Field Surveys		
7.0	ARCHITECTURAL SYSTEMS IN THE STRUCTURE			
7.1	FOUND. & PLINTH	Stepped laterite foundation. Plinth in coursed laterite - exposed with a projecting plinth course, plastered & painted.

9.2	MAINTENANCE	Good		
10.0	REMARKS			
10.1	CONSERVATION & DEVELOPMENT	A well maintained structure and its surrounding contributing to the townscape character. Detached additions may be permitted only in the north, east and south of the structure provided they relate sensitively to the main building in form, scale and treatment and respect the existing forest cover.

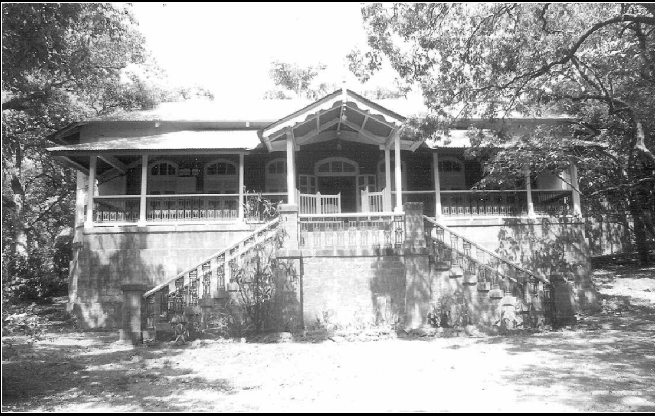
LOCATION		PIN	MH/RA/410102/Q-13/(0)/2000	GOLDCROFT

5.0 USAGE					
5.1	PAST USAGE	Residential			
5.2	PRESENT USAGE	Residential			
6.0 LISTING CRITERIA & REFERENCE					
6.1	ARCHITECTURAL DESCRIPTION	<p>The layout consists of the main bungalow, a double storeyed guest block (dilapidated condition) in the rear close to the bungalow and servants' quarters set on terraces levelled off from a site sloping from westwards. The property is popular for its unique rock formations with caves (locally believed to have a Panthers cave). The west facing single storeyed bungalow has a symmetrical planform with a central living room flanked on both sides by two bedrooms placed in double layered fashion with toilets and dressing rooms in the rear, a full length front verandah and a recessed rear verandah. The two bedrooms in the front project out from the sides with a half-hexagonal wall profile (like bay windows). The front facade has an elaborate treatment with a high plinth, a small squarish projecting porch with a grand flight of bifurcating stairs leading up which are designed to compose with the front facade of the building. The main rooms have higher walls and a linear hipped roof with half-hexagonal hipped ends. Over the front and rear verandahs are lean-to-roofs with hipped ends intercepted centrally in the front and rear by gable ended projections.</p>

6.5	REFERENCES	Municipal Records / Map (1903-04) / DP 1987 / Books on Matheran / Field Surveys			
7.0 ARCHITECTURAL SYSTEMS IN THE STRUCTURE					
7.1	FOUND. & PLINTH	Stepped laterite foundation. Plinth in coursed laterite - exposed and pointed with projecting plinth course plastered.

9.2	MAINTENANCE	Main bungalow - Good / Guest block - Poor			
10.0 REMARKS					
10.1	CONSERVATION & DEVELOPMENT	<p>A well maintained bungalow contributing to the townscape character but the guest block, needs urgent structural repairs. The main building has significant architectural value. The site holds importance due to its unique geological formations which have to be retained. Attached additions are not advisable. Detached additions may be permitted only in the north and south provided they relate sensitively to the existing building in form, scale and treatment.</p>

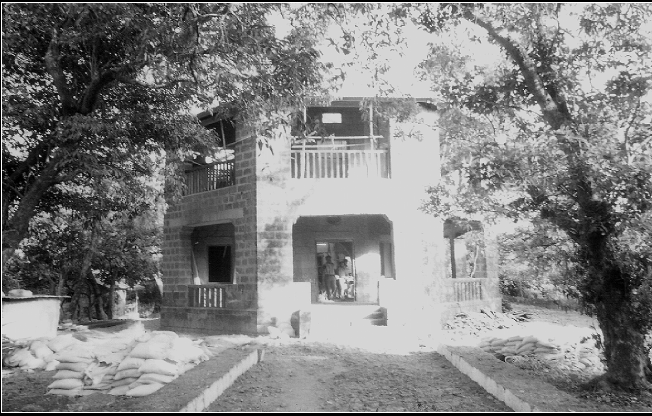
LOCATION		PIN	MH/RA/410102/Q-15/(0)/2000	BHEDWAR BUNGALOW

6.5	REFERENCES	Municipal Records / Map (1903-04) / DP 1987 / Books on Matheran / Field Surveys			
7.0 ARCHITECTURAL SYSTEMS IN THE STRUCTURE					
7.1	FOUND. & PLINTH	Stepped laterite foundation. Plinth in coursed laterite - plastered and painted.

8.0 TRANSFORMATION					
8.1	FORM	Addition of a patio on the west.			
8.2	STRUCTURE	Structural repairs have been carried out in the recent past with steel members replacing some timber members.

8.3	FINISHES				
9.0 PRESENT STATUS					
9.1	STRUC. STABILITY	Good			
9.2	MAINTENANCE	Good			
10.0 REMARKS					
10.1	CONSERVATION & DEVELOPMENT	On account of its unique planform with a viewing tower, the buildings holds significant architectural and landmark value. The building has been recently restored with a number of cohesive and sensitive structural interventions. No scope for additions and extensions. Note: The structure was under renovation while the survey was undertaken.

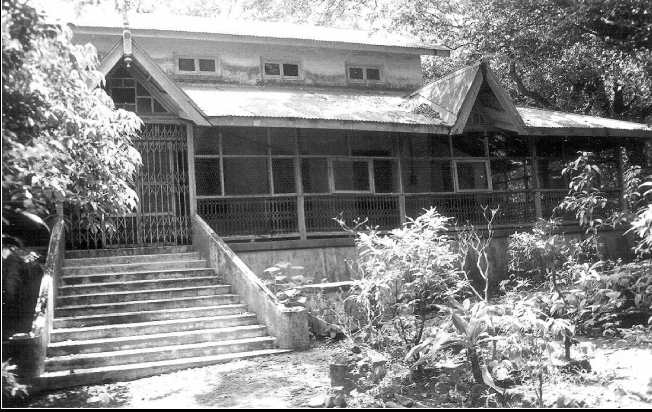
LOCATION		PIN	MH/RA/410102/Q-06/(0)/2000	KASTUR KUNJ

6.5	REFERENCES	Municipal Records / Map (1903-04) / DP 1987 / Books on Matheran / Field Surveys			
7.0 ARCHITECTURAL SYSTEMS IN THE STRUCTURE					
7.1	FOUND. & PLINTH	Stepped laterite foundation. Plinth in coursed laterite - plastered and painted.

8.3	FINISHES	Plastering and painting of walls.			
9.0 PRESENT STATUS					
9.1	STRUC. STABILITY	Fair			
9.2	MAINTENANCE	Unsatisfactory			
10.0 REMARKS					
10.1	CONSERVATION & DEVELOPMENT	<p>The structure holds potential for conservation and future use especially as a corporate holiday home. The structure and its surrounding need maintenance and upkeep. Detached additions may be permitted only in the north provided they relate sensitively to the main building in form, scale and treatment and respect the existing forest cover.</p>

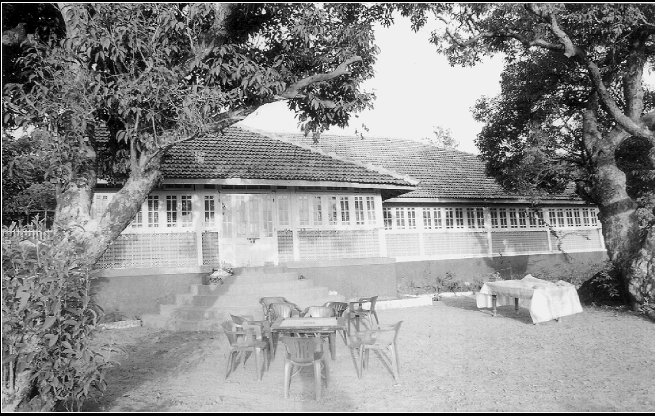
LOCATION		PIN	MH/RA/410102/R-01/(0)/2000	SALMONA BUNGALOW

6.5	REFERENCES	Municipal Records / Map (1903-04) / DP 1987 / Books on Matheran / Field Surveys			
7.0 ARCHITECTURAL SYSTEMS IN THE STRUCTURE					
7.1	FOUND. & PLINTH	Stepped laterite foundation. Plinth in coursed laterite - sand-faced plastered and painted.

10.0 REMARKS					
10.1	CONSERVATION & DEVELOPMENT	A well maintained historic building put to conducive use as a dormitory. The structure has a unique façade value which needs to be preserved. Detached additions may be permitted on site provide they protect the visibility of the façade from the foreground, relate to the existing building in form, scale and treatment and respect the existing forest cover.

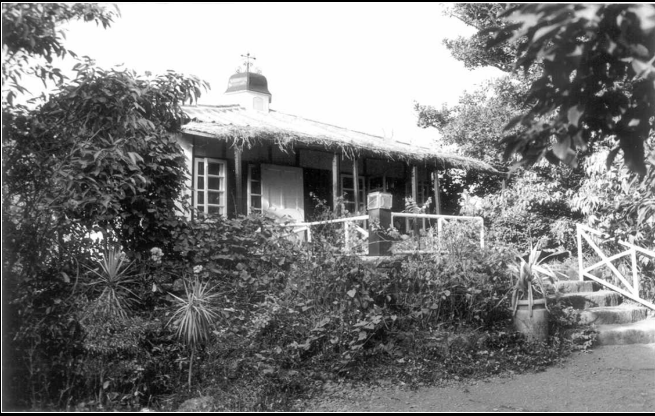
LOCATION	PIN	MH/RA/410102/R-02/(0)/2000	ZARSI

6.5	REFERENCES	Municipal Records / Map (1903-04) / DP 1987 / Books on Matheran / Field Surveys		
7.0	ARCHITECTURAL SYSTEMS IN THE STRUCTURE			
7.1	FOUND. & PLINTH	Stepped laterite foundation. Plinth in coursed laterite - exposed and pointed.

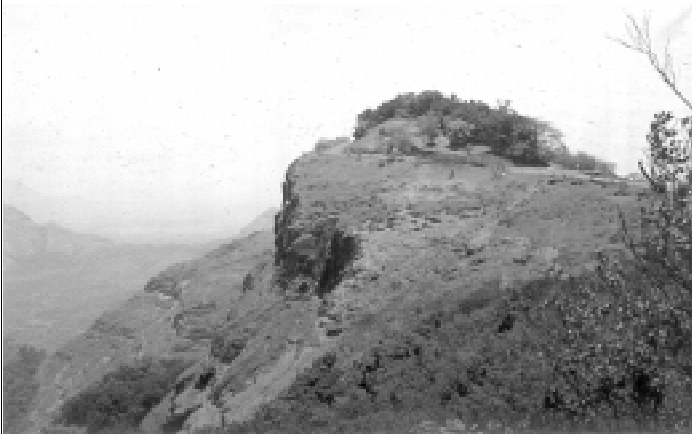
<p>Panorama Point marks the virtual end of the Panorama ridge that forms the northern part of Matheran. Located at about 2 kms. from Dasturi naka, it is reached by the picturesque Panorama point path. The point faces the fort of Peb directly. It offers an uninterrupted panoramic vista of east, west and north sides. Tourists visit this point at dawn to enjoy the beauty of sunrise. A formal garden is developed on a part of the plateau for the picnickers visiting the point. The garden has an ornamental fountain (now damaged) built by Mr. Barmukh in 1965.</p> <p>Distance from railway stn. - 5.00 kms. Height above m.s.l. - 750 m.</p>	Major Point. Garden and fountain not properly maintained. Road to the point needs levelling.
	2	GOVERNOR'S HILL

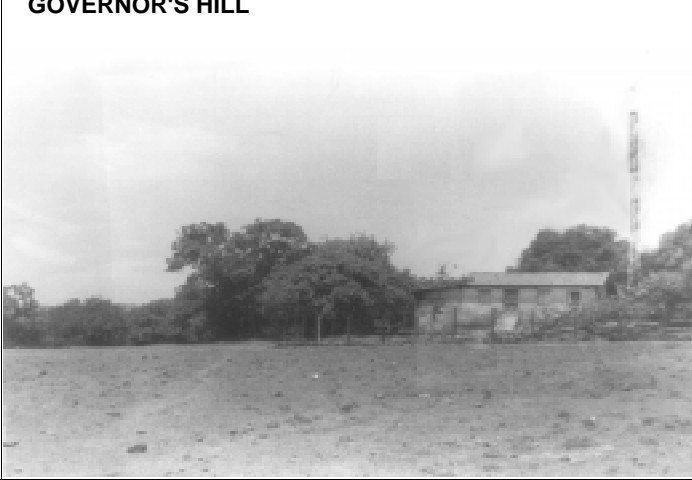
<p>A small plateau located towards north of Simpson's Tank, along the Panorama ridge. It is accessible by a wooded path from Dasturi naka. The spot was named after former Governor of Mumbai Presidency Sir Richard Temple. Its position commands a magnificent view of the region on all sides. The plateau is a reserved ground and a popular picnic spot. It presently houses communication towers and a recently installed seismograph.</p> <p>Distance from railway stn. - 3.90 kms. Height above m.s.l. - 767 m.</p>	Minor Point. Existing structure to be retained and maintained.

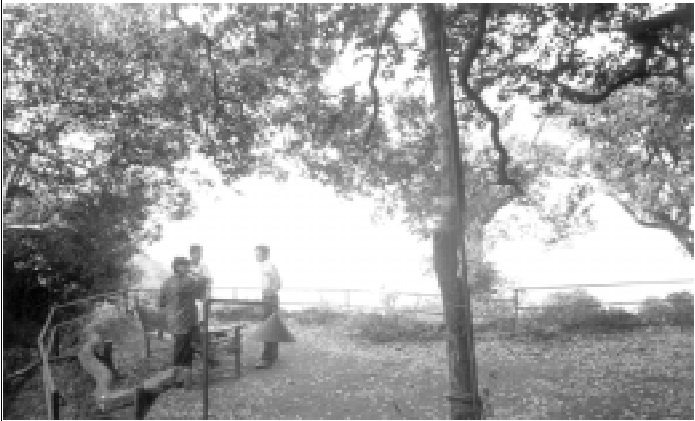
<p>Lying on the eastern edge of Matheran, Neral View is actually a private point of the bungalow 'The Chalet' and thereby accessed only from its site. As the name suggests, the point offers the view of the entire Neral town and its environs.</p> <p>Distance from railway stn. - 3.00 kms. Height above m.s.l. - 756 m.</p>	Private Point. Satisfactory environmental condition.
	9	GARBUT POINT

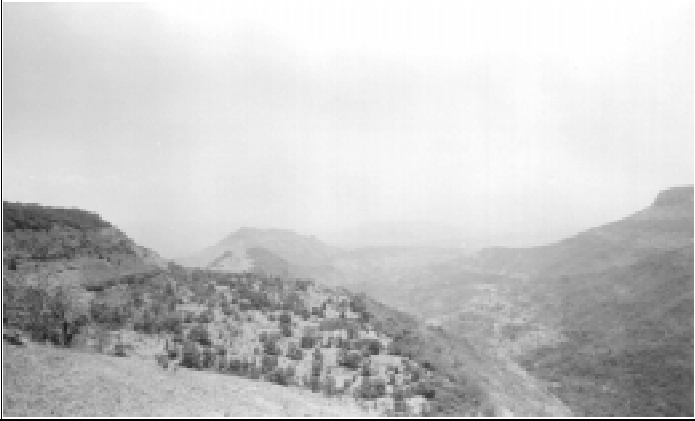
<p>Garbut Point lies at the extreme tip of the eastern wing of Matheran hill. This area abounds with laterite quartz rock formation locally called as 'Gharbutt', hence the name. The point can be approached by Baikra road from Dasturi and by Garbut road from the Ghogal Dara. The point itself is quite barren in spite of the existence of thick Hirda forest in the surrounding area. From the point one can get the vista of many hill ranges, villages as well as the Mumbai-Pune railway line in the east and the clear skyline of Matheran hill in the west. The point being fairly remote, is seldom visited by tourists.</p> <p>Distance from railway stn. - 5.00 kms. Height above m.s.l. - 733 m.</p>	Major Point. Very remote, hence rarely visited by tourists.

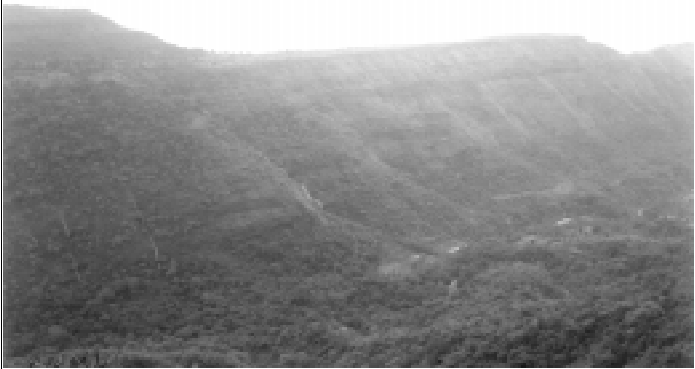
10	GARBUT CIRCUS

<p>This is a flat plateau in the middle of the eastern wing of Matheran hill. The roads leading to Garbut Point go around it enclosing the forest in their midst. This formation is known as Garbut circus. The roads leading to Garbut Circus pass through thick forest barely allowing the sunlight to penetrate. It is a very pleasant trek and also ideal route for horse rides.</p> <p>Distance from railway stn. - 3.80 kms. Height above m.s.l. - 757 m.</p>	Plant overgrowth hampers accessibility.
	11	BEATRICE CLIFF

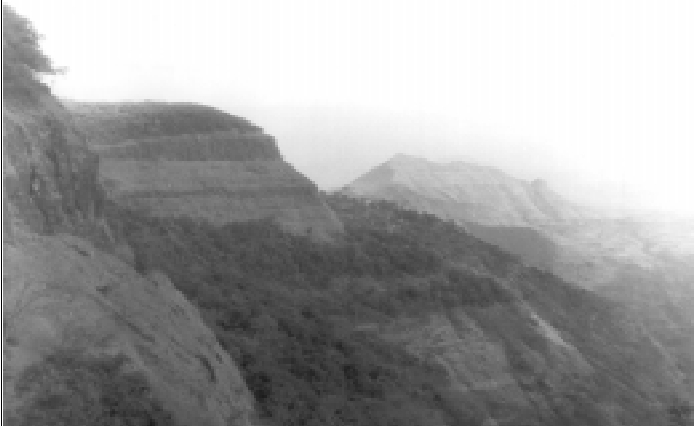
<p>A small plateau formed beside the cliff along the southern edge of Garbut wing is known as Beatrice Cliff. It overlooks Ghogal Dara and can be seen from Myra point and the Ghogal Dara bend of the Matheran railway. It can be reached by a steep and stony path off Garbut road. Earlier, a small clearing just below Beatrice Cliff was accessible by a forest path. This spot known as 'Undercliff Glen' is now hidden by forest overgrowth and hence remains unseen.</p> <p>Distance from railway stn. - 2.00 kms. Height above m.s.l. - 736 m.</p>	Access obstructed by plant growth. Protective railings needed. Signage indicating access to the point should be provided.

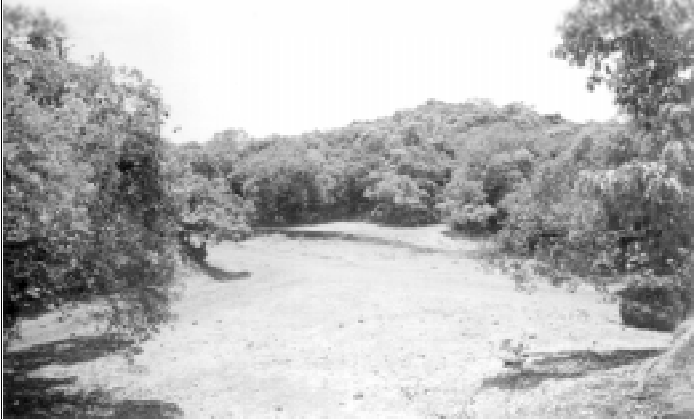
This path starts on one side from M. G. road near Dasturi and after traversing the entire Garbut headland on all its edges it joins M. G. road again near the Tryst. The entire path is well wooded and fairly levelled with only a few natural openings along the path for a view. The views on the east side are very extensive though not as interesting as on the west. The only point on this path is Garbut point that lies at the extreme tip of the headland.	A quiet wooded path considerably cut off from the main hill and seldom visited by tourists. Signages indicating important locations on the way and directions must be provided.

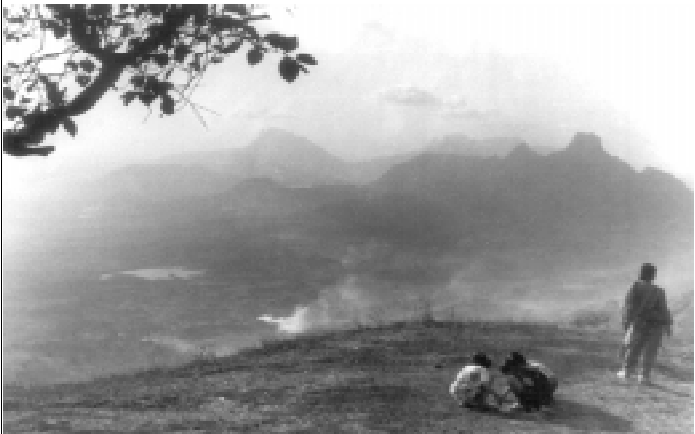
<p>Hart Point is located on a small low level promontory along the north-west edge of Matheran hill. It is named after Mr. Edward Hart, former Undersecretary to the Govt. of Bombay. The point is accessible by forest paths from Simpson's Tank road, Elphinstone road as well as directly from Monkey Point. Hart Point offers a unique view of the Matheran light railway going down the Panorama curve. In the monsoon one can get an excellent view of the Simpson's Tank waterfall from this spot. The dense forest just below Hart Point is known as Black Forest.</p> <p>Distance from railway stn. - 2.50 kms. Height above m.s.l. - 670 m.</p>	Major Point. Proper signage for directions needed.
	16	MONKEY POINT

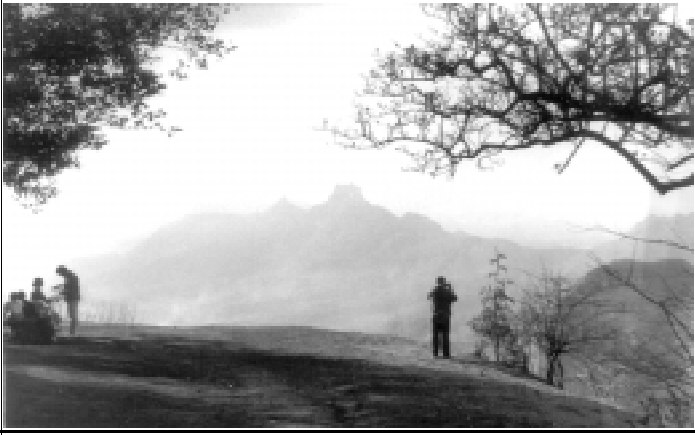
<p>Located in the north-west facing the Hart plateau, Monkey Point is a popular tourist spot. The point is so named because it is said to have been heavily inhabited by monkeys in the past. The point is accessible by a steep path descending down from Elphinstone road. From Monkey point one can enjoy the entire view of the north-western edge of Matheran from Porcupine Point in the west to the Panorama Point to the east. It also offers a great view of Malang gad and the Cathedral Rocks as well as the Matheran light railway creeping up like a snail round the Panorama hill.</p> <p>Distance from railway stn. - 2.00 kms. Height above m.s.l. - 691 m.</p>	Major point. Access to point is rocky and eroded. Needs maintenance. Stalls on the point should not be allowed or encouraged and a protective railing should be provided.

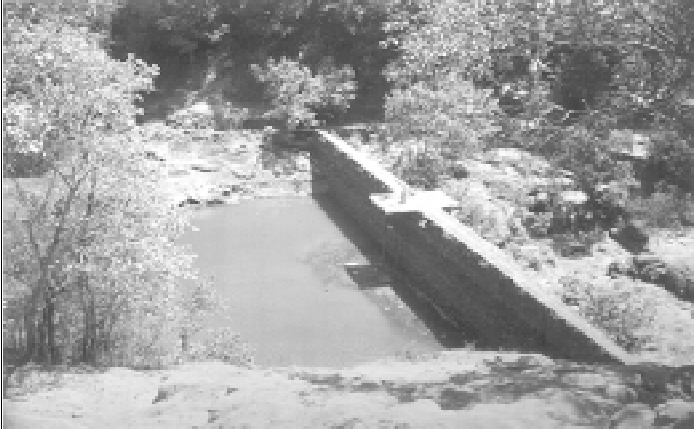
<p>Simpson's Tank is an artificially created storage of water situated near the railway line between Hart Point and Dasturi naka. It can be accessed by the Simpson's Tank road which branches off from M.G. road after the Tryst. In 1858, Lord Elphinstone had conceived the idea of a dam and a tank but it finally materialized in 1875. The capacity of the tank is 4.25 lakh gallons of water. The tank almost remains perennially full as there are several forceful springs feeding it.</p> <p>Distance from railway stn. - 2.40 kms. Height above m.s.l. - 666 m.</p>	Topography ideal for larger catchments if the height of the bund is raised. But area infested with horse mites due to close proximity to loading and unloading node. Good potential as a scenic spot. Can be the source of water, a valuable resource for the town.

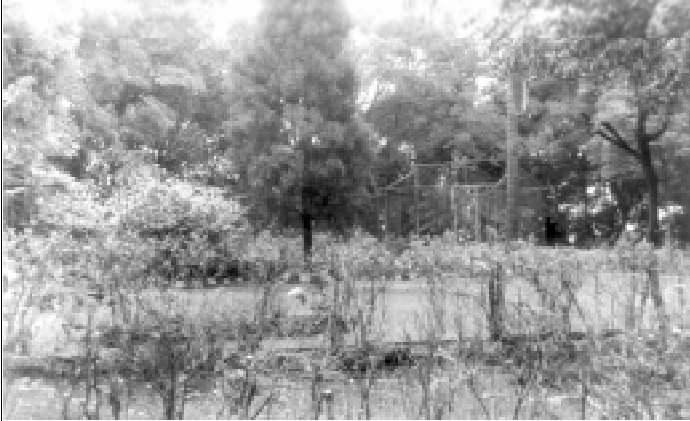
ZONE	SR. NO.	LANDSCAPE FEATURES (NATURAL AND MANMADE)	NOTES	REMARKS
HART POINT ZONE	19	FOREST PARK

<p>It is small park developed by the Forest department near the Simpson's Tank. In the past the park is said to have possessed a good collection of botanical specimens in the past. The park also had an ornamental garden with many flowering plants as well as play equipments for children. The park is surrounded by thick forest and a number of small paths run along the park and the Simpson's Tank through the Kalarai forest area, providing perfect trails for the visitors who love to wander through the forest.</p> <p>Distance from railway stn. - 2.30 kms. Height above m.s.l. - 680 m.</p>	Presently in a poor condition. Holds immense potential as a resource for local plant material for sale and display.
	20	DHODAMBA NALLA	Distance from railway stn. - 3.30 kms. Height above m.s.l. - 650 m.	Major drainage channel of surface run off. from Simpson's tank.

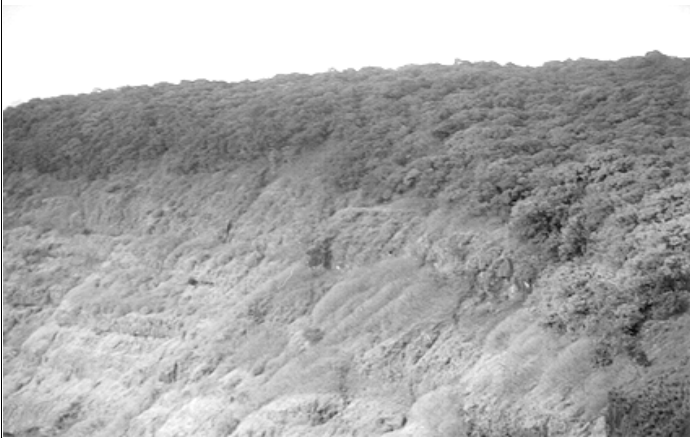
<p>Located in the north-west, Maldunga Point is accessed by a path descending down from Gymkhana road. Down from the point one can see a curved row of boulders resembling a necklace of stones 'mala', therefore the point has assumed the name 'Mala-dunga' i.e. 'Maldunga'. The point overlooks the gorge formed by the western fin or arm of Matheran where it is attached to the main body. After the monsoon, some of the most beautiful waterfalls can be seen falling down this gorge.</p> <p>Distance from railway stn. - 1.55 kms. Height above m.s.l. - 714 m.</p>	Minor Point. Inaccessible due to plant growth and erosion of approach path. Access path needs to be reinstated.
	28	PEB POINT	<p>Peb point is reached by the same path that descends down for Maldunga Point from Gymkhana road. It commands a good view of Porcupine point, Malang village below and Dherang dam built near Panvel town.</p> <p>Distance from railway stn. - 1.50 kms. Height above m.s.l. - 714 m.</p>	Minor Point. Inaccessible due to erosion of approach path.

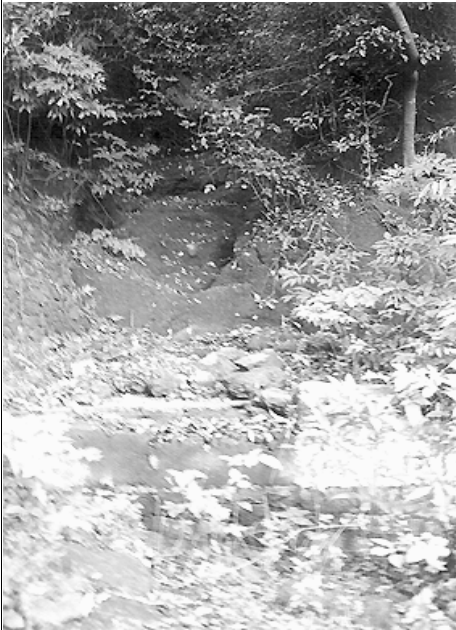
<p>Accessed by a small path branching off from Gymkhana road. It rises from the top of Maldunga valley and is made up of five to six different springs dripping from a considerable depth in the crevices of rocks. It is a perennial spring with sweet, healthy and cold water, still used by the locals for drinking.</p> <p>Distance from railway stn. - 1.65 kms. Height above m.s.l. - 720 m.</p>	perennial spring needs cleaning and maintenance. Approach path needs to be cleared. Plant overgrowth obscuring accessibility and view.

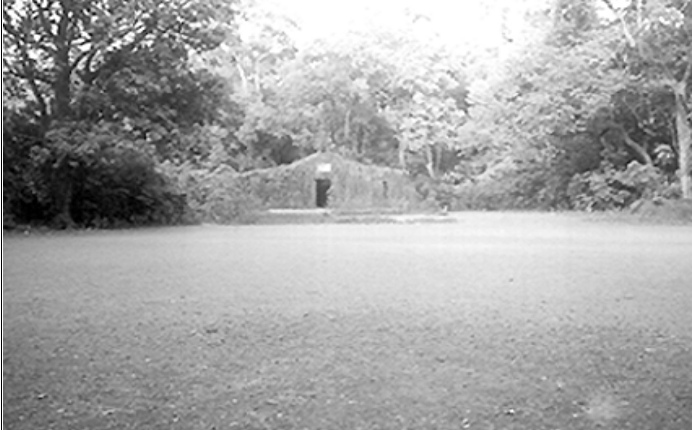
<p>Situated at a lower contour to the north-east of Artist point, the plot is said to have been carved out of the extensive grounds of Elphinstone Lodge. A small club with two tennis courts was first started in 1862, at the expense of Mr. Elphinstone Robertson, I.C.S., collector of Thana and was fairly enlarged by 1880 comprising of six tennis courts, two open and one covered badminton court, a shooting gallery and a children's corner. A small iron roofed pavilion in the centre served drinks and housed a shop for the sale of sports material. A 'calling board' for club members erected on a timber frame and sheltered by a tiled roof was a significant feature of the Gymkhana. The grounds were surrounded by a handsome belt of trees sheltering the courts from wind. The gymkhana was an ideal spot for mental and physical relaxation and recreation. It continued to be a popular and active institution up to 1930, after which the membership suddenly dwindled. A few years later some local sportsmen attempted to revive it by opening it as a sports centre by the name of Matheran Club.</p> <p>Distance from railway stn. - 0.6 kms. Height above m.s.l - 750 m.</p>	A historically significant site representing the cultural background and lifestyle of a particular period. Original pavilions are now in a dilapidated state. The courts are not used for their original purpose any more. Poor environmental condition of the complex. Holds great potential for revival and adaptive recreational use.

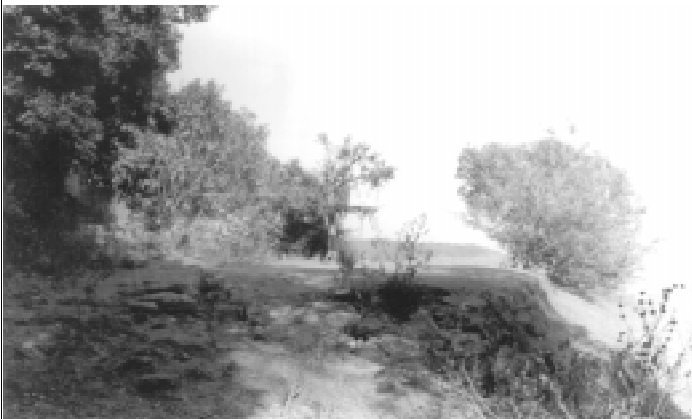
ZONE	SR. NO.	LANDSCAPE FEATURES (NATURAL AND MANMADE)	NOTES	REMARKS
GALTI DARA ZONE	36	MYRA POINT

<p>Myra Point is located on a small plateau formed at the headland along the eastern edge of Matheran hill. It is accessible by a path that branches off from M.G. road and then crosses the railway line. Myra point offers a different view of Garbut point in front, a deep valley to the left and Khandala point to the right. The Harrison spring is located on Myra Point. There is a path with random stone steps descending down to a small ledge formed just below the point.</p> <p>Distance from railway stn. - 1.10 kms. Height above m.s.l. - 710 m.</p>	<p>Major Point. Has good accessibility, hence is a popular tourist spot. Drainage channel along the approach pathway dumped with garbage and plastic waste needs urgent cleaning.</p>
	37	SAKHARAM TUKARAM POINT

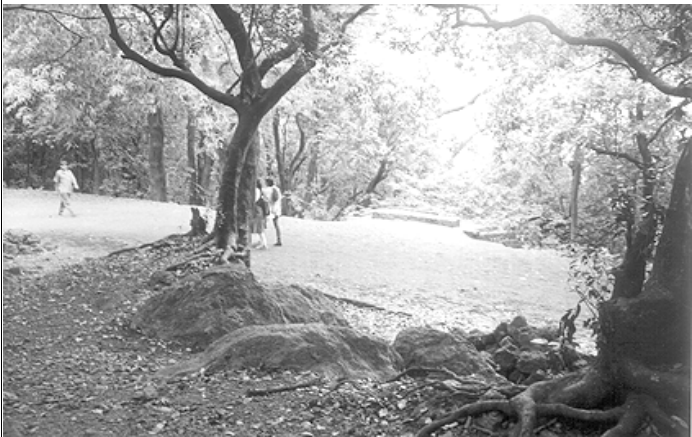
<p>The point is actually a small projected terrace created beside the M.G. road near the Tryst, to offer a splendid view of Ghogal Dara. It is said to have been named after two peons of the local municipality, Sakharam and Tukaram.</p> <p>Distance from railway stn. - 1.65 kms. Height above m.s.l. - 731 m.</p>	<p>Plant overgrowth obstructs view. Needs proper signages.</p>

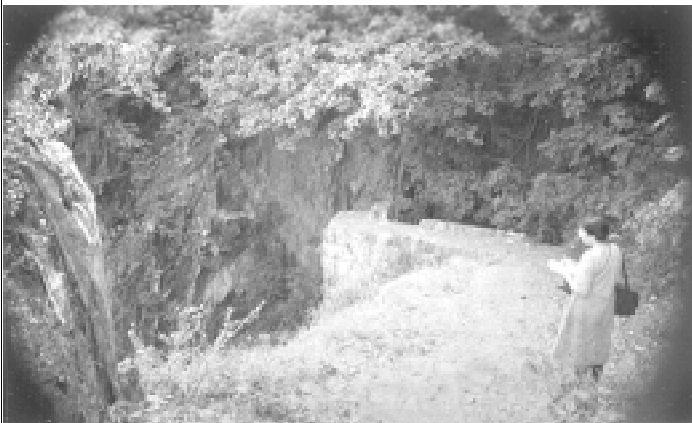
38	HARRISON SPRING

<p>This perennial spring is situated on Myra Point. Just below the source, a tank is created by building a small bund wall / dam to collect the water trickling through the spring. The local folks can draw water from the tank. The spring is also known as Galti zara by the locals.</p> <p>Distance from railway stn. - 1.10 kms. Height above m.s.l. - 710 m.</p>	<p>Perennial Spring. Needs cleaning and maintenance. Plant overgrowth obscures access and view.</p>
	39	THE TRYST	<p>It is a landmark node marking the meeting point of M.G. road, Chenoy road and Elphinstone road.</p> <p>Distance from railway stn. - 1.60 kms. Height above m.s.l. - 740 m.</p>	<p>Significant node of the town.</p>
