MATHERAN:
A COMPREHENSIVE HERITAGE LISTING
PROPOSAL

FINAL REPORT
VOLUME III & IV

PROJECT CONSULTANT
K. UNWALLA ARCHITECTS

FOR
**M.M.R. HERITAGE CONSERVATION
SOCIETY**

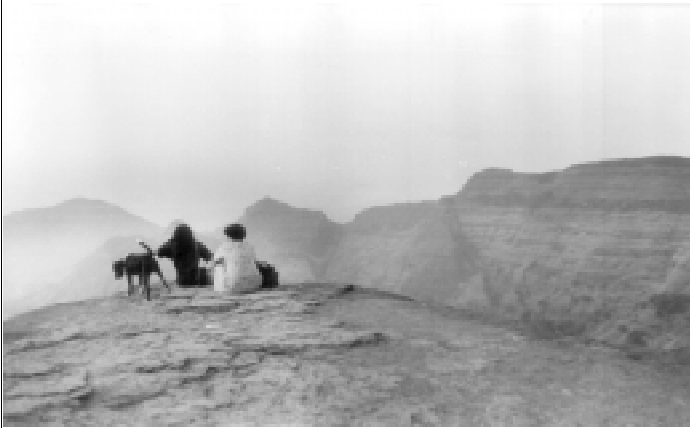
<p>Porcupine Point marks the northern end of the north-western ridge. It is a longish plateau resembling a porcupine snout when seen from the opposite side. The point offers a full view of Mumbai and the Gharapuri caves to the west, the Hart and the Monkey points to the east and the Cathedral rocks, the Malang gad range and the long headland of Panorama point to the north. The point is visited by large crowds daily to enjoy the sunset and every year on the full moon day in February, it is visited by large number of pilgrims who come to offer prayers to Baba Malang whose tomb is situated in the Malang gad range.</p> <p>Distance from railway stn. - 2.50 kms. Height above m.s.l. - 703 m.</p>	Major point. Most visited point. Path leading to the point needs maintenance.

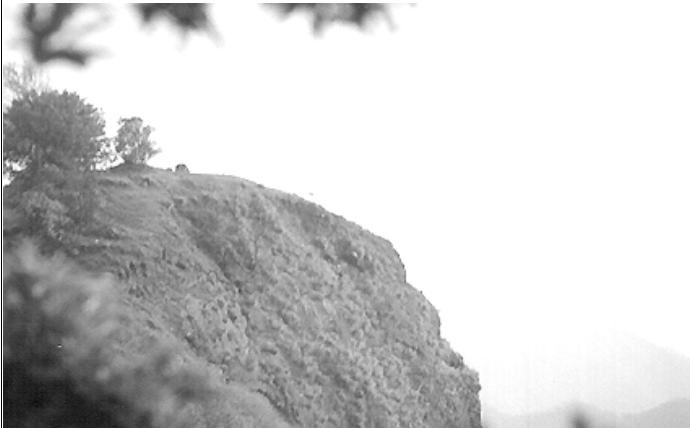
<p>Located at the gorge formed by the western fin of the Matheran hill, the point is reached by a narrow path branching off from Gymkhana road. It was proposed to be named as 'Malet Point' by Col. Hay in 1898. It offers a breathtaking view of the dense Maldunga valley.</p> <p>Distance from railway stn. - 1.80 kms. Height above m.s.l. - 719 m.</p>	Minor Point. Access obscured due to plant overgrowth. Needs signages to indicate locations.

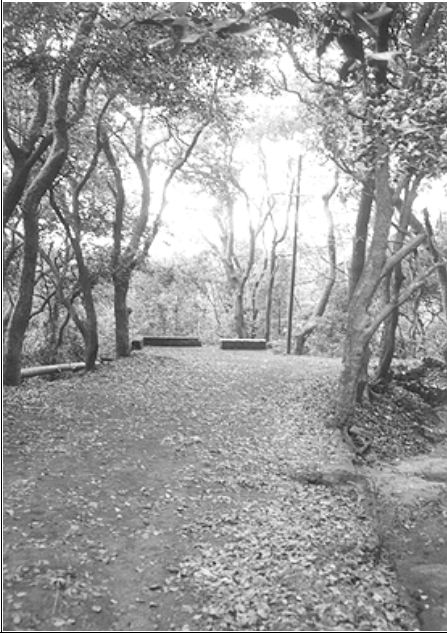
ZONE	SR. NO.	LANDSCAPE FEATURES (NATURAL AND MANMADE)	NOTES	REMARKS
ARTIST POINT ZONE	46	ARTIST POINT

<p>This point lies close to the Rugby plateau, very much inland, unlike the other view points. This was originally only a Griffith's Peep that gave the view of the Cathedral rocks and other hill ranges in the north, through a clearing made in the dense forest. Presently it has two flattened terraces with stone seats. It used to have a metal plaque that graphically showed all the hill ranges visible from the spot, along with their names.</p> <p>Distance from railway stn. - 0.55 kms. Height above m.s.l. - 777 m.</p>	<p>Plant overgrowth obstructing the view. View from the point needs to be restored. Needs signage to indicate location and directions.</p>
	47	PAYMASTER PARK

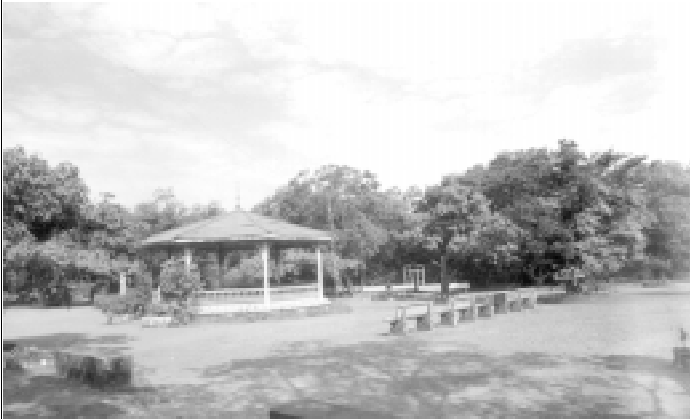
<p>Located right on top of the Rugby plateau, Paymaster Park was developed as a park and a children's play area by Col. Paymaster in 1927. The park was originally planned with well laid out pathways, hedges, flower beds and fountains. One of the fountains served as a memorial to express in stone the gratitude of Matheran to Sir Adamjee Peerbhoy. A few years later, a band stand was made in the centre of the park as a gift from Mr. D. B. Vakil. For many years, the official band was played from there. Presently, Paymaster park has three statues, that of Mr. Malet, Mr. Panday and Lt. Col. Paymaster.</p> <p>Distance from railway stn. - 0.60 kms. Height above m.s.l. - 796 m. Plot no. - 223 Survey no. - 67</p>	<p>Highly neglected. Not maintained. Needs to be restored and landscape material to be revived. Being a historically significant site it should be protected.</p>

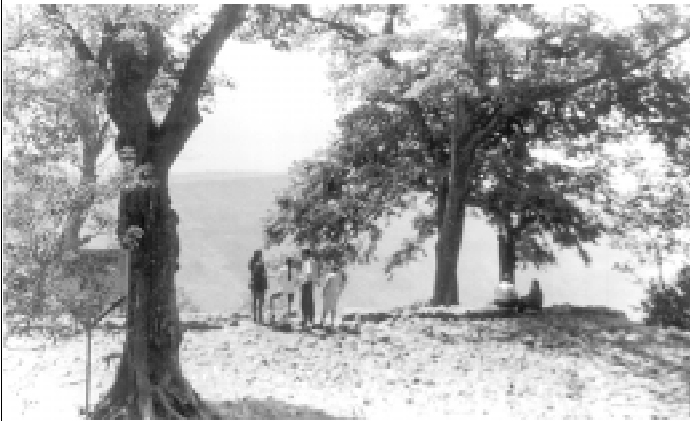
ZONE	SR. NO.	LANDSCAPE FEATURES (NATURAL AND MANMADE)	NOTES	REMARKS
BAZAAR ZONE	49	MADHAVJI POINT

<p>The point lies almost centrally along the eastern edge of Matheran hill. It is located in the bazaar area next to Kapadia Market on M.G. road and accessed through N. Lord park. The point derives its name from Madhavji Virji, a famous solicitor from Bombay who was greatly involved with civic affairs and welfare of Matheran. From the Madhavji point one can obtain complete view of eastern Garbut wing of Matheran right in front and the Alexander point towards right.</p> <p>Distance from railway stn. - 0.40 kms. Height above m.s.l. - 748 m.</p>	<p>Major Point. Rocky floor needs to be levelled and a protective railing needs to be installed. Holds unexploited potential.</p>
	50	KHANDALA POINT

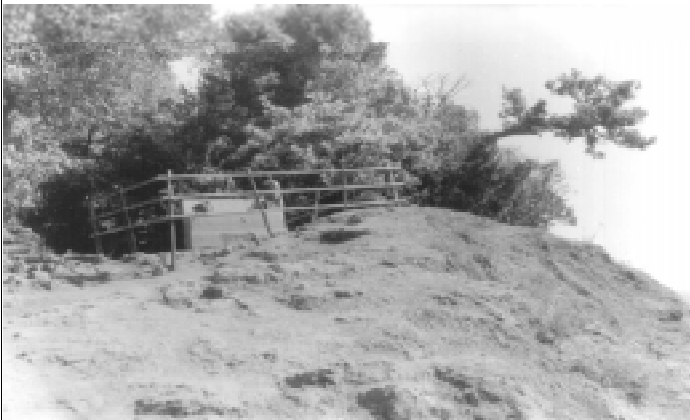
<p>The point is very near the bazaar, especially the Karsandas Mulji Library and Lords Hotel. It is accessed by a path descending down from M.G. road. Located on the eastern edge, the point offers a beautiful view of a deep valley, beyond which one can see Garbut point. The Sahyadri range and Khandala can also be seen from the spot, hence the point assumes its name. Towards the right, Alexander point and the stretch of hill all the way upto Little Chowk point, are visible.</p> <p>Distance from railway stn. - 0.80 kms. Height above m.s.l. - 746 m.</p>	<p>Major Point. Needs protective railing. Environmental condition to be improved. Subjected to pollution due to discharge of raw sewage, solid wastes and garbage in the vicinity.</p>

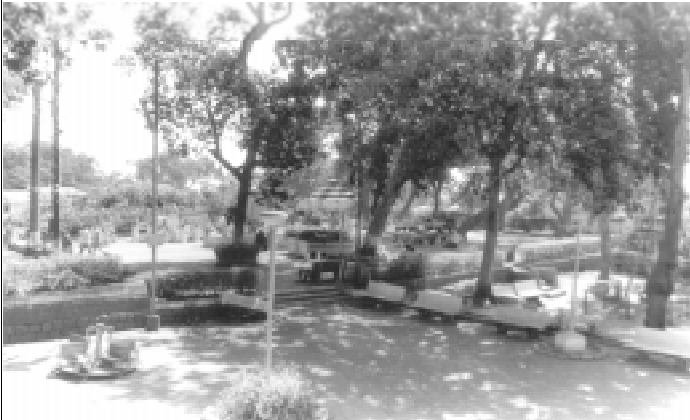
51	N. LORD PARK AND CHHATRAPATI SHIVAJI UDYAN.

<p>N. Lord Park is popularly known as Madhavji Park because of its location just next to Madhavji point. It was developed on the donation given by Mr. Cawas N. Lord and hence was named after his father Mr. Naval Lord. At the entrance is a memorial fountain to commemorate Late Mr. David Japeth, a well known veteran photographer of Matheran. Later, a statue of Late Shri. Vitthalrao Kotwal, the freedom fighter from Matheran, (who laid down his life in the freedom struggle) was erected in the park. The plot was later subdivided and its southern half was named 'Chhatrapati Shivaji Udyan' which mainly houses children's play equipment.</p> <p>Distance from railway stn. - 0.35 kms. Height above m.s.l. - 755 m. Plot no. - BP 224, BP 252 Survey no. - 285, 286.</p>	<p>Toilet block inappropriately located. Children's' play equipment needs maintenance. Unorganised hawking to be controlled.</p>

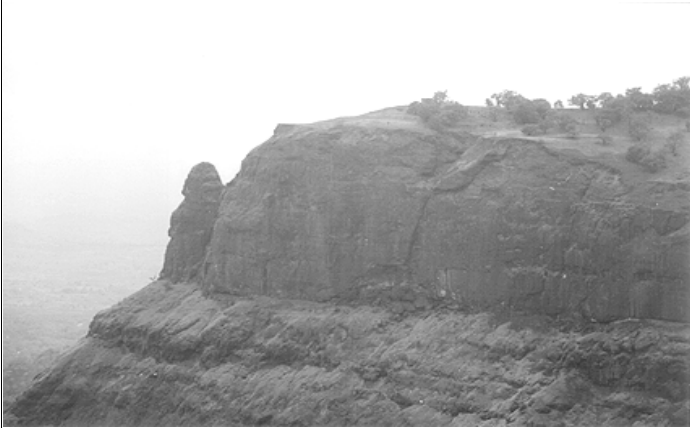
<p>This is a remarkable point located on a large plateau formed at the southern tip of the western wing of Matheran hill. It was named after the wife of Mr. E. Fawcett, the former owner of 'The Hermitage' who also developed the path (Lower Louisa road) leading to it. It is a very large point offering an unobstructed view of east, west and south. On the east one can have a view of Matheran skyline and also identify a few landmarks like the Tour Petit tower, Keepsake and Danger path. The west shows Prabal Fort in its entirety. Louisa point has a small plateau to its south and a small promontory on the west resembling the head of a lion, so it is also known as 'Lion's Head'.</p> <p>Distance from railway stn. - 2.70 kms. Height above m.s.l. - 732 m.</p>	<p>Major Point. The forest guard room is an incongruous structure situated prominently on a prime location on the point should be demolished. Protective railing is required but the present alignment is inappropriate and should be replaced and laid out properly.</p>

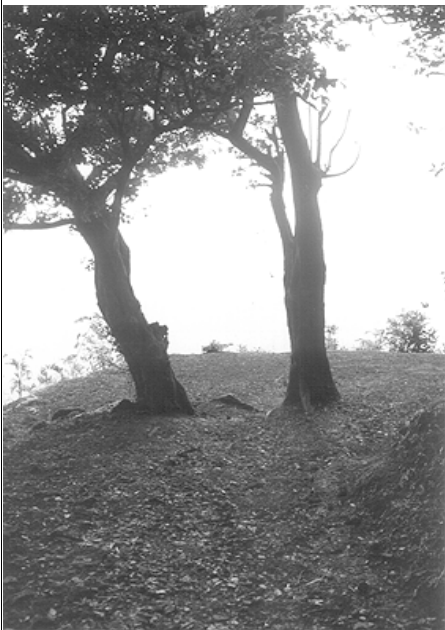
<p>It lies on the western edge, near Rustomji Point and is also reached by Porcupine Point road. It offers a clear view towards west. It was discovered, cleared and opened by Major J. B. Smith in 1903 on the day of Coronation of King Edward in Delhi.</p> <p>Distance from railway stn. - 2.40 kms. Height above m.s.l. - 744 m.</p>	<p>Minor Point. Access to the point to be improved. Needs protective railing.</p>
	57	HONEYMOON POINT

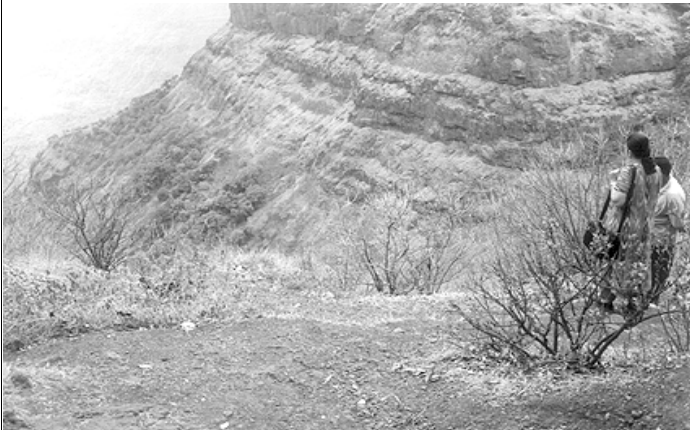
<p>It is located on western edge of Matheran, reached by a path branching off from lower Louisa road. It was developed by Mr. S. L. Panday in 1924 with the concept of creating an ideal spot for honeymooning couples that would combine solitude and scenery.</p> <p>Distance from railway stn. - 1.75 kms. Height above m.s.l. - 708 m.</p>	<p>Minor Point. Plant overgrowth needs to be controlled. Needs signages to indicate locations.</p>

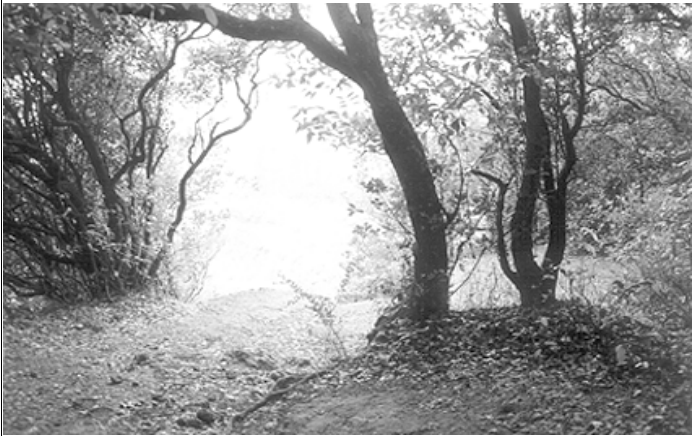
ZONE	SR. NO.	LANDSCAPE FEATURES (NATURAL AND MANMADE)	NOTES	REMARKS
LOUISA POINT ZONE	58	LANDSCAPE POINT

<p>It is a small point located between Honeymoon Point and Echo Point and overlooking the latter. It is accessible by Lower Louisa road. It is called so because of the beauty of landscape one can enjoy from the point.</p> <p>Distance from railway stn. - 1.60 kms. Height above m.s.l. - 721 m.</p>	<p>Minor Point. Access path obscured by plant overgrowth. Needs signages to indicate locations.</p>
	59	AMBA SPRING

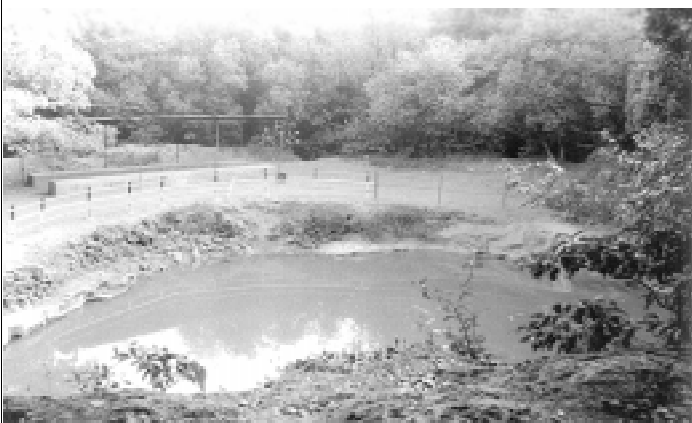
<p>Located near Gijnai Dara on Lower Louisa road.</p> <p>Distance from railway stn. - 2.00 kms. Height above m.s.l. - 708 m.</p>	<p>Perennial spring. Inaccessible due to plant overgrowth.</p>
	60	WALKERS TANK

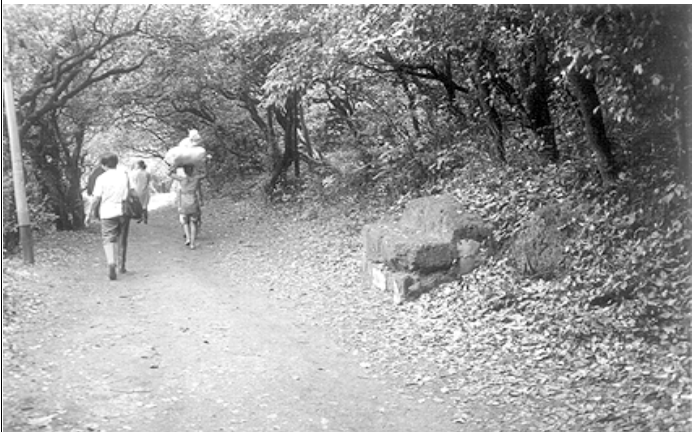
<p>Walker's Tank lies on the way to Louisa point from the lower Louisa road, near Robertson's Bungalow. It is more like a small lake than a tank. It is said to have been formed by blasting trap rock. In the monsoon the water fills up in the shallow cavity thus formed but it does not last for more than eight months. Locals are superstitious about the spot due to a few fatal incidences associated with the tank.</p> <p>Distance from railway stn. - 1.50 kms. Height above m.s.l. - 732 m.</p>	<p>Needs periodic cleaning and proper embankments. Presently used for recreation by a private adventure club. Needs signages to indicate location.</p>

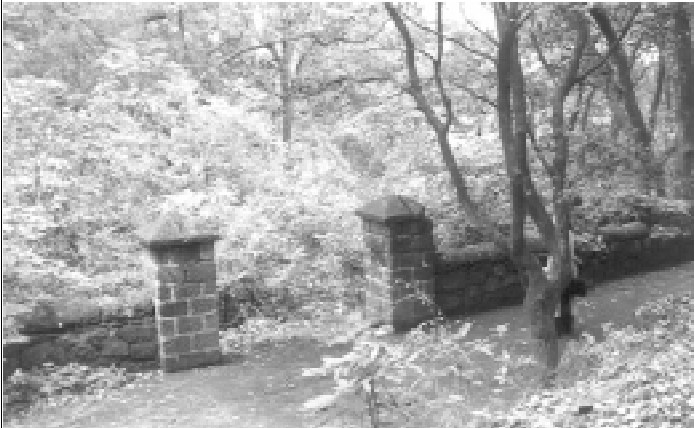
<p>The European cemetery is a small piece of land, located just under the Rugby Cliff, below the Church of England. This protestant cemetery was laid out in 1860's, after the Church of England was built. The first person to be buried in the cemetery was the wife of Mr. Elphinstone Robertson who died in 1867. The plot is bound by a low compound wall built in laterite with a formal entrance way located in the west which serves as the only entrance. This historical cemetery which holds the graves of many European men, women and children, is presently an abandoned site, completely covered with plant growth and not in use. Majority of the tombstones, neatly sculpted in gothic style are built of limestone or trap stone and bear the names of the deceased and quotes in their memory; many of which are now weathered and undecipherable. One of the graves belonging to Mrs. Augusta Gordon was even bound by an iron railing.</p> <p>Distance from railway stn. - 0.60 kms. Height from m.s.l. - 807 m. Plot no. - 238 Survey no. - 124</p>	<p>A historically significant site in an abandoned condition and in a poor state of preservation. The entire site is obscured by plant overgrowth. It holds potential for conservation, as an archaeological site.</p>

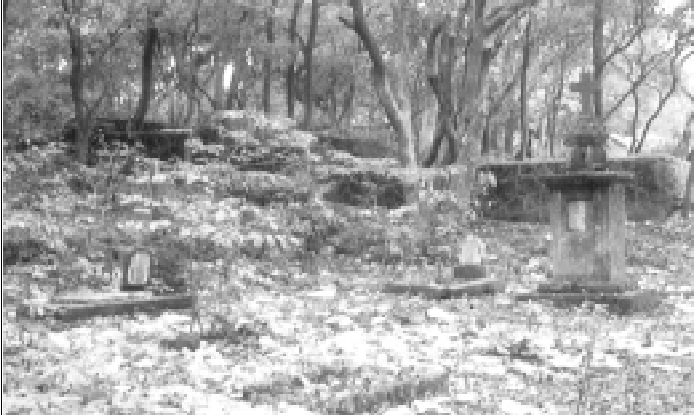
64	CATHOLIC CEMETERY

<p>Located to the east of the European cemetery at a lower level is a small plot containing a few graves which is the Catholic cemetery. This is also an abandoned cemetery like the European cemetery. The plot sloping from west to east is bound by a compound wall with a formal entrance gateway. One of the remarkable graves belongs to Mr. A. F. D'souza, father of Mrs. J. F. D'souza, is marked by a huge mausoleum built in stone bearing a marble plaque and a cross. Other graves are smaller in size and marked by low height tombstones. The cemetery also bears some graves of children.</p> <p>Distance from railway stn. - 0.50 kms. Height above m.s.l. - 803 m. Plot no. - 239 Survey no. - 123</p>	<p>A historically significant site, stands neglected, collecting garbage and litter. Original compound wall and gateway collapsed. Holds potential for conservation as an archaeological remain.</p>

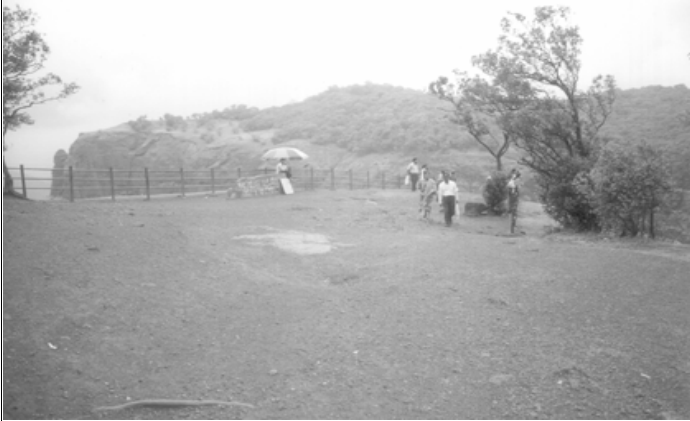
ZONE	SR. NO.	LANDSCAPE FEATURES (NATURAL AND MANMADE)	NOTES	REMARKS
BRIGHTLANDS ZONE	65	ECHO POINT

<p>It is a small promontory located on the western edge of Matheran, overlooking a valley and the Louisa Point wing. It is reached by a path branching off from King Edward road. The point is rightly called so because one can have remarkable echoes if one shouted from this point. The echo is obtained due to the sound waves reflected from the Landscape Point headland, which stands at the right distance from Echo Point. This point offers a view of Chowk village in the extreme left, the Tent Hill, Prabal Fort in the west and Louisa point across the valley.</p> <p>Distance from railway stn. - 1.70 kms. Height above m.s.l. - 740 m.</p>	<p>Major Point. Protective railing and a Tea stall exists on the point. Approach to the point subjected to heavy erosion. Needs to be restored and improved.</p>

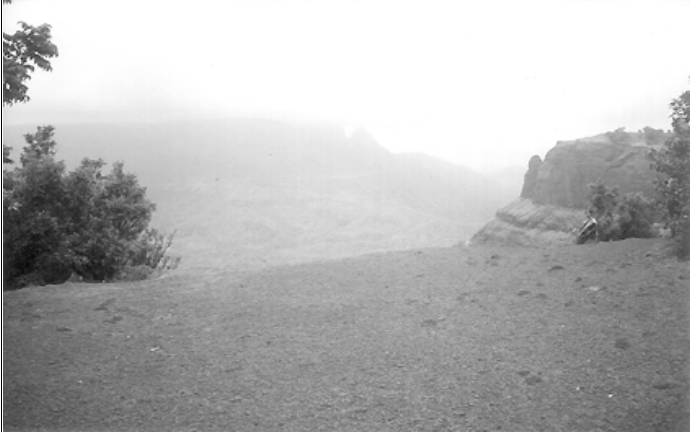
66	EDWARD POINT

<p>Situated near Echo Point and accessible by the same path, Edward Point is a small point located along the western edge of Matheran. It offers a picturesque view towards the west while the dry bed of Charlotte lake is visible in the south.</p> <p>Distance from railway stn. - 1.80 kms. Height above m.s.l. - 733 m.</p>	<p>Minor Point. Needs protective railing.</p>
	67	KING GEORGE POINT

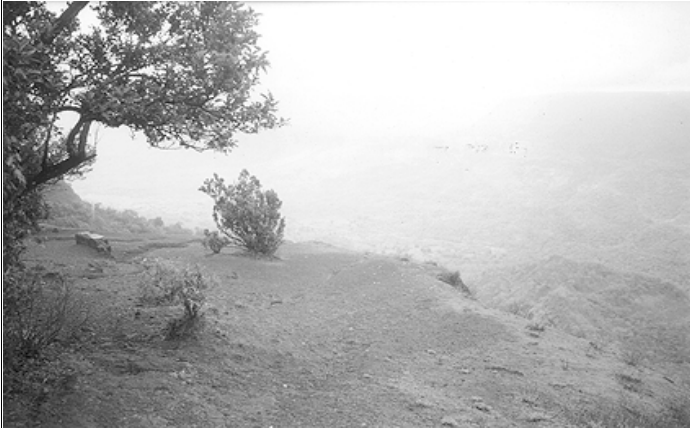
<p>The point was actually a ledge to the left of King Edward Point which was improved and brought into shape at the time of King George V's silver jubilee and therefore the point was named so. The view obtained from here is same as that from Edward Point.</p> <p>Distance from railway stn. - 1.85 kms. Height above m.s.l. - 730 m.</p>	<p>Minor Point. Soil erosion on the point needs to be checked. Approach path needs to be improved.</p>

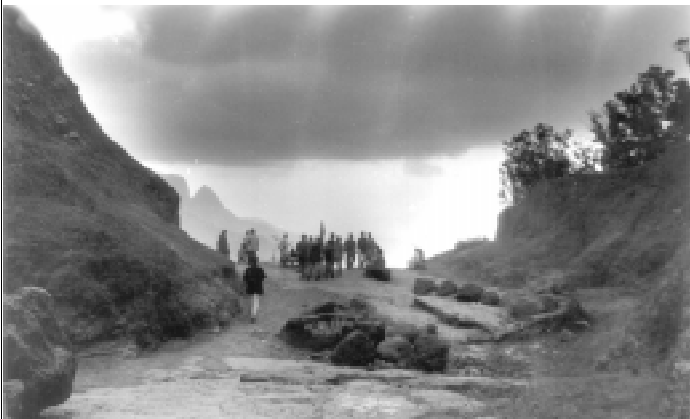
<p>The point is actually the location from where an overflow of Charlotte Lake finds its way down into the valley from a high rocky cliff. It is situated towards north-west of Charlotte lake and is reached by King Edward road. The point has rocky side walls that frame a magnificent view of the region in the west and also the Louisa Point wing in its entirety. As the point heads to a shear drop, it appears unsafe and prone to mishaps.</p> <p>Distance from railway stn. - 2.10 kms. Height above m.s.l. - 690 m.</p>	Major Point. Needs a protective railing. Children's access to the point should be prohibited.
	69	CHARLOTTE LAKE

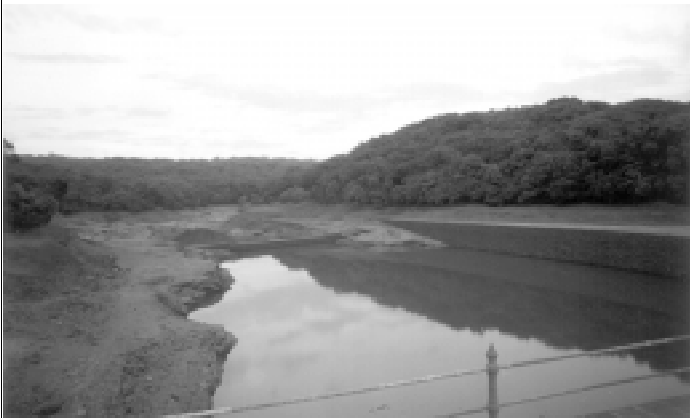
<p>It is a principal source of water for Matheran created by building a dam to arrest the major surface runoff from the hill. It can be reached by numerous pathways from different directions. The idea of a dam was initially conceived by Lord Elphinstone. Charlotte lake has four dams built in stages (between 1860 and 1880), one behind the other creating a catchments area over 3 acres and containing 15830194 gallons of water. The final height of the dam walls constructed in trap rock is 38 feet and the walls are provided with sluice gates that are opened in June and closed in September. The lake is also a popular scenic spot.</p> <p>Distance from railway stn. - 2.20 kms. Height above m.s.l. - 695 m. Plot no. - 287 Survey no. - 258</p>	<p>Paths around the lake should be cleared revived for use. Proper signage should be provided. Natural water channels leading to the lake should be cleaned of garbage. Original gardens below the lake may be revived and opened to public.</p>

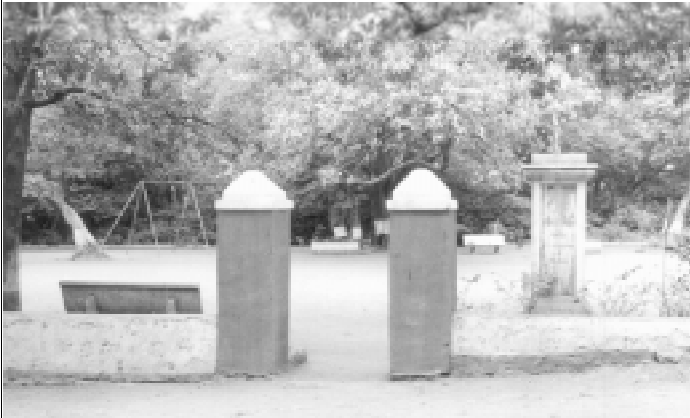
70	PANDAY PLAYGROUND

<p>Panday playground is a triangular plot abutting M.G. road, opposite Hotel Girivihar. It owes its existence to Mr. Sorabji Panday who developed this children's playground dedicating it to the memory of his deceased brother Fardunji Panday. The playground was formally opened to public on 21st Nov. 1921 by Lt. Col. A. Forbes Knapton. It has numerous shady trees with seats built around them as well as play equipments like swings and see-saw. Mr. Panday had originally erected a statue of Hugh Malet in the park which was later shifted to Paymaster Park.</p> <p>Distance from railway stn. - 1.40 kms. Height above m.s.l. - 743 m. Plot no. - 221 Survey no. - 235</p>	<p>Important public place. To be levelled and maintained. Play equipments in are poor state of maintenance.</p>
	71	WELL (NEAR THE DELL BUNGALOW)	<p>Situated in the open space between Usha Ascot and The Dell.</p> <p>Distance from railway stn. - 1.40 kms. Height above m.s.l. - 740 m.</p>

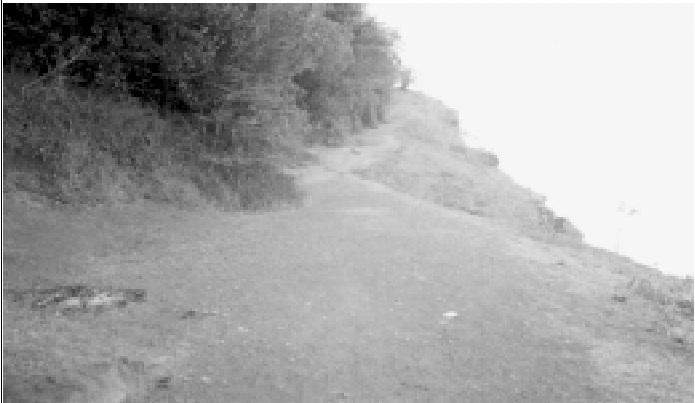
<p>The path is actually a trail running parallel to the western valley edge, starting at the Lord Point and joining the Chowk Point road below the Scottish Orphanage. The name was given to the path by Dr. J. P. Barry on account of fine vista over the broken landscape in the midst of which lies the Funnel Hill. The path is fairly dangerous at some locations where it substantially narrows down and directly overlooks a deep, valley below. The latter part of Danger path which joins Chowk point road near Sharda Villa (Scottish Orphanage) is known as Belvedere Path.</p>	Entry to be restricted for adults only. Proper signage needed.

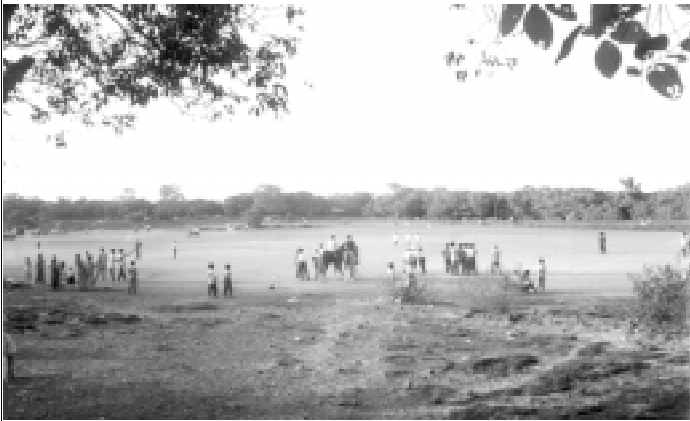
ZONE	SR. NO.	LANDSCAPE FEATURES (NATURAL AND MANMADE)	NOTES	REMARKS
OLYMPIA ZONE	81	OLYMPIA GROUND

<p>It is a large oval ground standing on a high plateau about the centre of the Chowk ridge. It has a well defined race course about 2.5 Kms long running all around it. The ground provides ample space for vigorous riding as well as for organized horse racing. Olympia was used as a popular sports arena since 1880 when the European Gymkhana was just started in Matheran. Races and athletic sports were regularly held here, especially in the month of May and prizes were given away.</p> <p>Distance from railway strn. - 2.60 kms. Height above m.s.l. - 777 m. Plot no. - 253 Survey no. - 220</p>	Major resource. Race course to be levelled and remetalled.
	82	WILLINGDON PATHS	<p>The Willingdon paths were in existence since 1915 but were mere footpaths leading from the backdoors of the houses on Chowk road upto Olympia and extending along to the other bungalows dotted around and terminating at the beginning of Birdwood path. When Lord and Lady Willingdon visited the hill in 1915 these two paths were widened and given their names to commemorate their visit. Steps were also provided at regular intervals to reach the Olympia ground.</p>	Paths obscured due to plant overgrowth. Needs to be cleared.

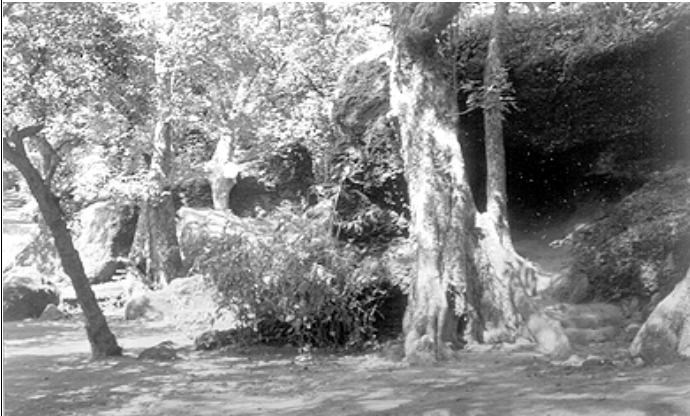
83	CAVES (GOLDCROFT)

<p>In the premises of a private bungalow - Gold Croft formerly known as Rockside, near the Olympia plateau a set of small caves exist. These caves have various legends of folklore associated with them.</p> <p>Distance from railway strn. - 3.20 kms. Height above m.s.l. - 773 m. Plot no. - 133 Survey no. - 215</p>	<p>A point of geological interest in a private property. Should be revived and opened for visitors. Needs proper signages to indicate locations.</p>

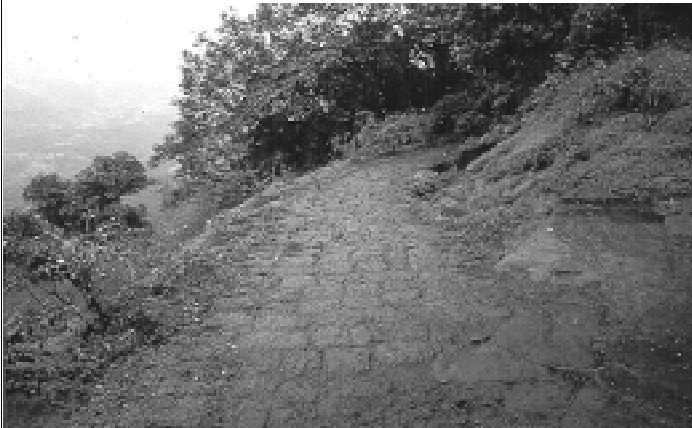
<p>Circling the entire southern and south-eastern end of Matheran Hill is the Rambaug forest. A well cobbled but narrow pathway called Rambaug Path starts from the Rambaug Point and goes a several hundred feet downhill through the dense Rambaug forest to the foot of the hill to the Rambaug village. This was the first path to be built in Matheran, originally, a footpath used by the natives to go uphill, which Hugh Malet on his first visit to Matheran in 1850 chose for his descent to the Chowk. It continued to be used as the approach to Matheran in the later years also. A picturesque path popular among the trekkers.</p>	Well laid out path of historic significance. Needs proper signages to indicate directions.

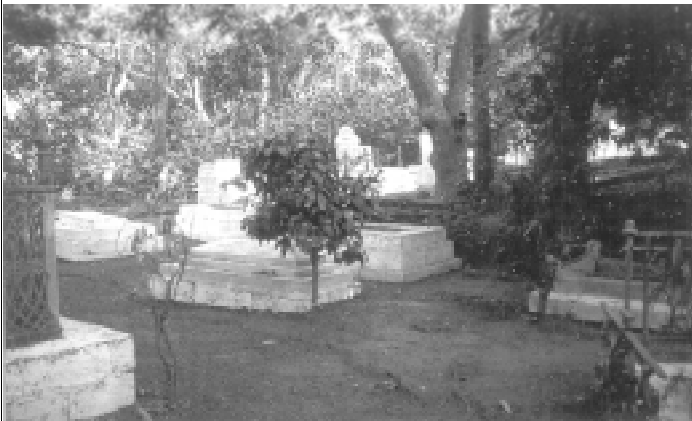
<p>To the east of Little Chowk road is the Parsee cemetery ('Aramghah') which is accessed by a well laid out cobbled pathway, leading through a formal gateway. The historic site was revived in 1915 by Mrs. Khareghat, wife of Lt. Col. Khareghat, superintendent of Matheran at that time. The cemetery bears about 18 - 20 graves, most having elaborate tombstones built in marble with inscriptions and beautiful intricate carving. An ornate lamppost was donated by the family of Bai Rattanbai Kapadia in her memory to keep a fire ever burning, but the tradition was not observed later. The site also has a water reservoir, a small building erected in the memory of Late Cawasji and the tomb and statue of Rattanbai Kapadia with an elaborate inscription. A formal garden is laid out around the graves in semicircular terraces. The graves are properly fenced and kept clear. A ground is also marked in two tiers to seat the people around for the annual Jashan ceremony which was started by Mrs. Khareghat.</p> <p>Distance from railway stn. - 2.30 kms. Height above m.s.l.- 137 m. Plot no. - 156 Survey no. - 227</p>	<p>A historically significant site holding social and cultural value. Holds potential as an archaeological site. Needs regular maintenance and cleaning.</p>

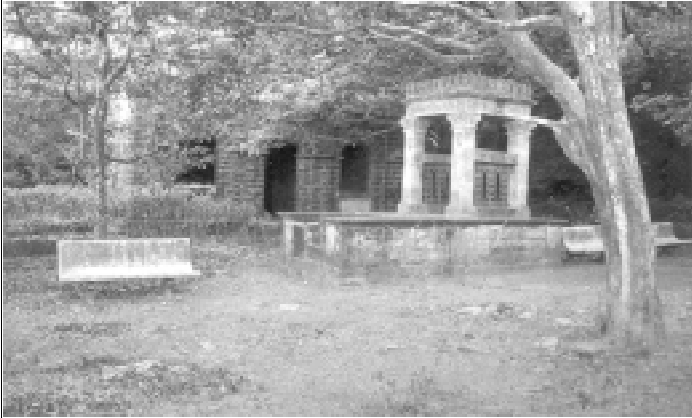
<p>To the east of Little Chowk road, edging the eastern valley lies the well laid out 'Amar Dham' or cremation ground for upper class Hindus, especially visitors and bungalow owners on Matheran. It was developed by Sir Mangaldas Nathabai in 1885. The site has a pavilion built for the rituals, a dharamshala and a small pavilion built in Porbunder stone in the memory of the grandson of Thakur Digvijay Singh. The dharamshala is an elaborate structure built in trap with rusticated finish but the structure is presently unused. The burning ground itself is like a well kept compound. The site is bound by a compound wall and two massive concrete gates make the entrance.</p> <p>Distance from railway stn.- 2.2 kms. Height above m.s.l. - 738 m. Plot no. - 222, 228 Survey no. - 228, 229</p>	<p>A socially significant site in a fair state of preservation. Existing structures on site need maintenance and revival. The site is of archeological significance.</p>

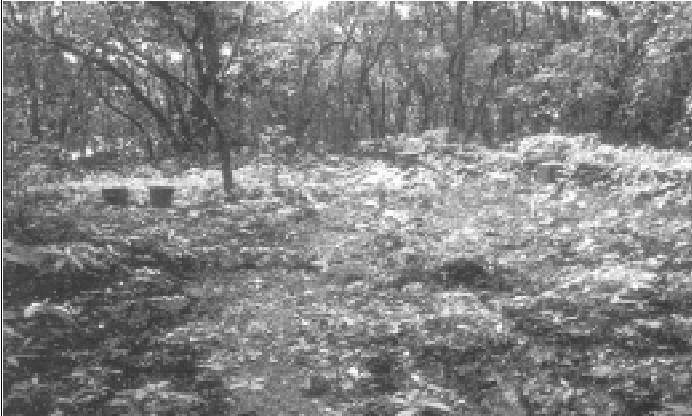
<p>The burial grounds are laid on three independent plots forming a cluster, located on the east of Little Chowk Point road and accessible by a descending cobbled pathway from it. Each burial ground is meant for the local population of that particular sub-caste. The plots are bound by laterite boundary walls with entrance gateways. The graves are marked by tombstones, some of which are even elaborately sculpted and bear religious motifs.</p> <p>Distance from railway stn. - 2.75 kms. Height above m.s.l. - 753 m. Plot no. - 229, 230, 281 Survey no. - 208, 207, 209</p>	<p>Culturally significant sites presently abandoned. Plant overgrowth has obstructed the approach paths as well as the sites. The site is of archeological significance</p>
	98	MARATHA BURIAL GROUND	<p>A large plot on the east of Little Chowk Point road was identified as Maratha burial ground meant for the local population of the particular sub-caste. The plot is bounded by a compound wall and has graves marked with tombstones.</p> <p>Distance from railway stn. - 2.85 kms. Height above m.s.l. - 732 m. Plot no. - 232 Survey no. - 206</p>	<p>A culturally significant site presently abandoned. Plant overgrowth has obstructed the approach path as well as the site. The site is of archeological significance.</p>

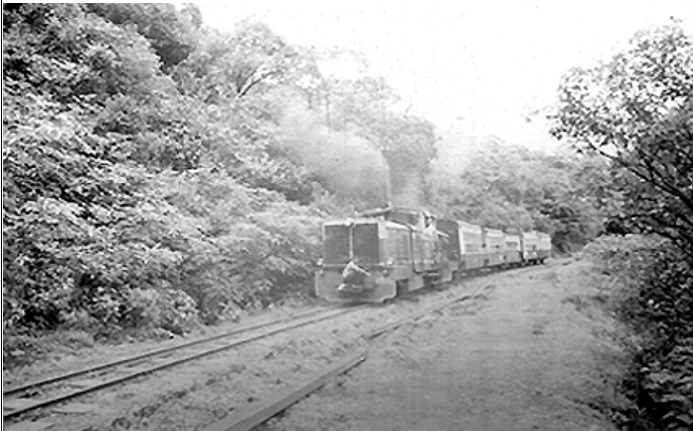
<p>The present Mini-train at Galti Dara.</p>	<p>By 1854, Neral was connected to Bombay by rail, on the Bombay-Pune line. The Ghaut road connecting Neral to Matheran was completed in 1856. For the next fifty years, the only mode of transport from Neral to Matheran was by means of horses and hand-drawn rickshaws. The inconvenience of this cumbersome and time consuming mode of transport led the Government to think of having a railway between Neral and Matheran and schemes were invited for the purpose. Sir Adamjee Peerbhoy the famous businessman and philanthropist of Bombay came forward with a practical scheme of laying down a mountain rail between Neral and Matheran, which was sanctioned by government in 1903. With painstaking efforts and perseverance by Hon. Abdul Hussein Peerbhoy, the son of Sir. Adamjee Peerbhoy and under the able supervision of well known engineer Raisaheb Hirachand, who planned the railway on the same lines as the Shimla-Kalka hill railway, the railway was completed in four years.</p> <p>The tracks of twelve miles were laid, at an expense of sixteen lacs and the railway was thrown open to public in 1907. The terminus of Matheran was located close to bazaar spine. The first trains were said to have been pulled by locomotives bought from the Darjeeling railway. Matheran railway distinctly differed from the G.I.P. railway in its gauge size of carriages and other details therefore, the railway came under the Tramway Act and not under the Railway Act and the railway was known as the Matheran Steam Tramway. Till 1927, the possession of the Matheran railway and its management was in the hands of the Peerbhoy family. Later the management was taken over by Gwalior Interests with Late Mr. Sohrabji Panday as the managing director, whose personal service and attention was responsible for increase in popularity of the Matheran railway.</p> <p>After independence, the railway was taken over by the G.I.P. railway and it is presently owned and managed by the Central railway. The railway track, about 21 kms. in length and a ruling gradient of 1in20 starts at Neral and proceeding northwards from there takes numerous turns and hairpin bends as it meets and crosses the Ghaut road (Neral road) at many points offering the most picturesque views throughout its entire stretch. On its way it halts at three intermediate stations Jumma Patti, Water Pipe and Adam Lodge before it reaches Matheran after a journey of about 2 hours. The Matheran railway is indeed the pride of Matheran and an important element of its tourist attraction.</p>	<p>Historic significance and uniqueness qualify the Matheran railway, the tracks and the carriages for grading of highest order. The railway needs regular maintenance and upkeep. The edges of railway corridor need stabilization and restoration as these have heavily eroded over the years leading to exposed and unsupported tree roots which will very soon lead to the collapse of numerous trees all along the corridor. Environmental quality and infrastructure of intermediate stations needs to be improved. Signages along the railway tracks indicating important locations and directions are needed.</p>
