LISTING & GRADING OF HERITAGE BUILDINGS & PRECINCTS IN MUMBAI  
 TASK II: Review of Sr. No. 317 to 632 of the Heritage Regulations

622		D.L. PERIERA'S VILLA - VILCDAMERZ	
 	Common Ref no:2005/GII/622		 
	Card No.306		
	Ward (Part) H- West		
	CS No. 434-B		
	Plot Area 117 sq m		
	B U Area NA		
	Date 30 <sup>th</sup> March 05		
	Record by Aishwarya Tipnis		
	Review by Abha Lambah		
Int AT Ext AT			
Photo Ref 622a-622ac

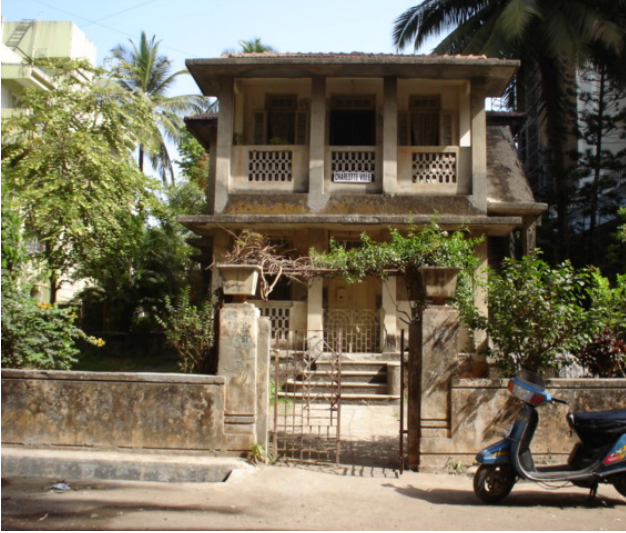
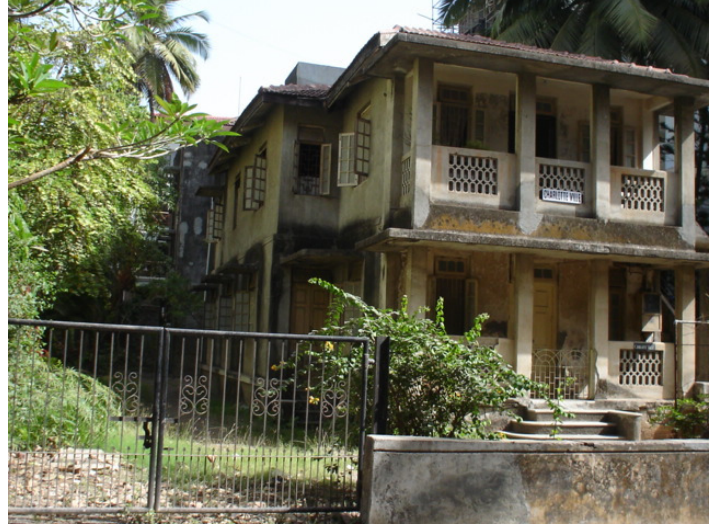
623

9.4	Stairs	Appears to be in a structurally sound condition, some recent repairs have been undertaken.
9.5	Openings	Some glass panes have been broken; most windows have been encased in MS grills. Most ventilators are kept closed on permanent basis but are in a fair condition. AC units have been introduced in some doors and windows. The doors on the ground floor on the side display paint flaking and warping due to water ingress.

9.10	Overall Condition	As the building is tenanted, with rents frozen at Rs 40, the owner does not get enough to maintain the building and the tenants do not maintain the building shirking their responsibility as a result the building is neglected Maintenance level Poor needs immediate structural consolidation.

12.0		<b>ADDITIONAL NOTES/REFERENCES/DOCUMENTS AVAILABLE/RECOMMENDATIONS &amp; SUGGESTIONS FOR IMPLEMENTATION</b>
		The Heritage Conservation Regulations, Gist of Suggestions and Objections Vol II does not state any reasons for its deletion. Although the building has been deleted from the list, it should be re-inducted into the list for its group value within the already disintegrating Bandra Village precinct.

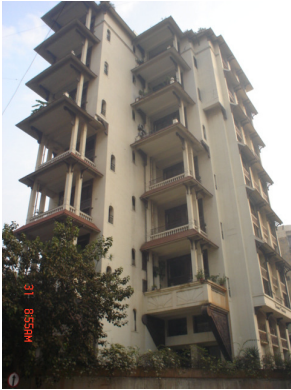
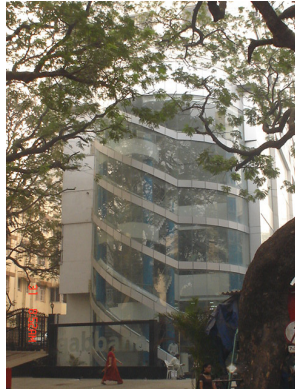
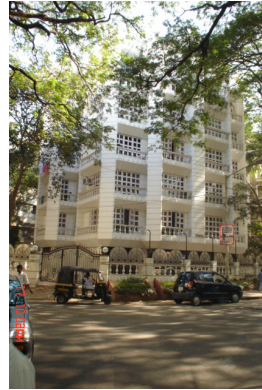
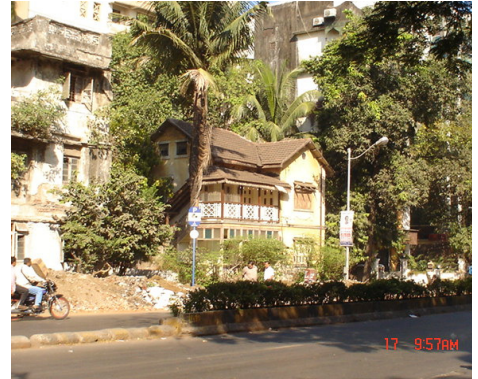
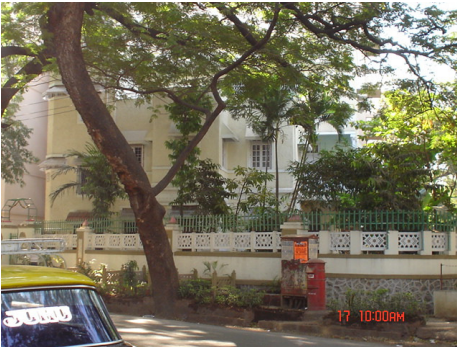
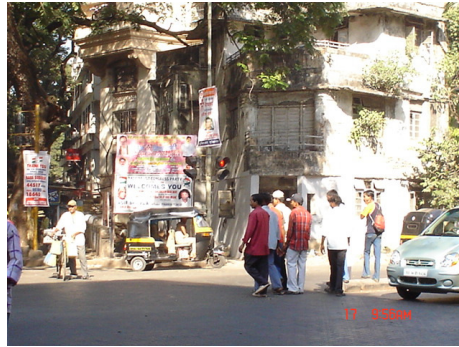
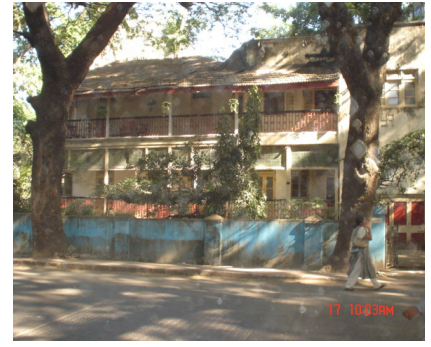
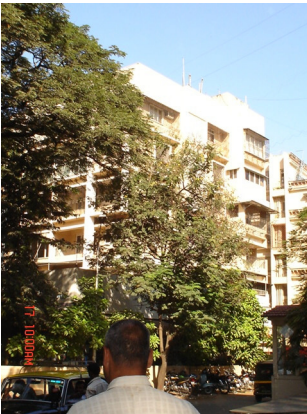
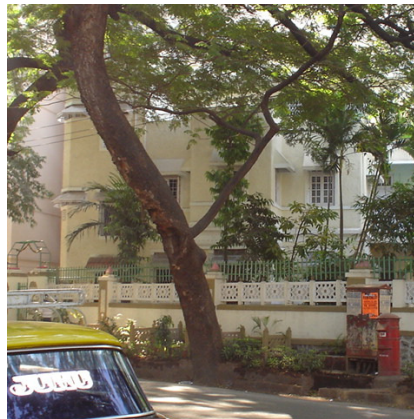
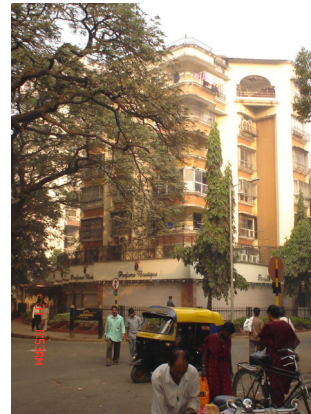
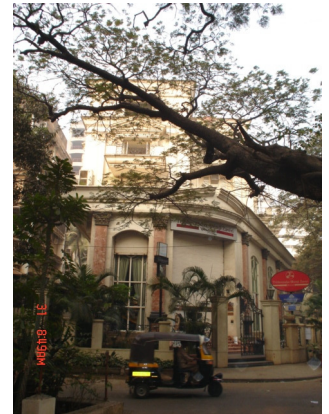
624 CHITRAKAR DHURANDAR MARG

5.1	Townscape(Natural/Manmade)	Houses on either side of a tree lined avenue, originally ground plus one storey bungalows with sloping Mangalore tiled roofs, today the precinct has changed completely with multi-storey apartment blocks having replaced the earlier bungalows, resulting in the loss of character of the entire precinct.

9.9	Outbuildings	Not applicable as original fabric has been totally altered.
9.10	Overall Condition	Not applicable as original fabric has been totally altered. Maintenance level Not applicable as original fabric has been totally altered.

11.0		<b>DP REMARKS/PERCEIVED THREATS</b>
		NA
12.0		<b>ADDITIONAL NOTES/REFERENCES/DOCUMENTS AVAILABLE/RECOMMENDATIONS &amp; SUGGESTIONS FOR IMPLEMENTATION</b>
		<p>As per the Heritage Conservation Regulations Report of Designated Officer Volume 1 "<b><i>Lastly under Sr. No. 624 Chitrakar Dhurandar Marg, houses on both sides of the road have been included in the heritage list wherein it has been mentioned that bungalows situated on this road were once upon a time bungalows facing the sea. On site inspection it is observed that there are a large number of shady trees on this road. However only 5 to 6 ground floor old structures are existing and rest of the properties are of recent origin and multi-storied buildings. It is surprising why such a road is included in the heritage list when it does not reflect any character worthy of preservation. This entry needs to be deleted from the list</i></b>"</p> <p>Since the entire precinct has lost its character it is recommended that this precinct be delisted and the four buildings namely</p> <ol style="list-style-type: none"> <li>1. Corner Building at junction of Linking Road &amp; Chitrakar Dhurandar marg on the northern side</li> <li>2. Colonial Vernacular Bungalow adjacent to no 1. on Linking Road</li> <li>3. Radha Nivas</li> <li>4. Colonial Vernacular bungalow on corner of 16<sup>th</sup> Road Be listed as individual entries.</li> </ol>

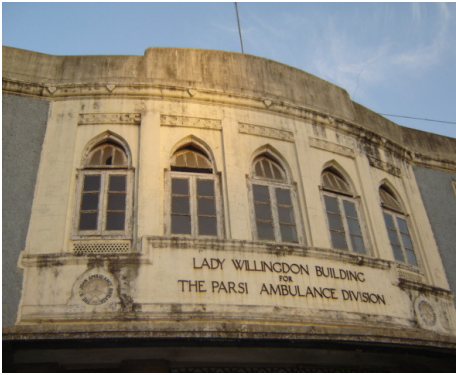
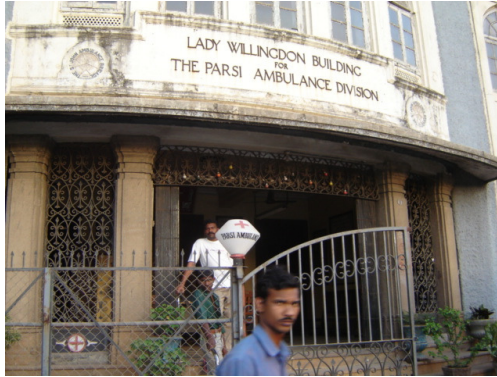
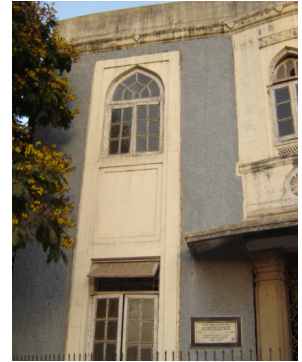
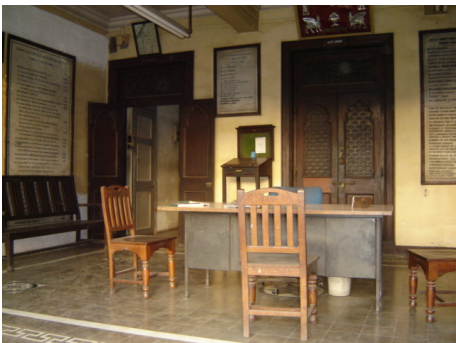
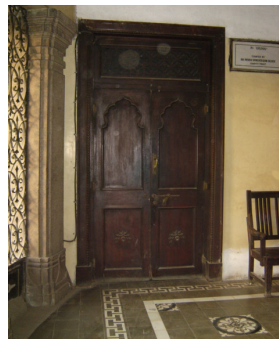
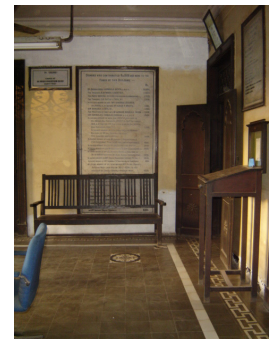
8.7	Other (HVAC/BMC/Security Systems)	None
9.0		<b>CONDITION</b>
9.1	Plinth	No visible sign of deterioration
9.2	Walls	No major structural distress seen. Paint and plaster deterioration visible

9.5	Openings	No alterations to the original openings except addition of ad hoc chajjas outside windows on side facades
9.6	Roofing	No major issues
9.7	Articulation & Finishes	In good condition

630	LADY WILLINGDON BUILDING FOR THE PARSİ AMBULANCE DIVISION	
		abutting the building. This is in corrugated sheet construction, with a lean to roof.
9.10	Overall Condition	The Lady Willingdon Ambulance Building enjoys a good level of maintenance and is in a satisfactory state of repair. The building is quite well maintained and is regularly painted and repaired.

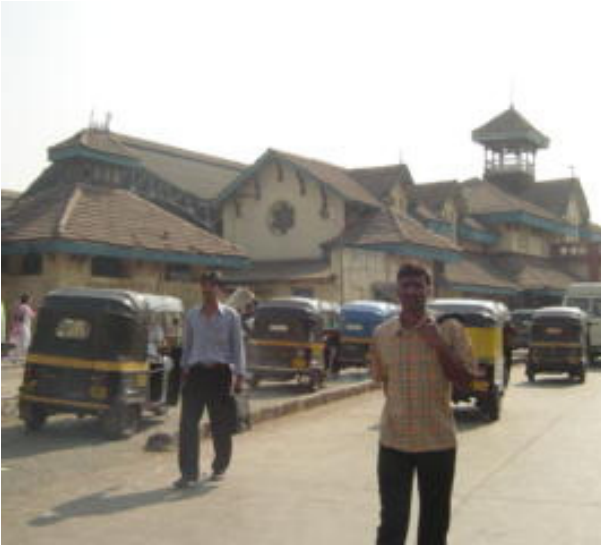
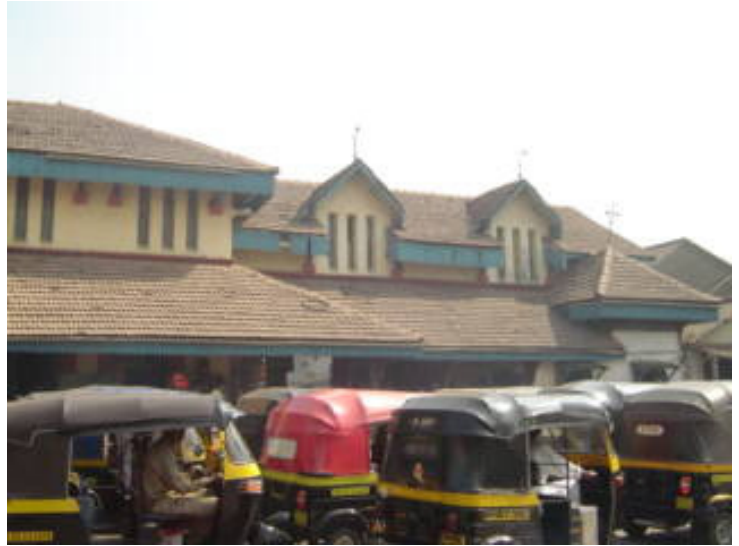
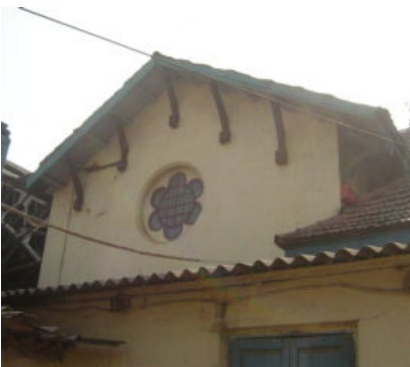
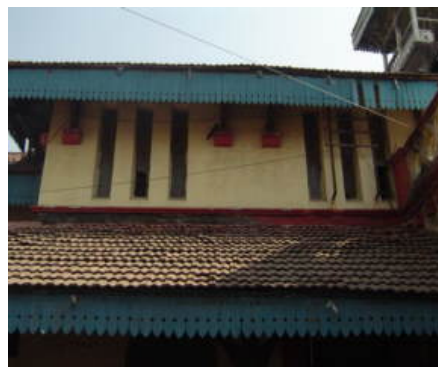
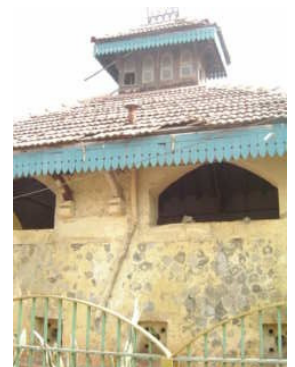
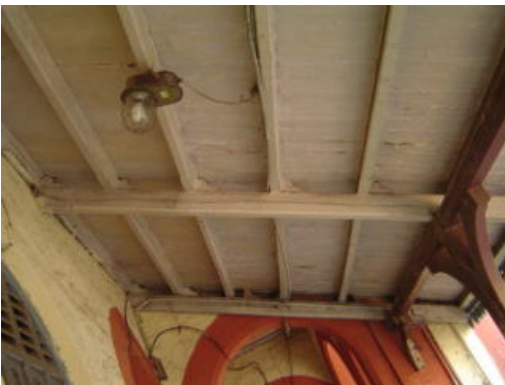
9.1	Plinth	Rising damp observed almost everywhere in the building, especially along the rear and side staircases. An oil paint dado of up to 3' is painted all around the building.

9.2	Walls	Water seepage is a pertinent problem with the building, mainly from the roof and masonry, the extensive use of oil paints and weakened lime stucco plaster allow for water ingress and the use of oil paint does the allow the stone to breathe. Water seepage is visible at the front porch. Ficus growth is visible along the front porch which also exhibits cracks and resulting seepage from the terrace above. Cracks are visible in places and a ceramic tile dado of green tiles in some of the walls.

9.3	Floor	Some cracks and pan stains are visible at most places.
9.4	Stairs	Steel staircases, leading upto the concourse are in a rather poor condition, the asbestos sheet roofing on some is broken; some of the steps are broken.

9.5	Openings	Many doors, windows and ventilators are kept closed on permanent basis but are in a fair condition. The main signage for Bandra station is placed prominently on the main porch and obliterates both the arches on the front elevation. The installation of indicators and hoardings has obliterated most of the pointed arches inside.

9.6	Roofing	The Mangalore tiled roof, is broken in places, The ridges and eaves of the roofs show signs of shoddy repair and patch work. The roof of the entrance portico on the west side has the original timber joists supported by steel I sections and the same suffers from problems of leakage. Water seepage from the roof, causes wet rot and warping of timber boardings. The asbestos cement sheet roofing is also broken in parts; a part of the overhead bridge is open to sky.

631 BANDRA STATION		
		design. Carved wooden balusters and eaves boards on the topmost central tower are broken and indicate wet rot. Cast iron finials at gable ends are missing or damaged. Though the original cast iron pillars, brackets and benches survive they are in dire need of restoration. Asbestos chajjas have been added to most openings.

12.2	Recommendations & Suggestions for Implementation	It is critical that replacement of original details must be done with utmost care, only when rendered absolutely essential. If this is however necessary, the

631	BANDRA STATION
	<p>original design should be replicated for details such as eaves boards and traceries as these greatly impact the visual quality of the facades.</p> <p>Bandra Station, though definitely worth conserving as a significant heritage building, does not merit classification as a Grade I structure and its heritage status could be revised to Grade II A. Moreover, the Heritage Committee should take cognisance of the insensitive additions and alterations to the structure, which are in total disregard to the heritage ambience.</p>

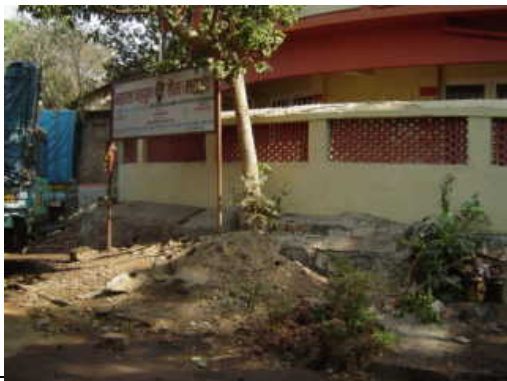
634(iii) MILESTONE -3 MILE FROM ST.THOMAS CHURCH

9.5	Openings	Not available
9.6	Roofing	Not available
9.7	Articulation & Finishes	Not available
9.8	Services	Not available
9.9	Outbuildings	Not available
9.10	Overall Condition	According to the Heritage Regulations, 1991, the milestone was cracked right across the middle and painted blue. Hence, its absence can be accorded to the lack of maintenance and decay due to neglect.

12.0		<b>ADDITIONAL NOTES/ REFERENCES/ DOCUMENTS AVAILABLE/ RECOMMENDATIONS &amp; SUGGESTIONS FOR IMPLEMENTATION</b>
		As the milestone no longer exists it should be removed from the list.

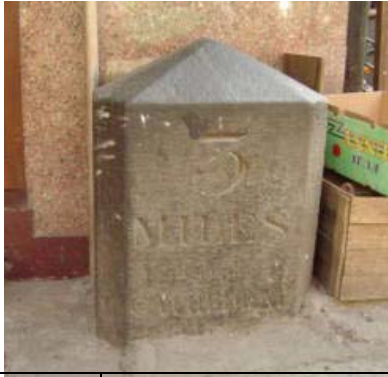
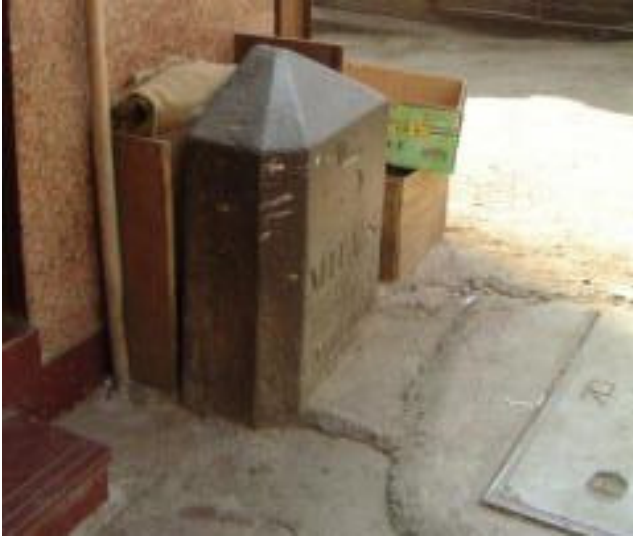
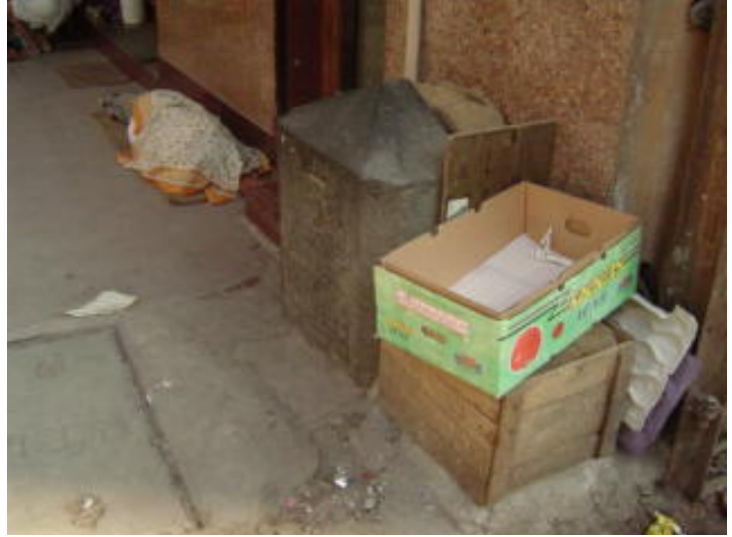
634(iv) MILESTONE-3 MILE FROM ST. THOMAS CHURCH

9.7	Articulation & Finishes	Not applicable
9.8	Services	Not applicable
9.9	Outbuildings	Not applicable
9.10	Overall Condition	Chipped along its edges, there is a total lack of maintenance of the milestone.

10.3	Articulation & Finishes	Stone staining and accumulation of grime

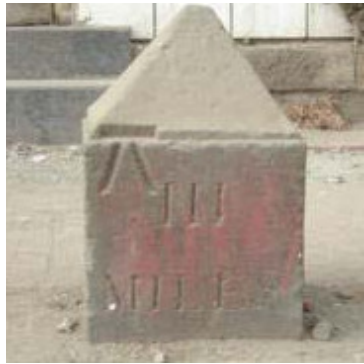
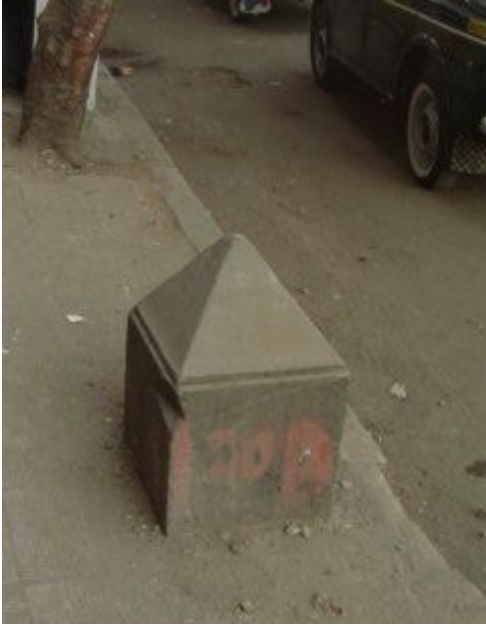
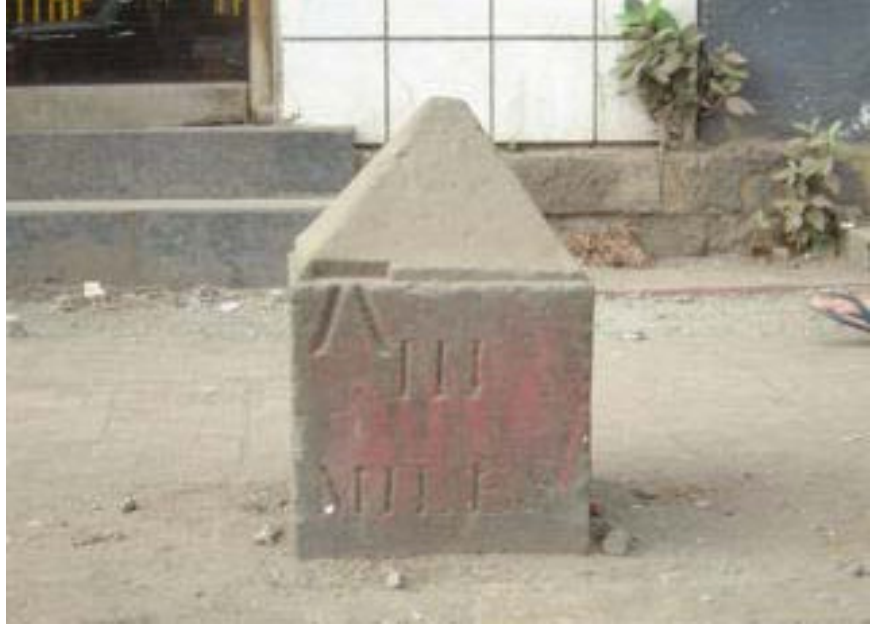
634(V) MILESTONE -3 MILE FROM ST.THOMAS CHURCH

9.7	Articulation & Finishes	Cuboidal stone shaft with a pyramidal top
9.8	Services	Not applicable
9.9	Outbuildings	Not applicable
9.10	Overall Condition	A little paint or chalk stains are seen on the stone, which further accentuate its deliberate poor condition. Slight Cracks are also observed at the side and the rear. The raised level of the pavement hides the base of the milestone from view and has dwarfed the original size.

10.3	Articulation & Finishes	Staining and dirt accumulation
11.0		<b>DP REMARKS/PERCEIVED THREATS</b>
		None
12.0		<b>ADDITIONAL NOTES/ REFERENCES/ DOCUMENTS AVAILABLE/ RECOMMENDATIONS &amp; SUGGESTIONS FOR IMPLEMENTATION</b>

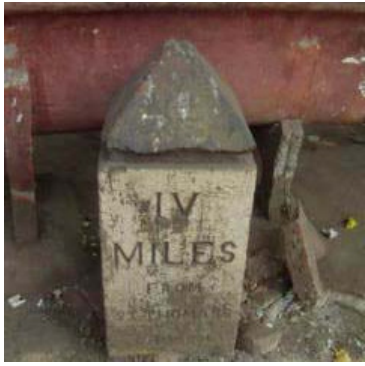
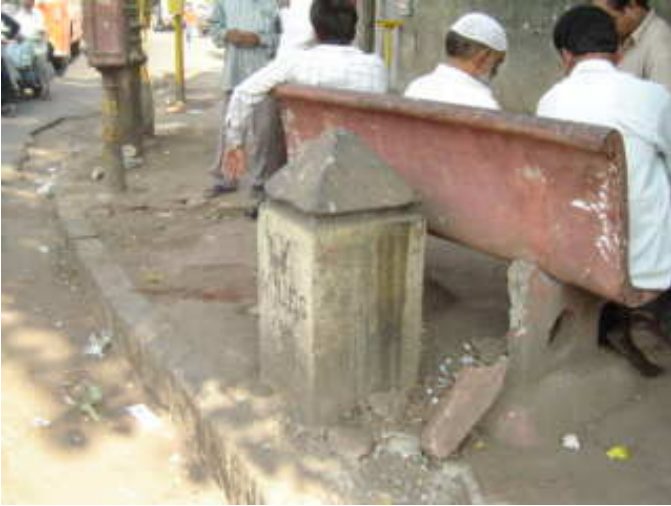
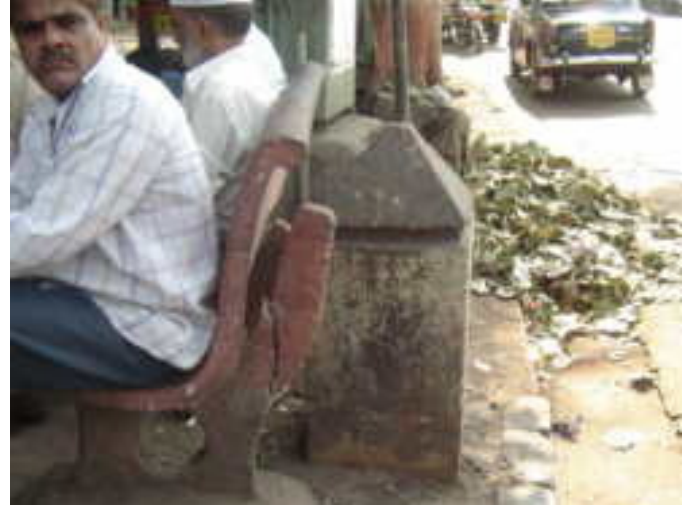
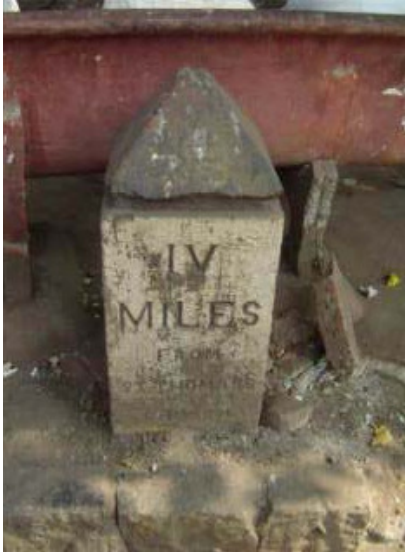
634(vii)		MILESTONE -4 MILE FROM ST.THOMAS CHURCH

9.10	Overall Condition	White painted stone with chipping and red stained by Paan chewers, this milestone also needs immediate attention and regular maintenance.

10.3	Articulation & Finishes	Stone staining, paan stains and grime
11.0		<b>DP REMARKS/PERCEIVED THREATS</b>
		None

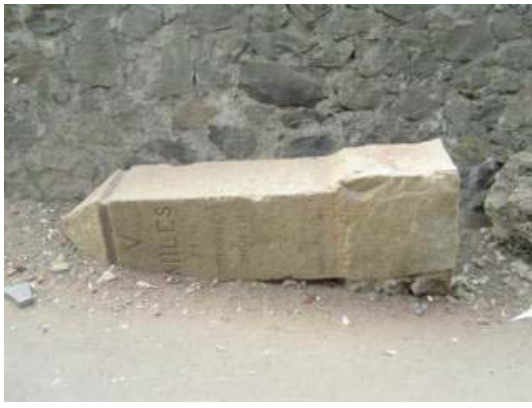
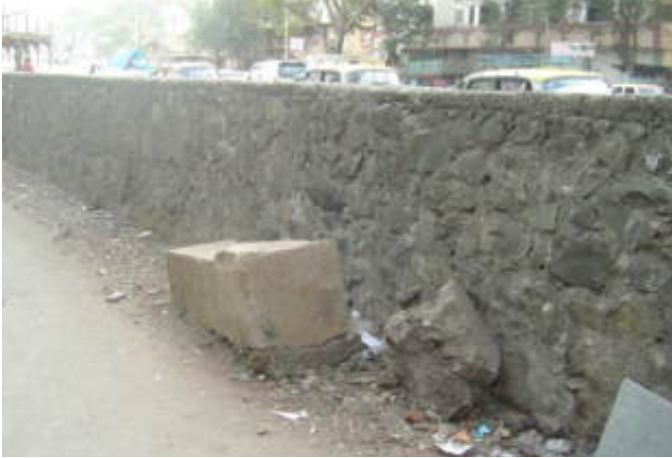
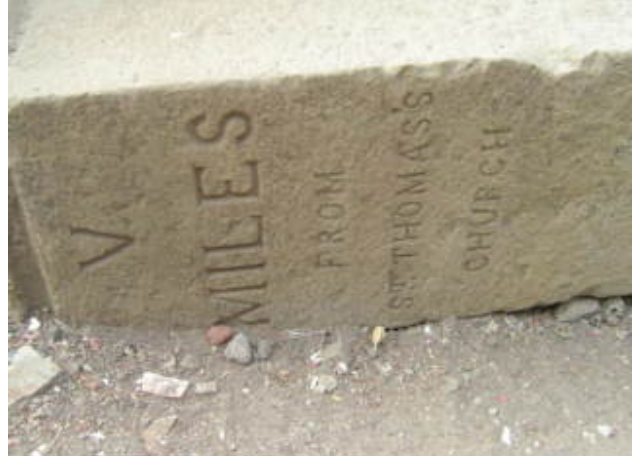
9.10	Overall Condition	Chipped at its edges, the large block of stone, an original entire milestone lies in a pathetic up state, upturned and lying in the dust.

634(ix)	MILESTONE -5 MILE FROM ST.THOMAS CHURCH	
		None
12.0		<b>ADDITIONAL NOTES/ REFERENCES/ DOCUMENTS AVAILABLE/ RECOMMENDATIONS &amp; SUGGESTIONS FOR IMPLEMENTATION</b>
12.1		In 1794, under the Governor George Dick, the City Civil Architect Lt. John Cunliffe was directed to set up Stone Markers in selected areas. These were constructed 18” above the ground level and marked the limits of the Town of Bombay. The Government reduced the limits of Bombay in 1813 to the Fort. Also, after 1830, St. Thomas Church was consecrated as St. Thomas Cathedral <sup>1</sup> .
		The Milestone needs to be re-rooted in its original location as an immediate step to restore it. Further appropriate maintenance plans should be drawn with due recognition to their significance and with sensitive interventions.

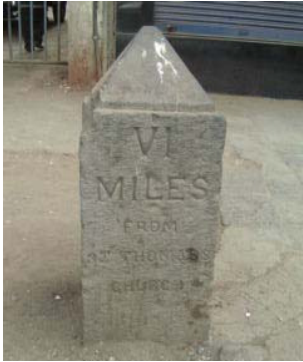
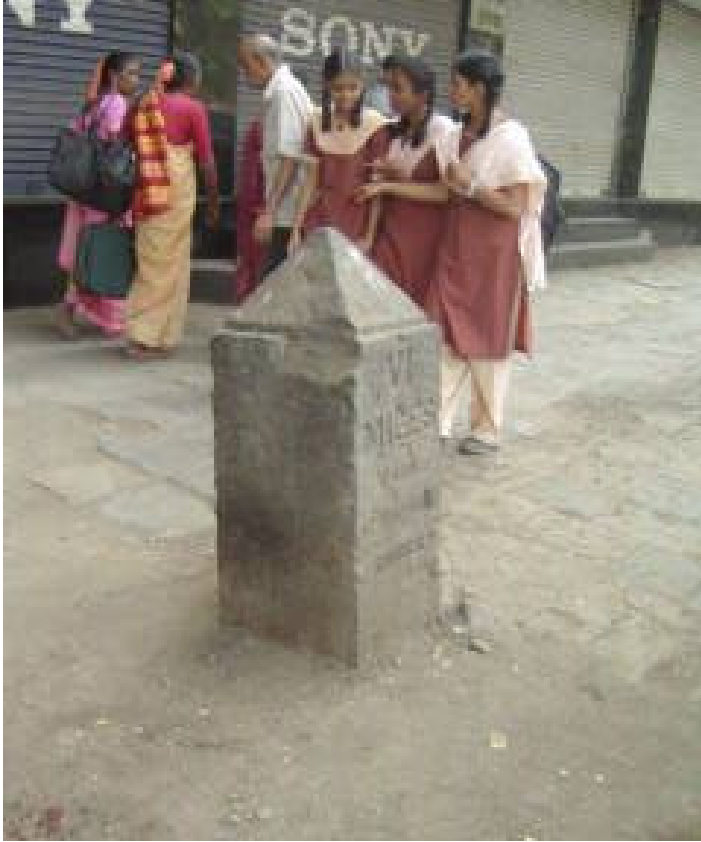
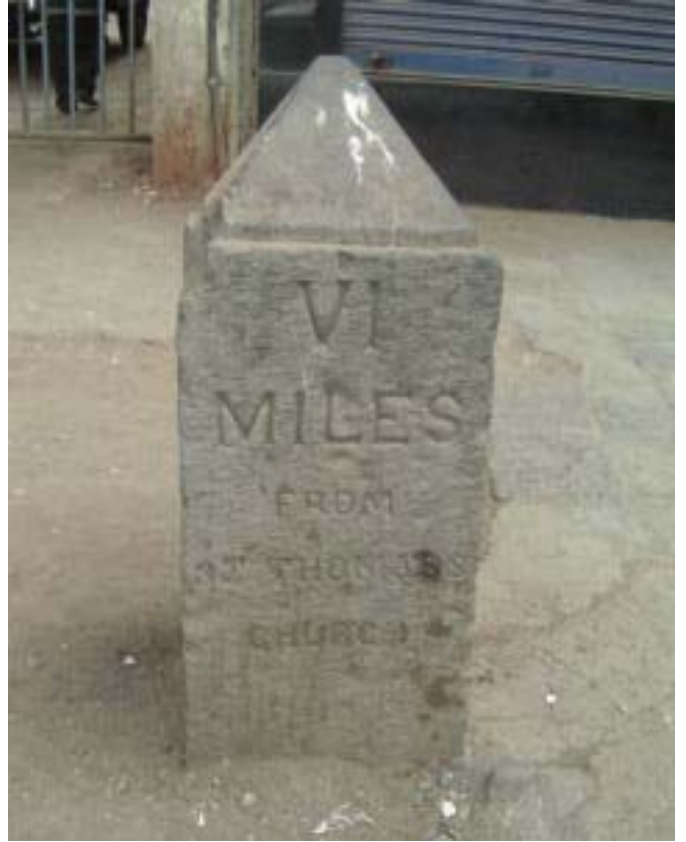
634(X) MILESTONE -6 MILE FROM ST. THOMAS CHURCH

9.8	Services	Not applicable since it is a milestone
9.9	Outbuildings	Not applicable since it is a milestone
9.10	Overall Condition	Chipped at its edges, the large block of stone leans tiredly pockmarked with bird droppings and stains. The pavement surfacing is uneven and broken
