DELINEATION AND LISTING OF MADH, ERANGAL, AKSA, MARVE, MANORI, CULVEM, AND GORAI PRECINCTS IN MUMBAI

STUDY CONDUCTED BY RIZVI COLLEGE OF ARCHITECTURE CONSULTANCY CELL, MUMBAI FOR MMR-HERITAGE CONSERVATION SOCIETY

REPORT

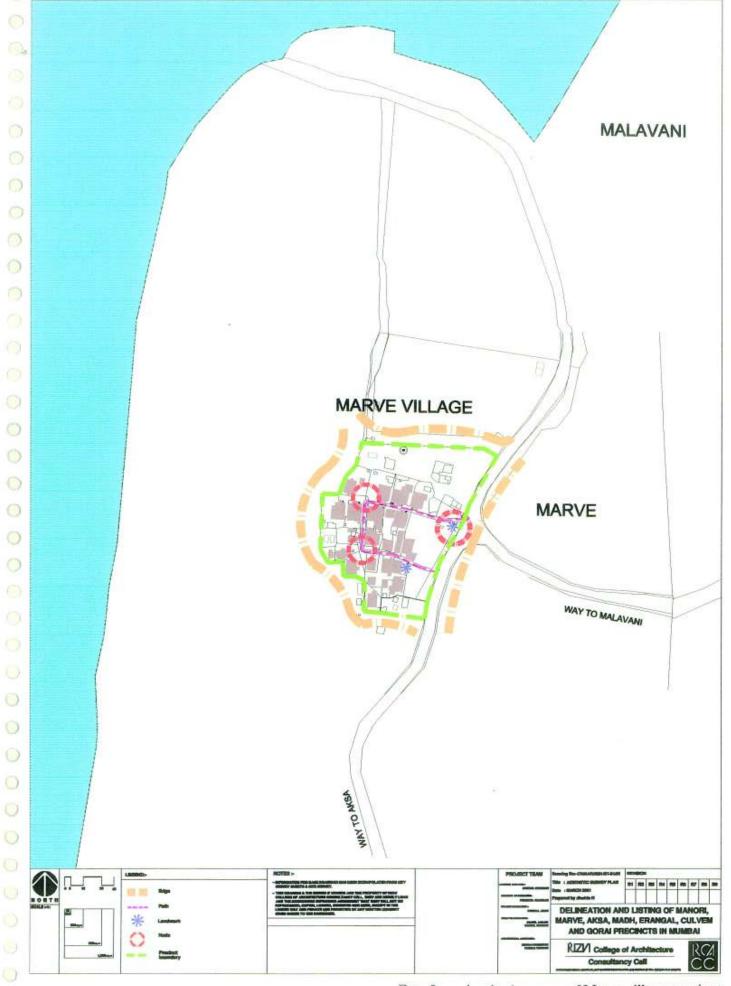
Drg. 8 Aesthetic survey of Marve village precinct Source RCACC (2001)

The Marve Gaothan area is physically bound by the defence land on the north and a main Malad-Madh road on the east side. (Refer Drg. 8)

- 4.1.8.1 Malad Madh road is the major path connecting all the coastal villages on the eastern side.
- 4.1.8.2 The south and the western sides are edged by the defence residential areas.
- **4.1.8.3** There are few smaller landmarks like crosses, which impart the settlement its way finding values.

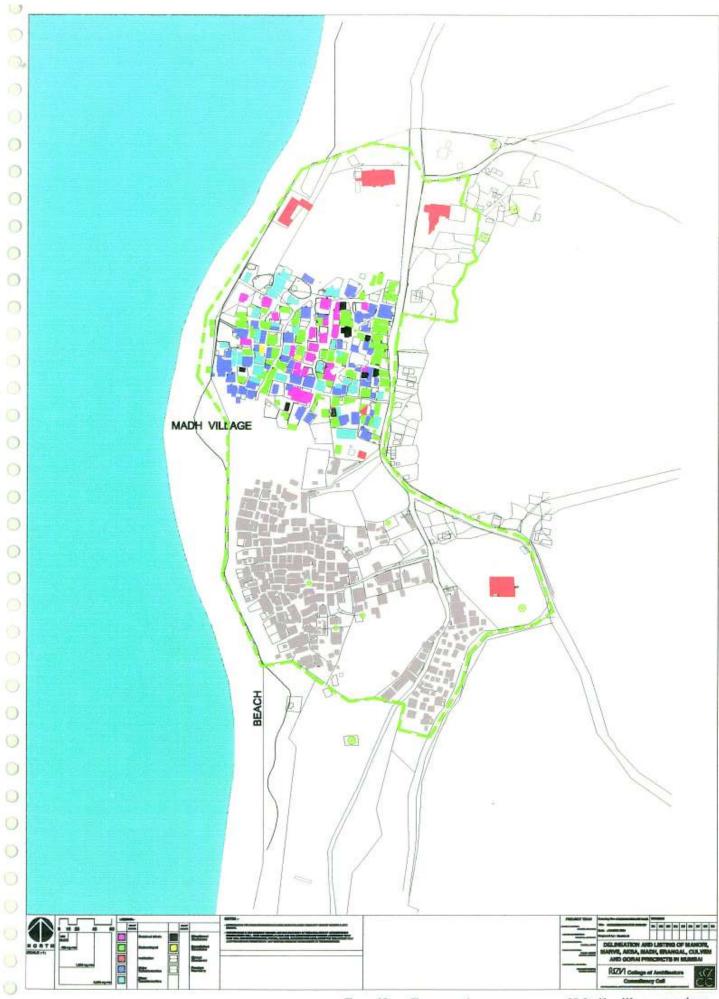
Drg. 12 Reconnaissance survey of Madh village precinct Source RCACC (2001)

The above details exhibit that nearly one-third of the built fabric has already transformed in addition to another one-third, which has been redeveloped. Out of the remaining one-third, half of the structures have undergone minor transformation. There is imminent need to render protection and support to the retained fabric to enhance their longevity. This could be achieved through delineation of the significant fabric as a listed heritage precinct (Refer section 4.2.5).

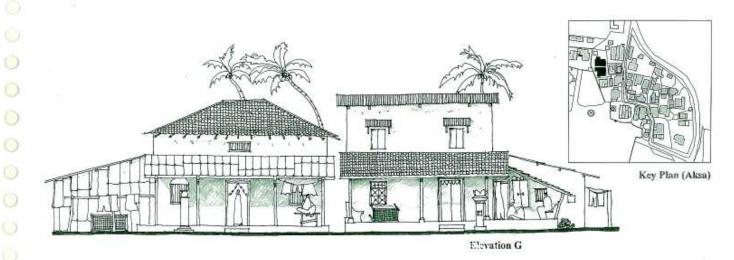
Elevations of the residential pattern in Aksa villageprecinct RCACC (2002)

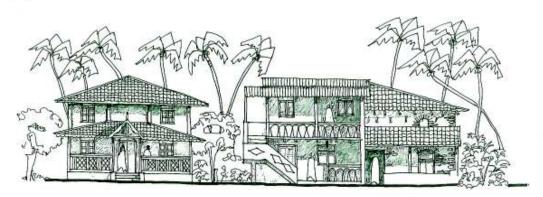
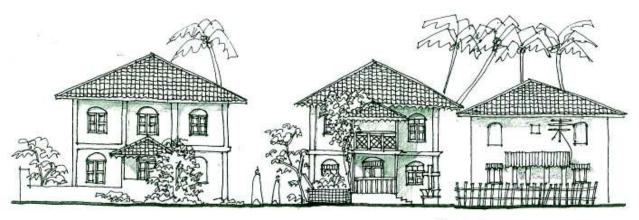
Drg 33 Elevations of the residential pattern in Culvem village precinct
Source RCACC (2002)

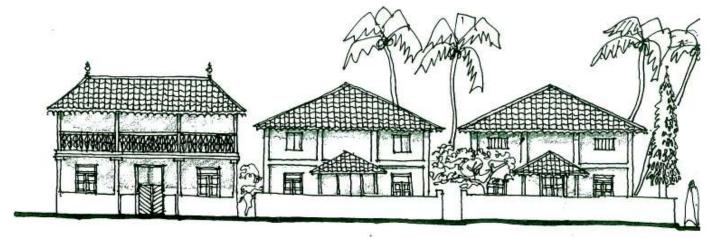
Drg 34 Elevations of the residential pattern in Gorai village precinct RCACC (2002)
