Nagpada Police Hospital complex

Card No.: E-1			
	Ward (Part): E IV			
	CS No.: 1447			
	Plot Area: 4992.60 sq.m.			
	B U Area: Not available			
	Date: June, 2005			
	Record by: Ojas P, Gauri J			
	Review by: Neera Adarkar			
	Internal: As above			
External: As above				
Photo Ref.: T-III-E:Ward E\ Nagpada Police Hospital complex

1.0	Denomination			
1.1	Name of Premises	Nagpada Police Hospital complex		
1.2	Earlier Name	Not applicable		
1.3	Built in	Late 19 th century	Extension Date (if any)	Not applicable

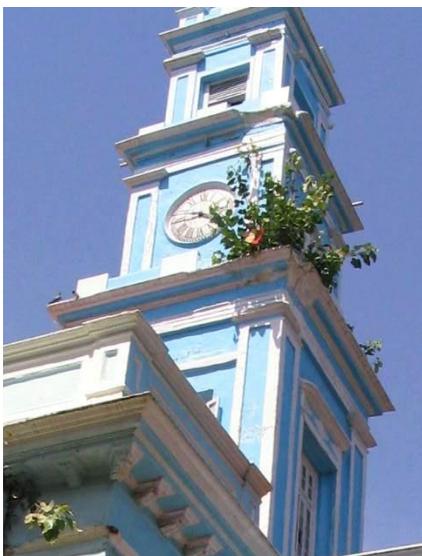
9.0	Condition			
9.1	Plinth	Excellent (No cracks or settlement observed)		
9.2	Walls	Good (Tree growth on clock tower, no cracks observed)		
9.3	Floor	Good (No deflection observed)

Horizontal bands on clock tower with beginning of tree growth on the tower

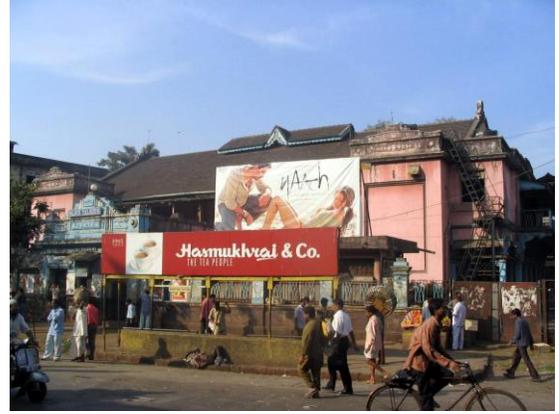
Large size movie posters hide the façade

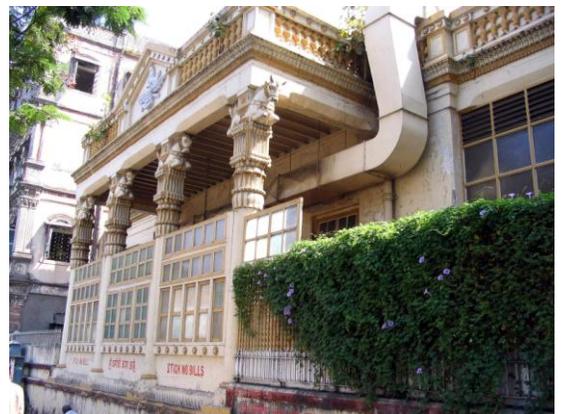
9.8	Services	Access denied		
9.9	Outbuildings	Good (Maintained clean)		
9.10	Overall condition	Good	Maintenance level	Good
10.0	Transformation			
10.1	Form	Duct seen on front façade.

Duct projecting from the front wall disturb the composition of front façade

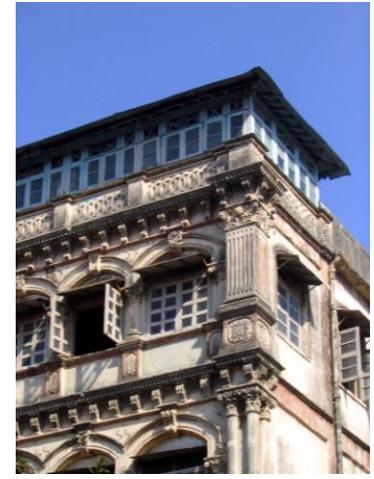
9.10	Overall condition	Fair	Maintenance level	Fair
10.0	Transformation			
10.1	Form	Addition of top floor without regards for the overall style box grills added to some windows, some of the timber windows replaced by aluminium windows. M.S. Chajjas added Ground floor openings Covered by signboard.

Details of dentils, pilasters, capitals, architraves with part top floor addition

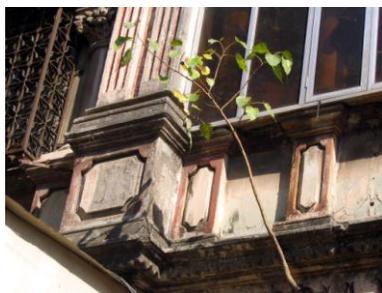
10.2	Structure	Ground floor and first floor timber staircase replaced by R.C.C. staircase.		
10.3	Articulation & Finishes	No transformation		
11.0	DP Remarks / Perceived Threats	Tree growth observed at entrance on first floor level out of wall.

Tree growth on front façade

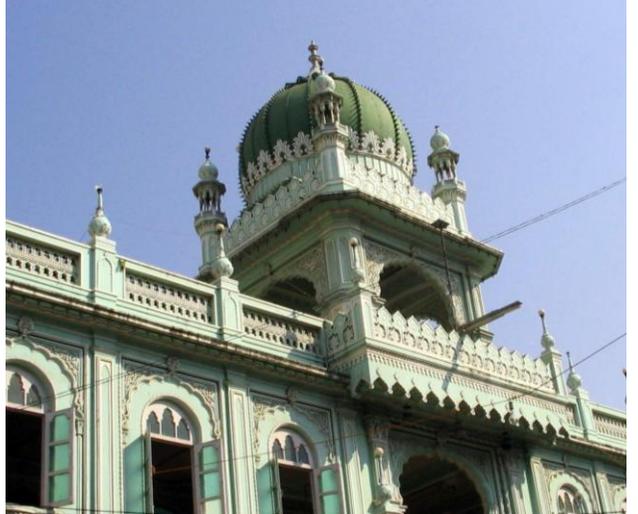
Front elevation facing Tank Street

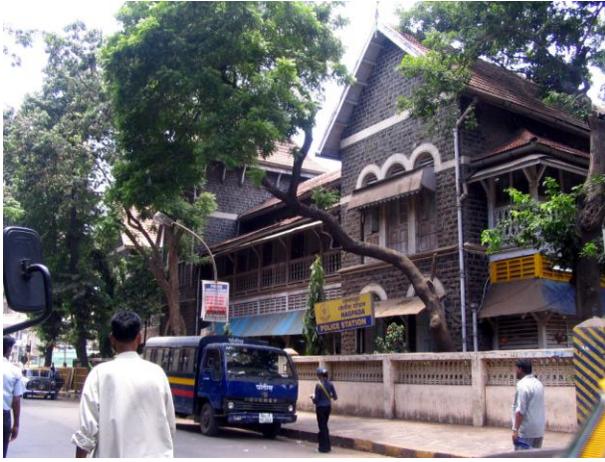
View from Sofia Zubair Road

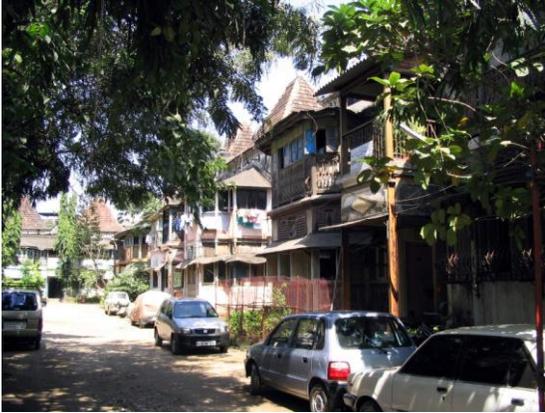
View of 'The Retreat' as seen from the gate on Bellasis Road

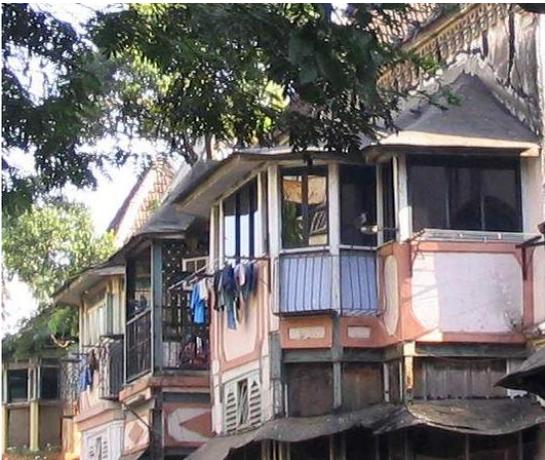
Carved wooden balconies replaced by parapet walls at some places

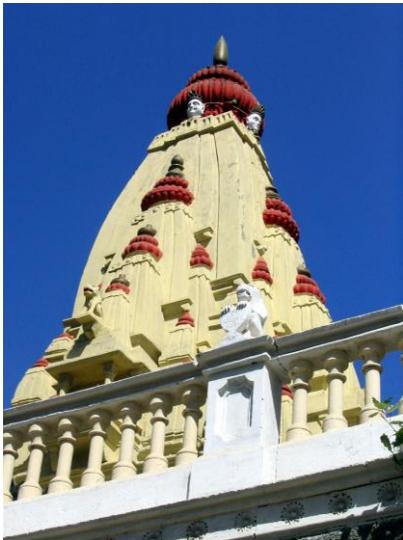
Stone Kalasha, newly painted in bright colours

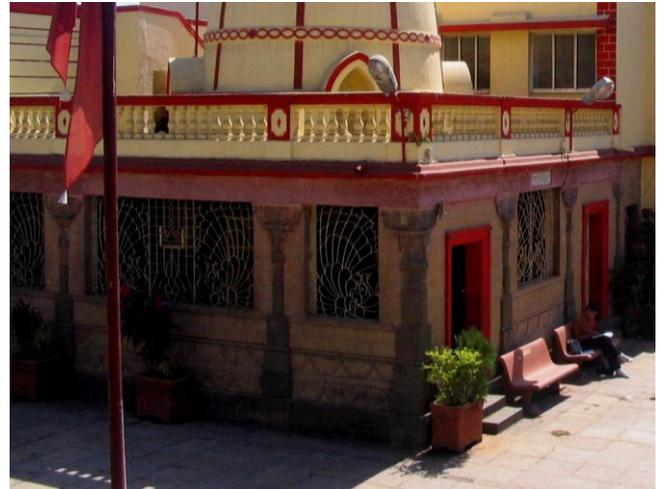
Façade with original carved stone pillars with newly constructed brick walls plastered & painted like Malad stone

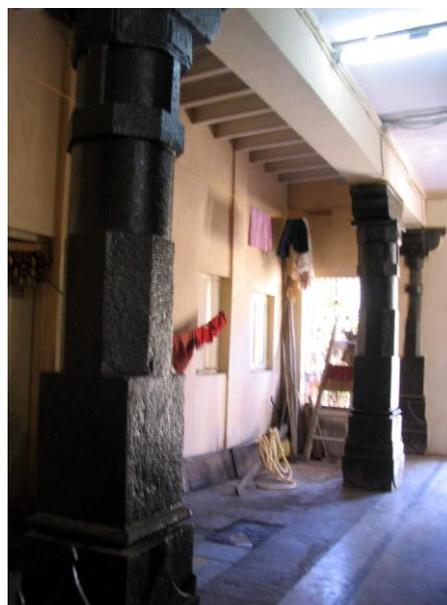
Old stone pillars, now painted to a black shiny finish

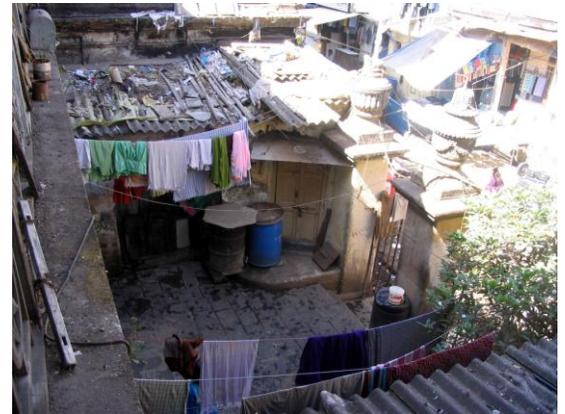
Encroachments in the front open space

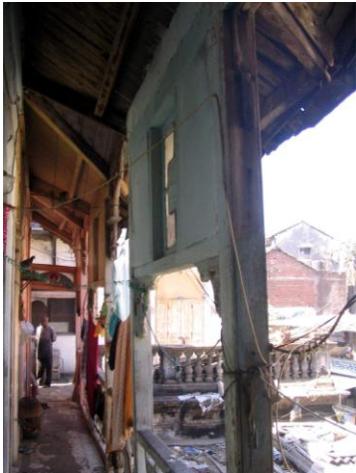
9.5	Openings	Poor (Windows broken at many places)		
9.6	Roofing	Poor (Leakage at many places)		
9.7	Articulation & Finishes	Poor (Intricately carved details need a lot of maintenance, not in very good condition with wooden members decayed at some places and broken articulation, needs immediate repair)

Terrace railing in dilapidated state

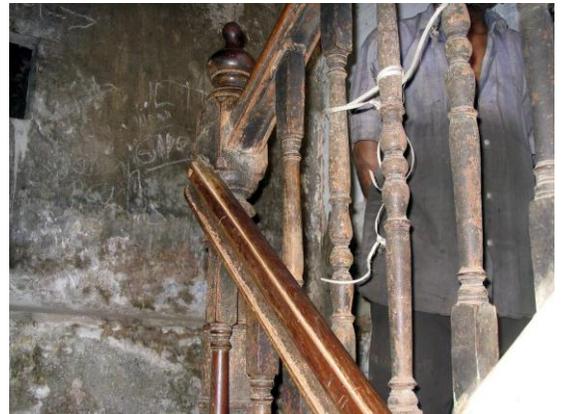
9.2	Walls	Poor (Dampness observed at many places with chipped off plaster and cracks at some places)		
9.3	Floor	Poor (Sagging at many places)		
9.4	Stairs	Poor (structural members need maintenance)

Wooden members of staircase need maintenance

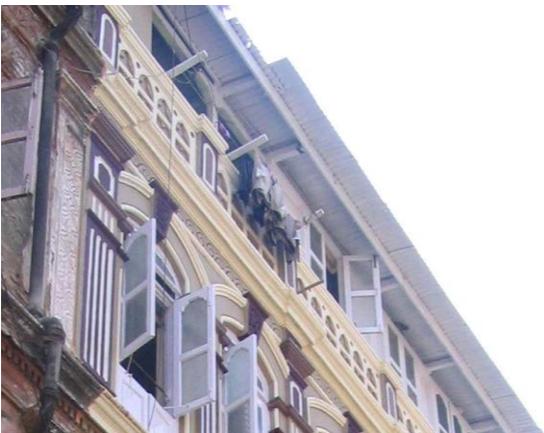
Detail of the Top floor added subsequently

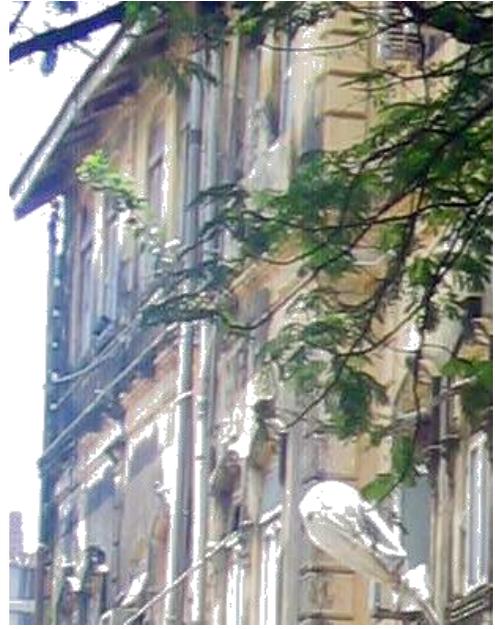
Detail of semicircular arched windows on side along with the chipped off plaster

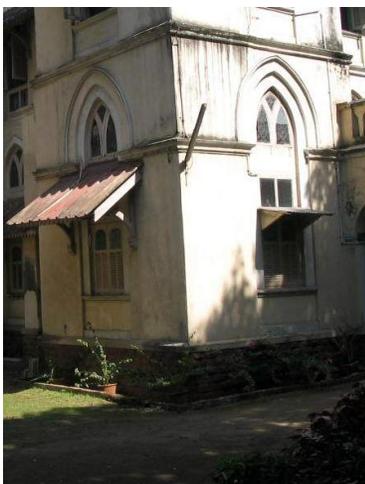
Chajjas added subsequently over the windows on western side

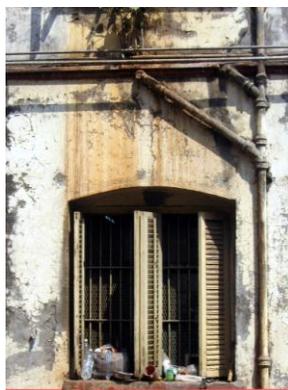
Leakage from the downtake pipes damage the plaster

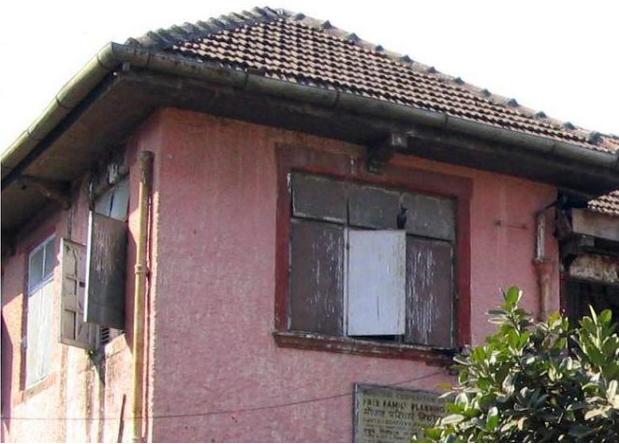
Some window panes replaced by tin sheets

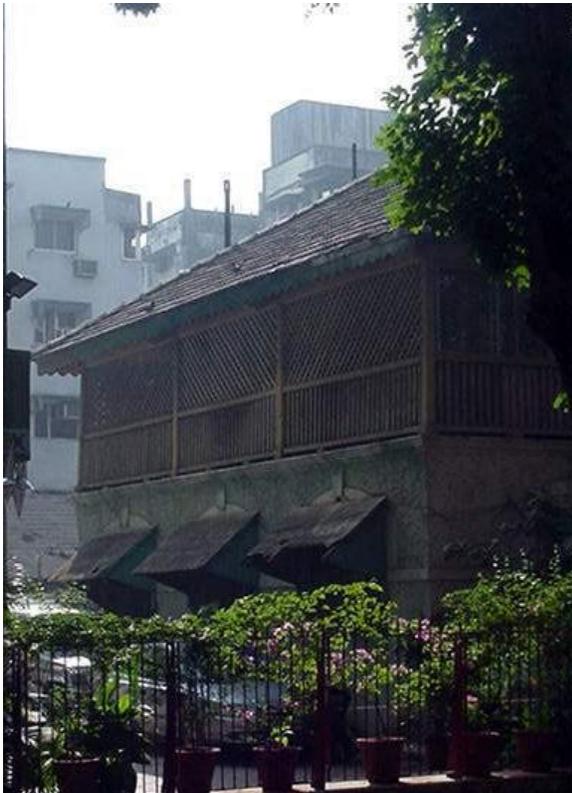
Detail of wooden jall on first floor with chajjas added to the ground floor arched openings

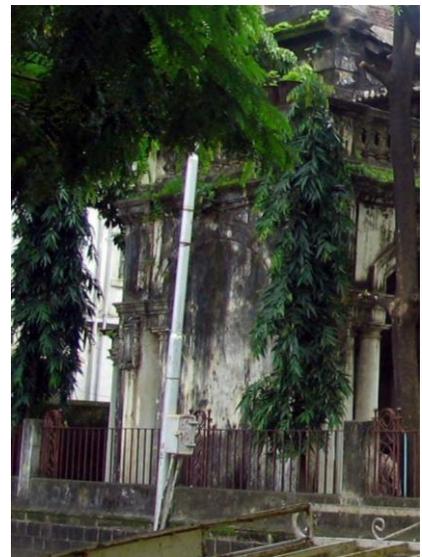
10.1	Form	Front arch in the porch filled up by brickwork with plaster, balcony roof replaced by AC slides, M.S Chajjas added at some places.		
10.2	Structure	No transformation

Front arch of the porch has been enclosed by plastered brick work

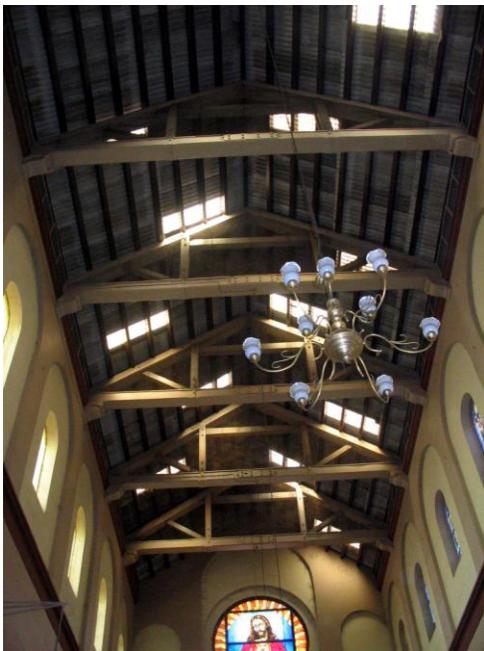
Original timber boardings removed and acrylic skylight along with asbestos sheet roof is an add-on

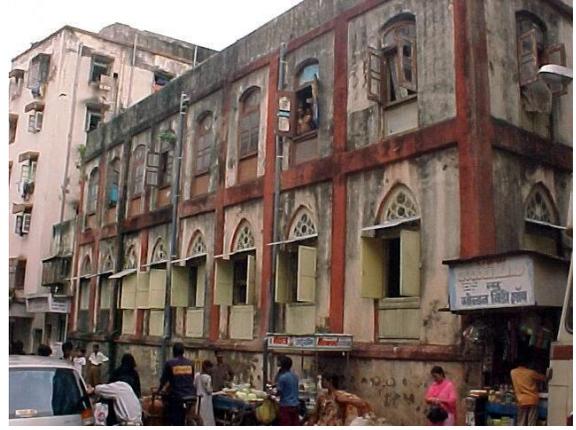
Replastered façade facing D'Lima Street

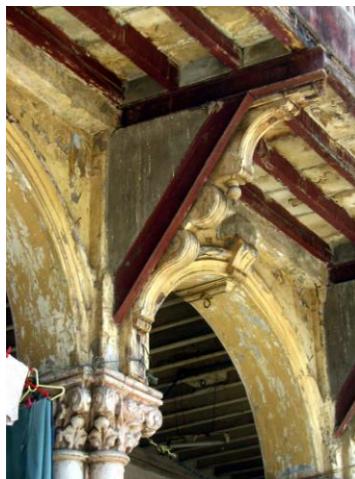
Restrengthening of brackets and slab by M.S. members

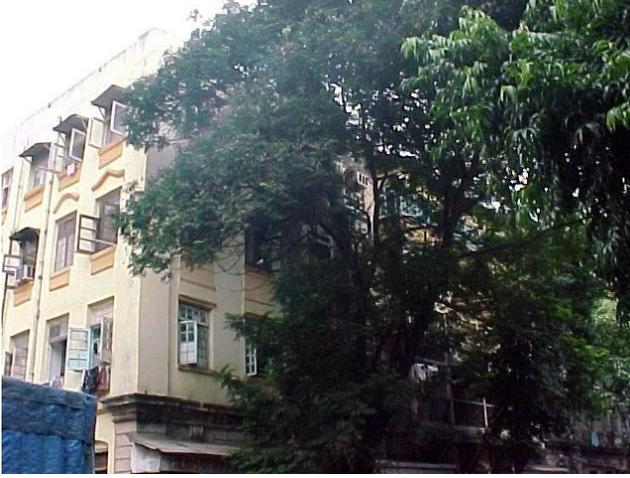
Front view facing Nawab Tank Bridge, partly hidden behind trees

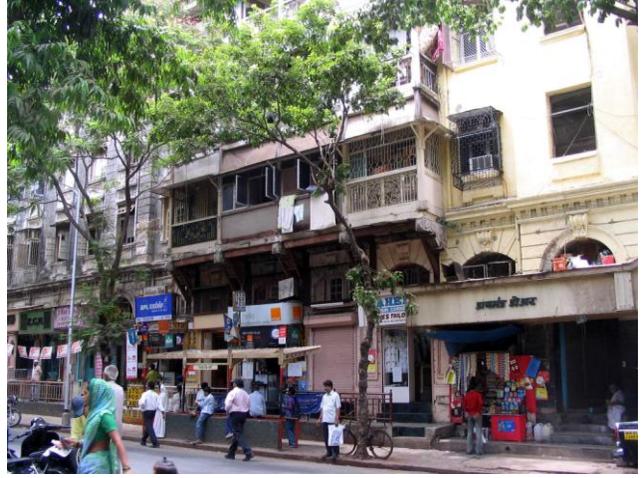
9.9	Outbuildings	Poor		
9.10	Overall condition	Poor	Maintenance level	Poor
10.0	Transformation			
10.1	Form	Some Chajjas added. Ground floor shop front hidden behind signboard.

Front view showing the shopfront on ground floor

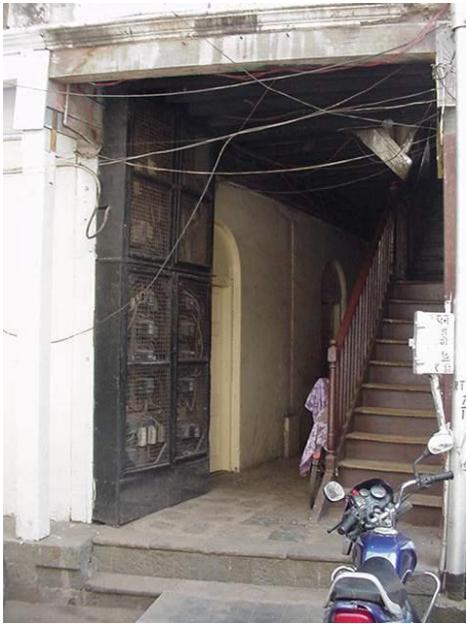
9.4	Stairs	Fair (Sagging of some treads)		
9.5	Openings	Fair		
9.6	Roofing	Fair (No leakage observed, some wooden members need maintenance)		
9.7	Articulation & Finishes	Fair (Needs replastering externally)

Straight flight wooden staircase

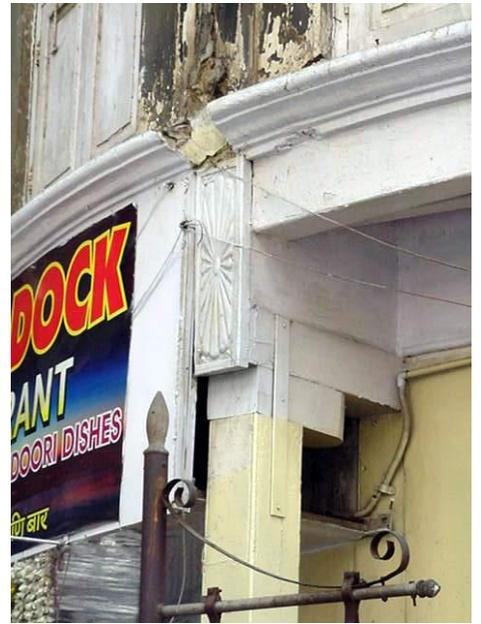
10.1	Form	No transformation		
10.2	Structure	Wooden columns on ground floor, wooden joist replaced by MS I section		
10.3	Articulation & Finishes	First floor is replastered

Detail of the load bearing wooden structural members near the staircase

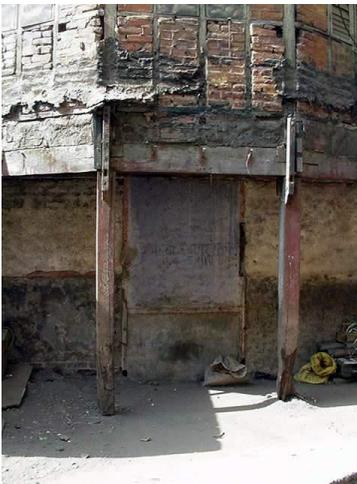
8.6	Fire precaution	Access denied		
8.7	Other (HVAC / BMS / Security Systems)	Not provided		
9.0	Condition			
9.1	Plinth	Extremely poor (Plinth settlement in South-Eastern and North-Eastern corner and cracks at many places)

9.2	Walls	Extremely poor (Structural members failed, Cracks at many places)		
9.3	Floor	Extremely poor (Sagging at many places, structure rests on profs at many places)

9.7	Articulation & Finishes	Extremely poor (Needs maintenance)		
9.8	Services	Access denied		
9.9	Outbuildings	Fair		
9.10	Overall condition	Extremely poor	Maintenance level	Extremely poor

Extremely dilapidated structure supported on props

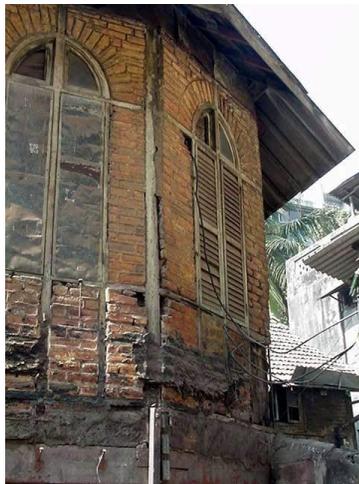
Most of the windows are masked by tin sheets on place of wooden louvers

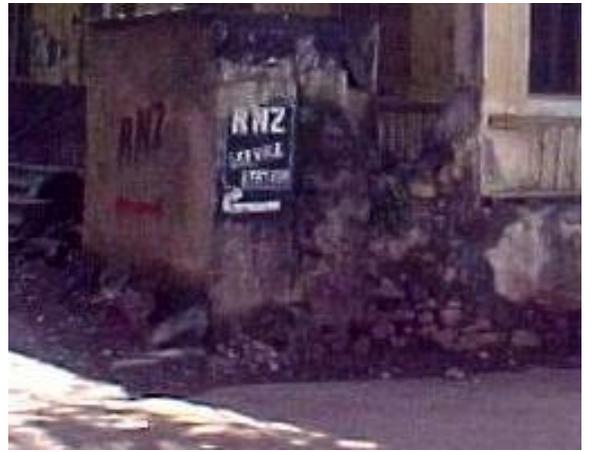
9.0	Condition			
9.1	Plinth	Poor (Settlement observed near the road junction, cracks at some places)		
9.2	Walls	Poor (Cracks in plaster, dampness at a few places, plaster chipped off)

Settlement of plinth observed near the road

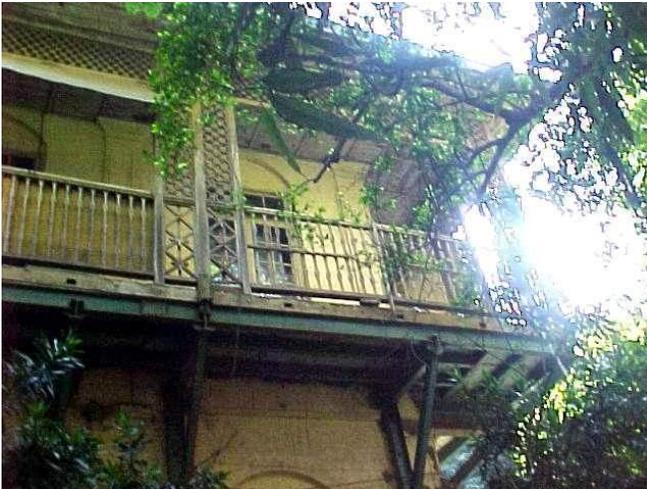
9.10	Overall condition	Fair-Poor	Maintenance level	Fair
10.0	Transformation			
10.1	Form	No transformation		
10.2	Structure	M.S. brackets added in place of wooden brackets.

Wooden brackets of balcony, now replaced by steel members

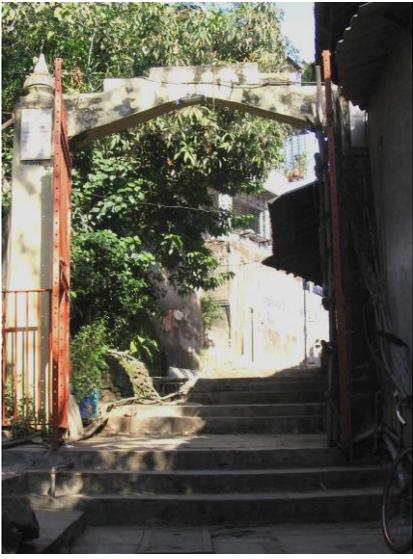
9.9	Outbuildings	Good		
9.10	Overall condition	Good	Maintenance level	Good
10.0	Transformation			
10.1	Form	Ground floor replastered, asbestos sheet roof on M.S. truss added to the external staircase

Asbestos sheet roof added later on

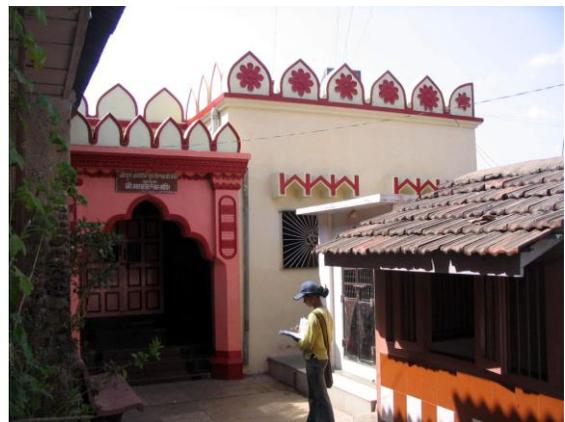
9.10	Overall condition	Fair	Maintenance level	Fair
10.0	Transformation			
10.1	Form	Recently painted		
10.2	Structure	Mankeshwar Temple rebuilt		
10.3	Articulation & Finishes	No transformation

Reconstructed façade of the Mankeshwar Temple

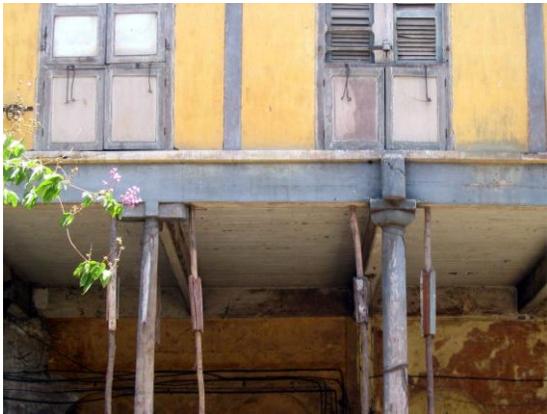
9.0	Condition		
9.1	Plinth	Poor (Cracks and settlement at some places)	
9.2	Walls	Fair (Cracks observed at some places)	
9.3	Floor	Poor (First floor shows deflection to a large extent and the projecting portion over the entrance portico is supported on motifs. The floor requires immediate attention and repairing)

The dilapidated projecting portico in front rests on props

12.0	Additional Notes / References / Documents Available	Notes: One of the old clubs of Mazagaon used for social gatherings and residential use. The structure is historically and socio-economically very significant as it is amongst one of few clubs for which Mazagaon was known. Has a high heritage value. Needs attention for maintenance on priority basis. Documents: C.S. Sheets, D.P. Sheets, Eicher City Maps-Mumbai.

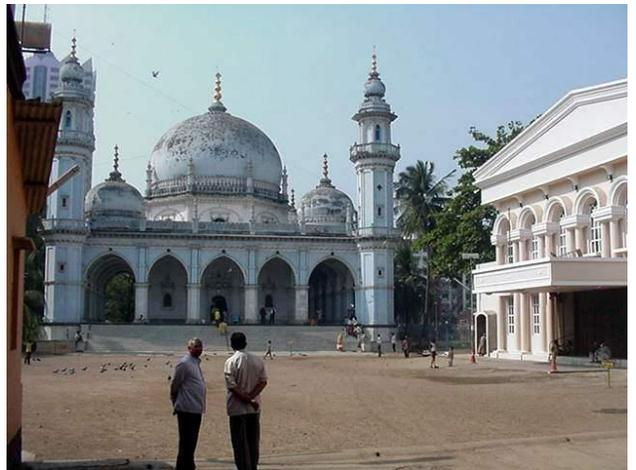
View of the Mausoleum with newly constructed structure in the compound

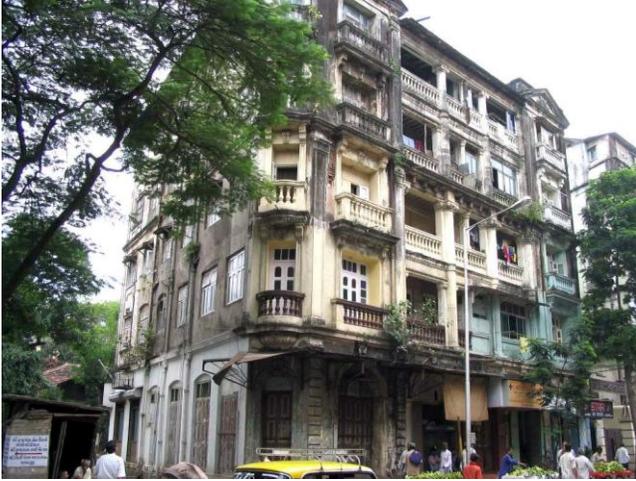
9.8	Services	Fair (Some pipes need repairs)		
9.9	Outbuildings	Fair		
9.10	Overall condition	Fair	Maintenance level	Fair
10.0	Transformation			
10.1	Form	Ground floor arched shopfront enclosed by signboard.

View of the Mazgaon Mansion facing Dr. Mascarenhas Road (Mount Road) along the corner of the right of way to other property

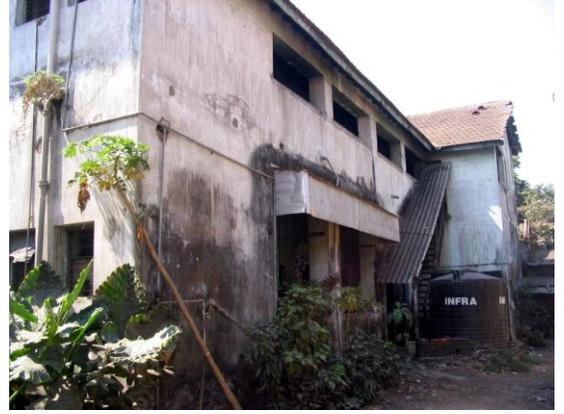
Rear elevation of St. Stephen Village Home showing the service staircase

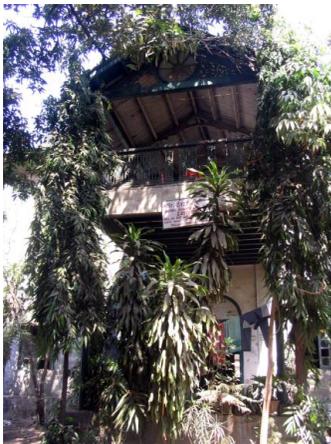
Large trees in front hide the front façade

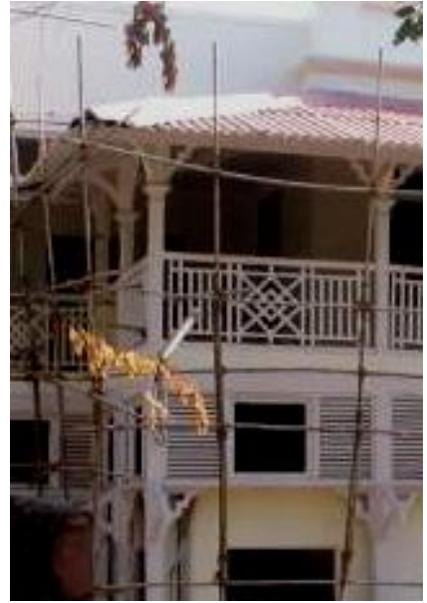
Detail of timber balcony at corner

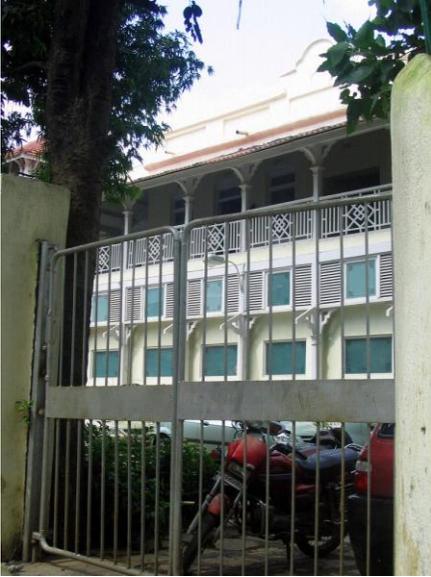
Frosted glass fixed panels added subsequently on ground and first floors

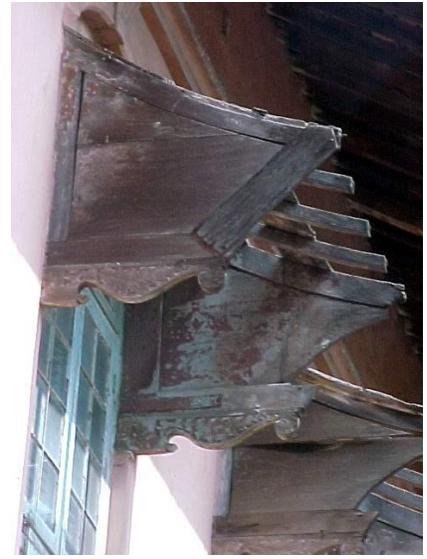
10.0	Transformation			
10.1	Form	No transformation		
10.2	Structure	No transformation		
10.3	Articulation & Finishes	Some wooden chajjas replaced or broken, canopy added at entrance.

Detail of the decorative wooden chajja, now broken

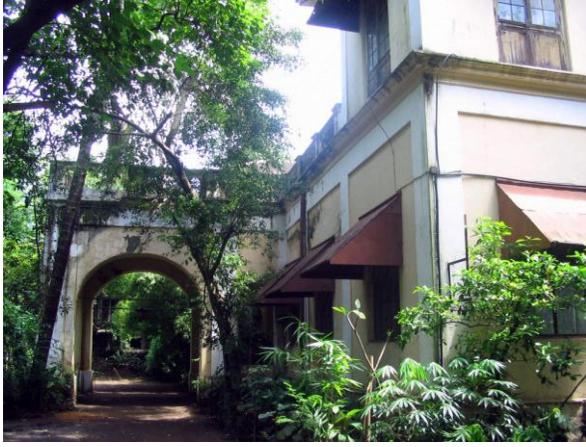
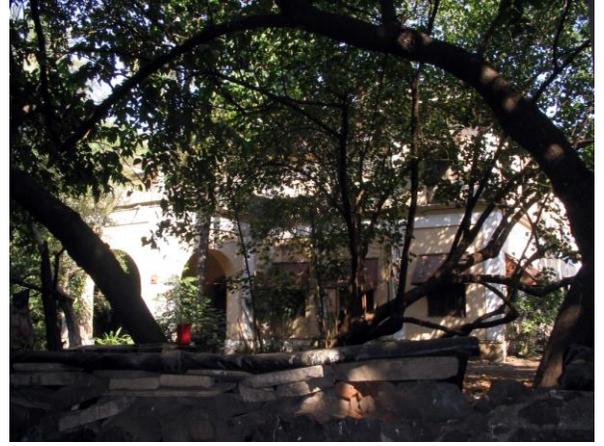
Part façade hidden due to dense vegetation

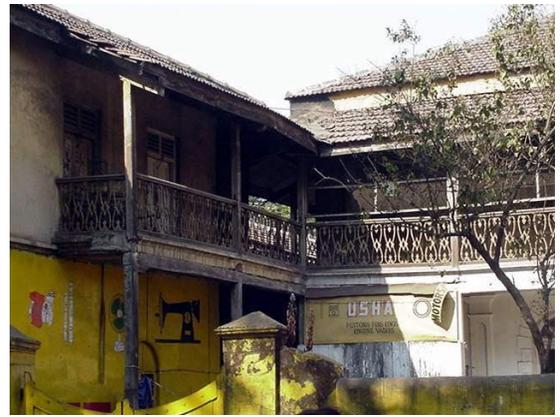
Part front façade hidden behind trees

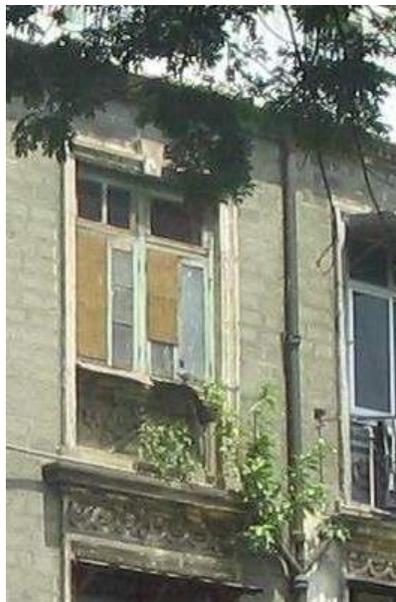
Tree growth on façade near the downtake pipe

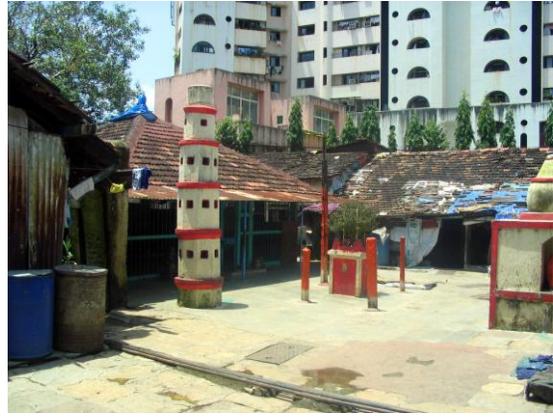
View of the front open space in front and the encroachments around, construction of a multistoried tower spoils the skyline

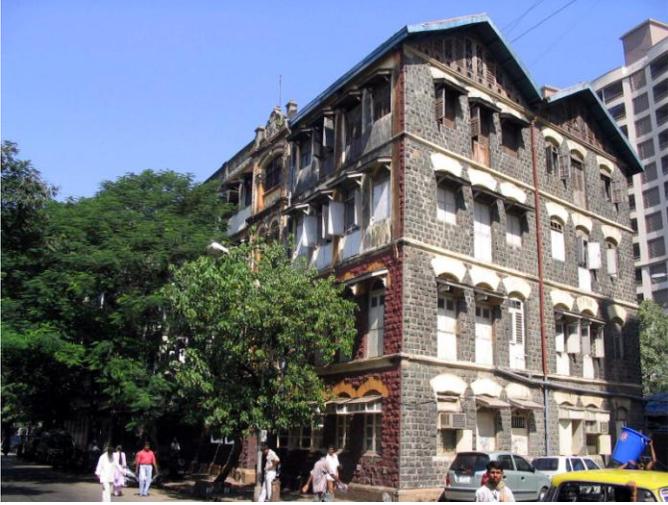
Detail of façade at corner, part of front façade hidden behind the tree foliage

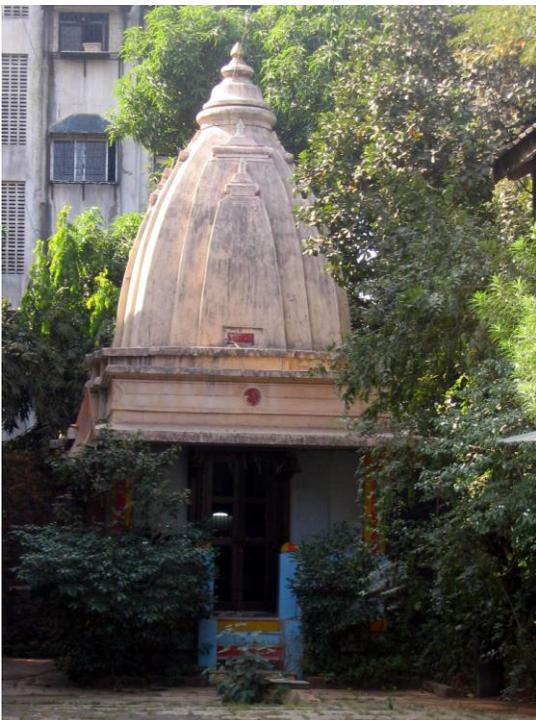
9.8	Services	Poor (Completely shut down)		
9.9	Outbuildings	Poor (Needs immediate clean-up)		
9.10	Overall condition	Poor	Maintenance level	Poor
10.0	Transformation

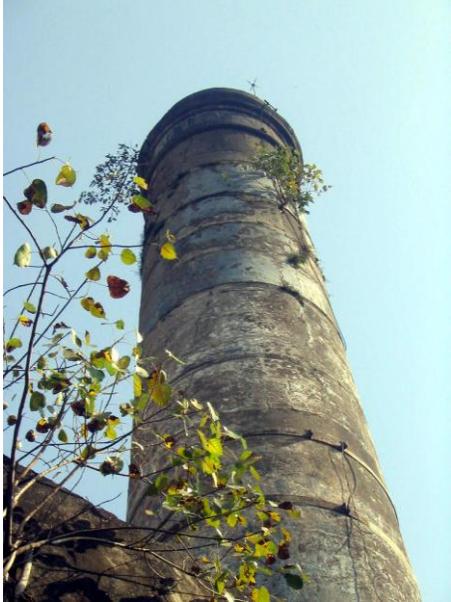
9.2	Walls	Fair (Cracks observed at many places, tree growth on façade)		
9.3	Floor	Not applicable		
9.4	Stairs	Not applicable		
9.5	Openings	Not applicable

View of the chimney top, with tree growth seen on façade

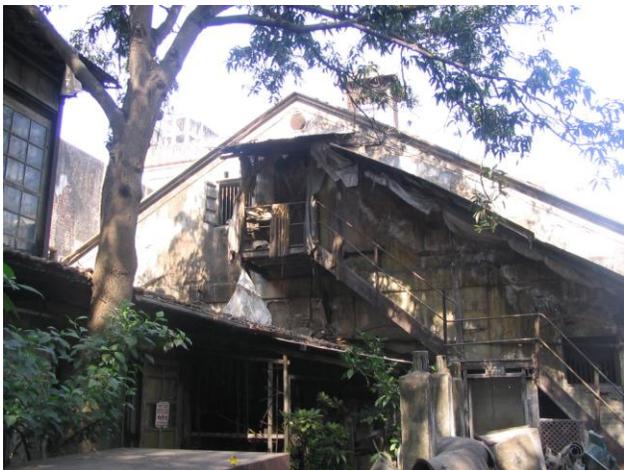
Some structures in the mill are in dilapidation

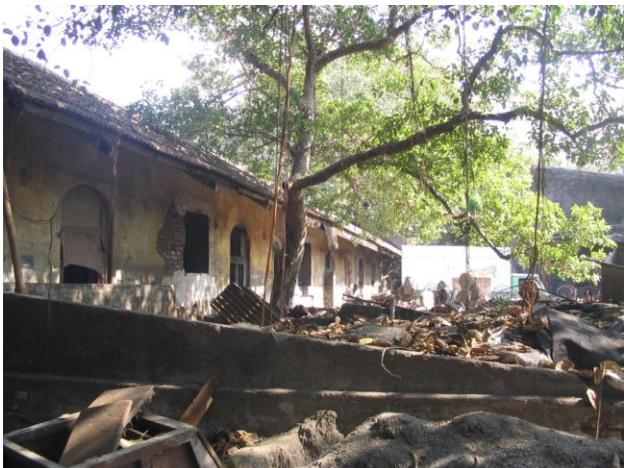
View of the debris in the mill premises

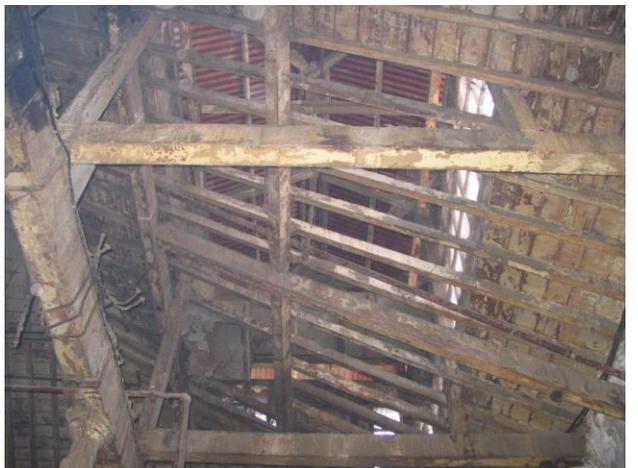
View of the broken roof

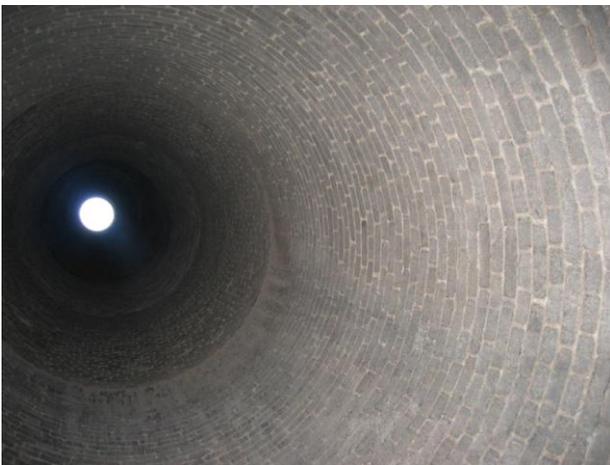
Interior of the chimney with construction of brick masonry in cylindrical profile

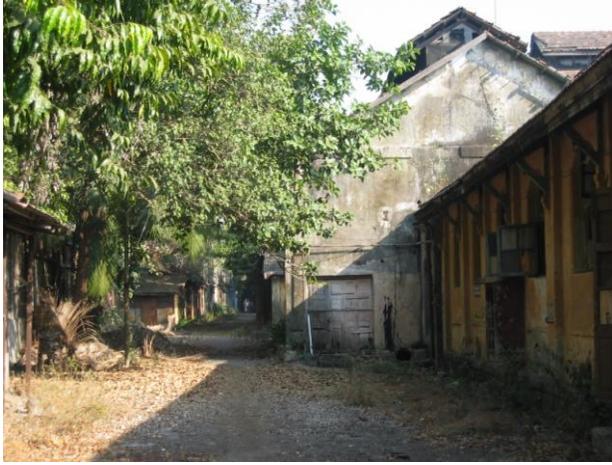
Elongated façade of the Weaving Shed

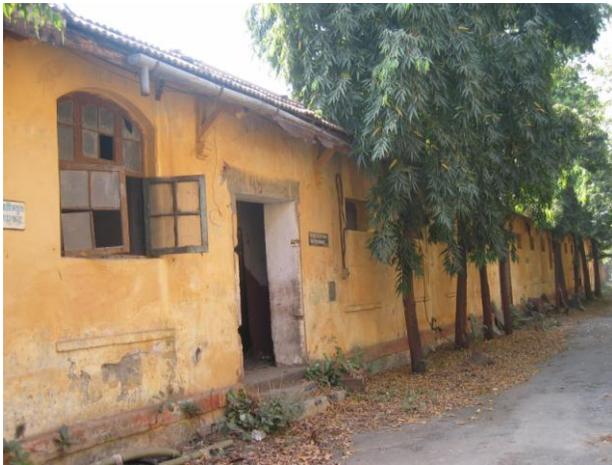
Front view of the Weaving Shed

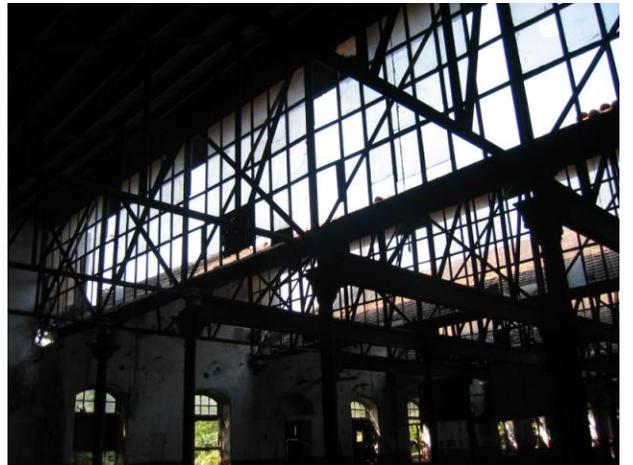
Detail of north light glazing in north light roof

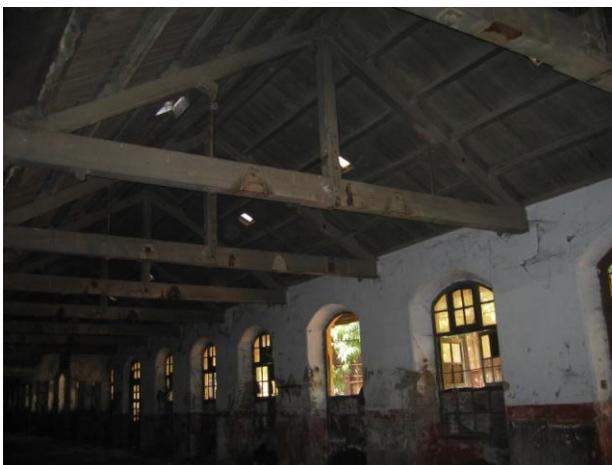
Segmental arched windows at equal intervals and detail of wooden roof trusses

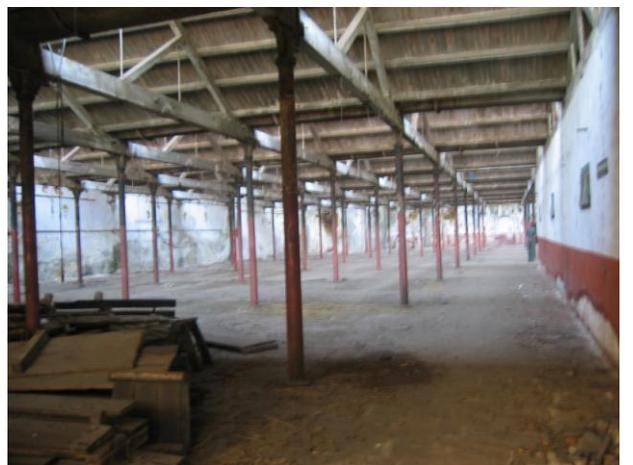
Weaving Shed- internal view
