LISTING & DOCUMENTATION OF HERITAGE SITES IN THANE DISTRICT

URBAN AREAS

MUMBAI METROPOLITAN REGION HERITAGE CONSERVATION SOCIETY

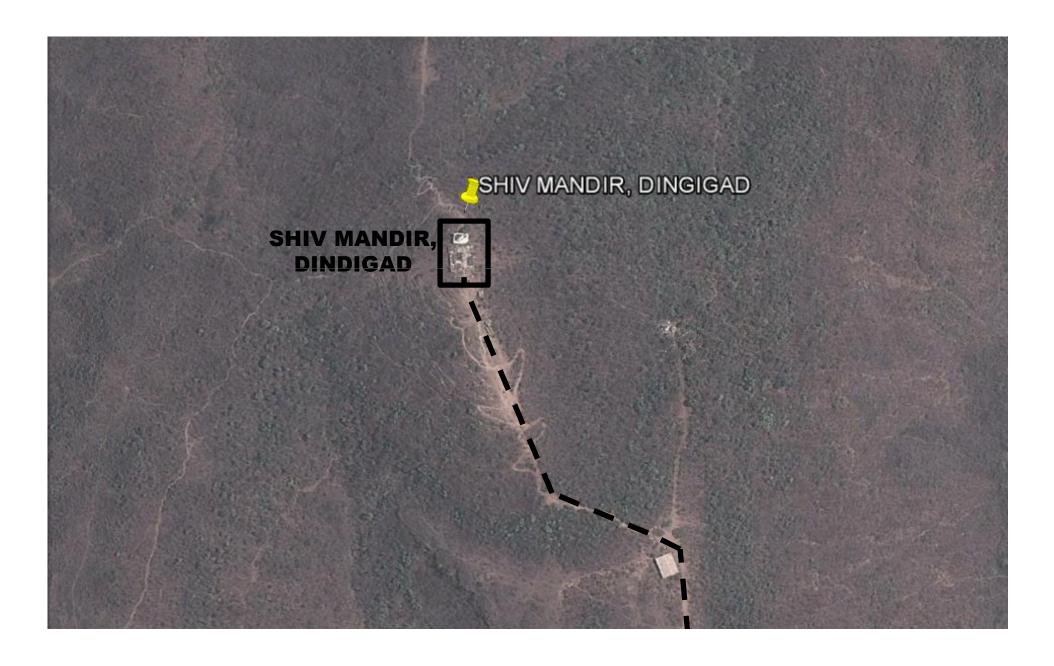
SITE NO: BWU10 NAME: SHIV MANDIR, DINDIGAD

Excavated material nearby

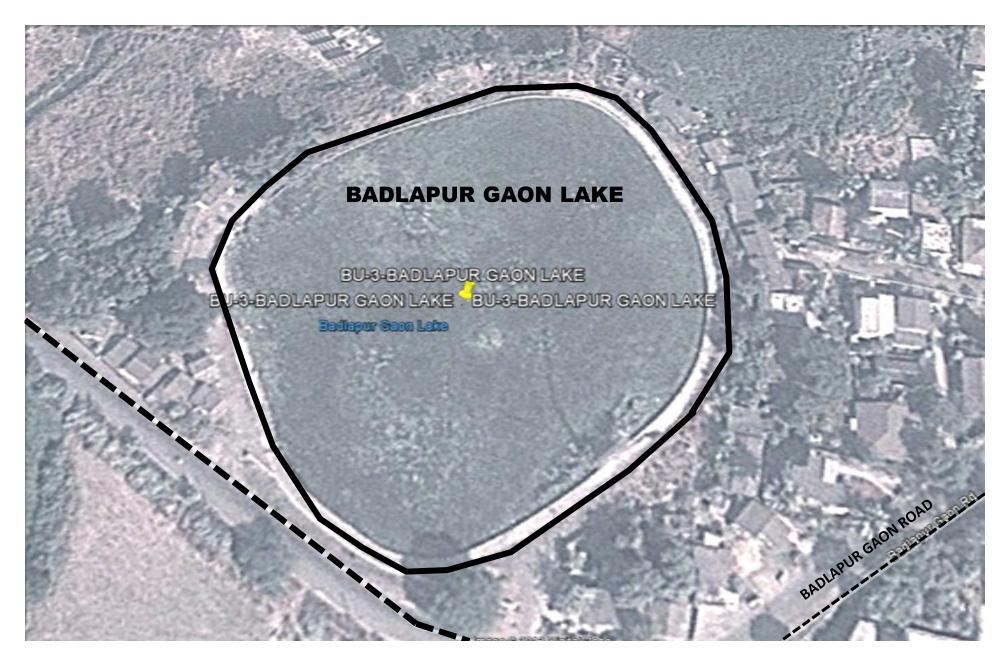
SITE NO:BU8 NAME: BADLAPUR GAON LAKE

Immediate surroundings of lake used as dumping area

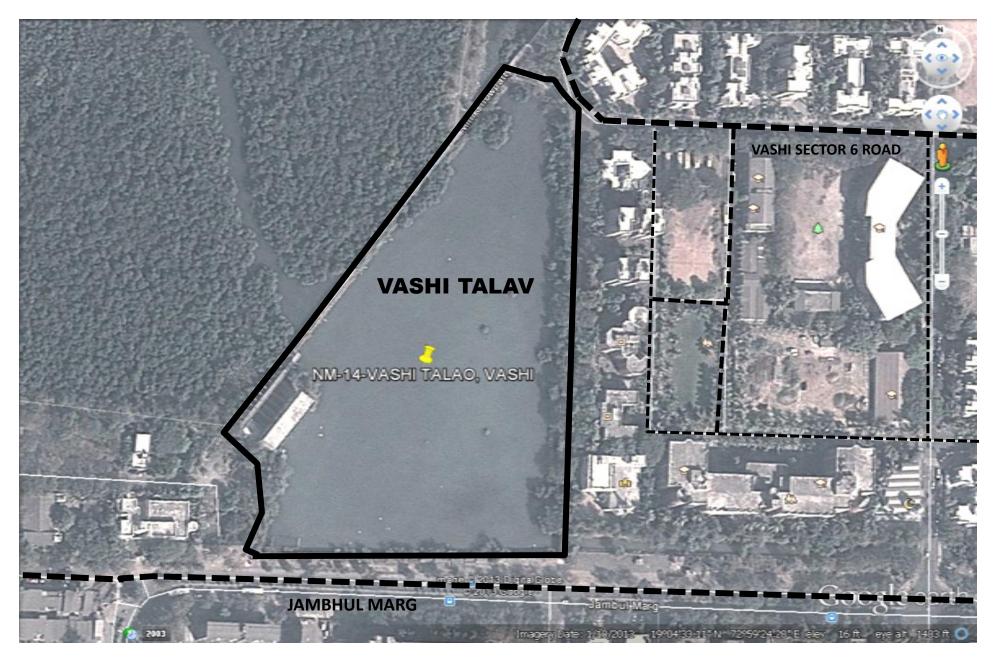
SITE NO:NM13 NAME: VASHI TALAV

Newly constructed RCC temple near talav

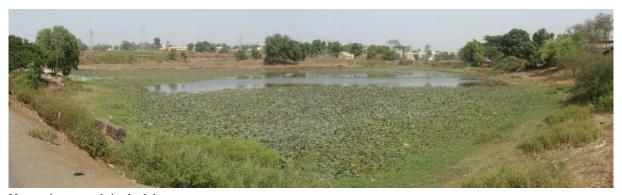
Vegetation growth in the lake

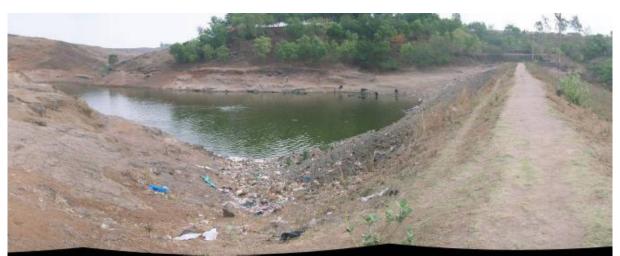
View of lake from end of the dam. Water polluted with plastic bags and garbage

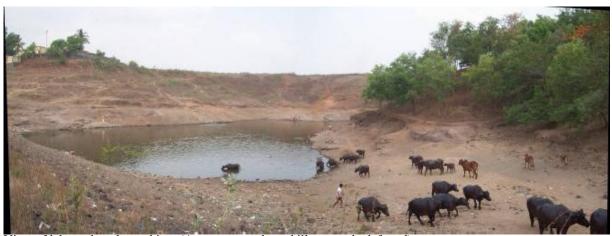
View of lake and cattle washing. (Ayyappa temple on hill top on the left end)

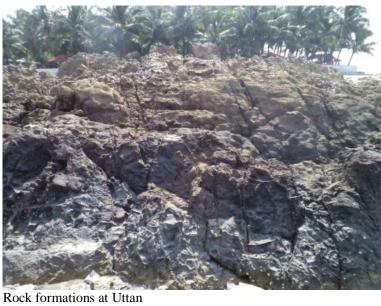
Image Title: Rock formations
Image Type: Front-View
Reference: D:IndrayaniMMRHCSAfter 24 Nov 2011Photos for
Presentation

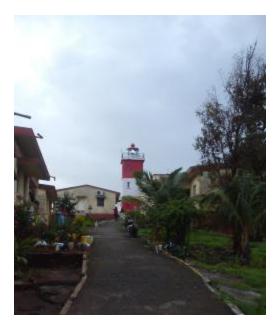
Site No. MB3 Name: Light House

View from the approach road

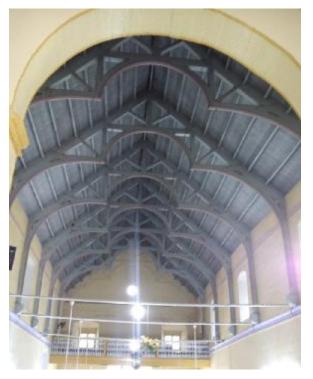
Name: Our Lady of Bethlehem Church

3.08	Openings	Timber framed windows and doors	Fairly maintained	Minor Repair
3.09	Roof	Manglore tiled Sloping roof supported by wooden trusses and masonry buttresses	Fairly maintained	Minor Repair

Truss supporting the Roof

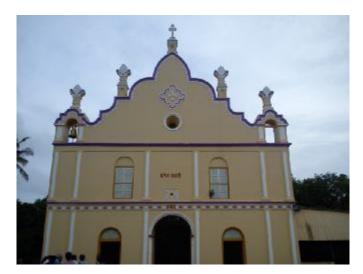
3.10	Articulation	The façade reveals a well balanced set of typical gable features. The upper part is stepped in the combination of concave and convex curves, with steps between them and segmental apex which carries a Cross.	Fairly maintained	Minor Repair

Church Facade

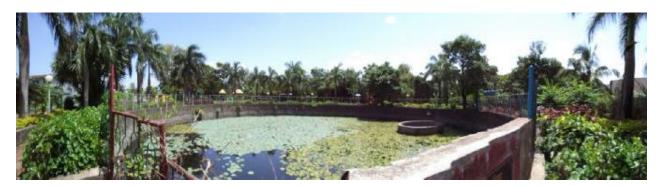
Panoramic view of the lake and well

4.03	Guidelines for Interventions: The water body needs to be cleaned periodically. All inflow channels should be unclogged to ensure ingree of fresh water. Adequate garbage bins need to be provided in the immediate vicinity to prevent dumping or refuse. A buffer of 10 m all around should be kept free of any construction. A water body is an important component of natural heritage, often associated with historic periods. Nature resources are limited and are eroding at an alarming rate. The water bodies i) support rich and varied ecosystems including flora and fauna over centuries; ii) they conserve rain water, iii) they are significant nodes for social and cultural gatherings and iv) offer psychological recreation to the residents in the nearbareas. They are of great Environmental value.

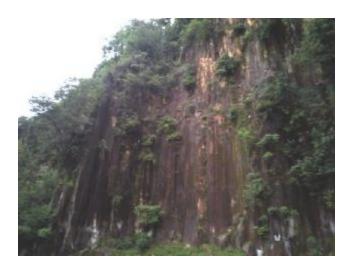
Columnar Rock Formation
